RESIDENTIAL BUILDING SURVEY

Kent

Mr & Mrs X

INDEPENDENT CHARTERED SURVEYORS

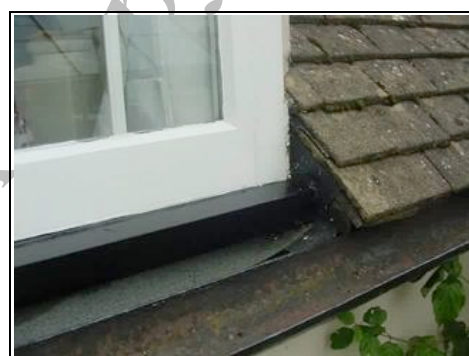
Some of the windows have been updated and some of the windows are double glazed. From what we understand Listed Building Consent was not obtained or sought. You will need to be aware that you will become liable for replacing these with appropriate windows if the listed building/conservation officer was made aware of them and felt them inappropriate.

Modern replacement timber window

ACTION REQUIRED: Your legal advisor to speak to the council/conservation officer to ascertain whether listed building consent should have been sought.

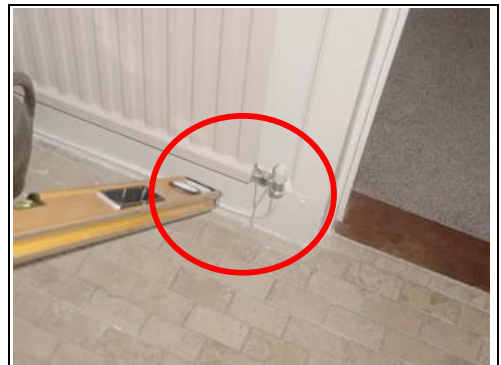
Micro-bore pipes

ACTION REQUIRED: We would recommend that the micro-bore is replaced. We would also change any single panel radiators to double panel convection radiators.

ANTICIPATED COST: In the region of £150 - £250 per radiator depending upon the pipework repositioning; please obtain quotations.

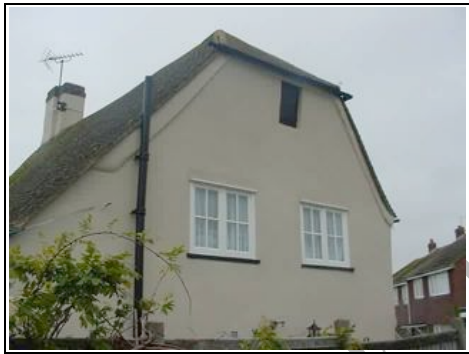
The entirety of the external of the property has had a cement render rather than a lime render which unfortunately with a timber frame structure that this property has will accelerate deterioration.

Thickening of the render at high level

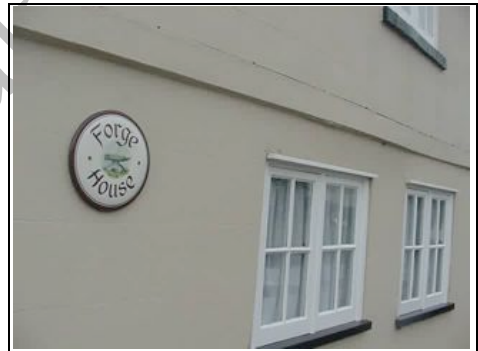
Lip on the render

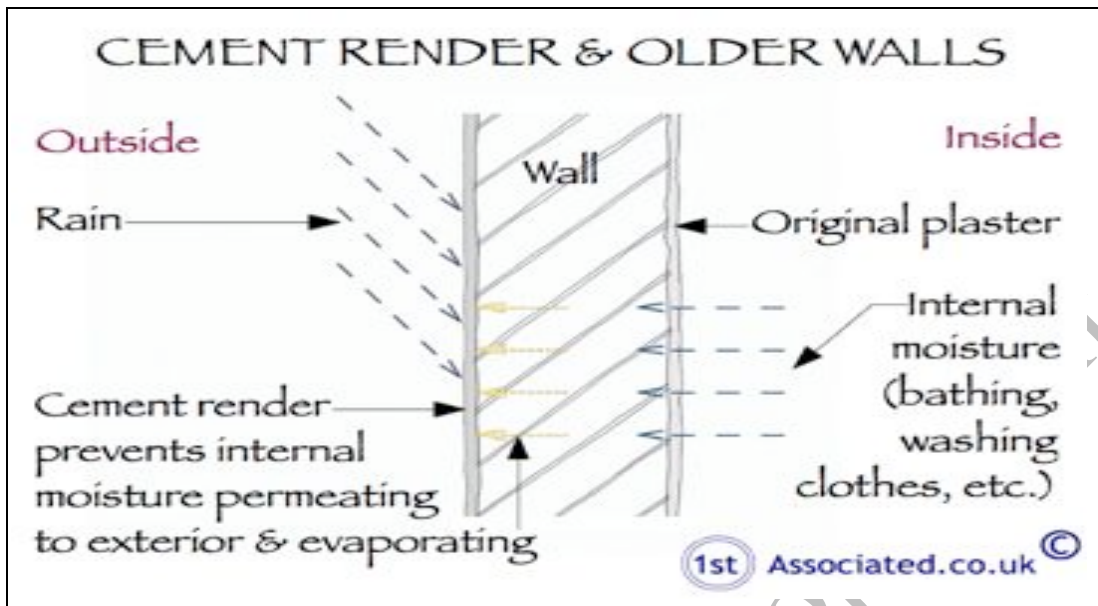
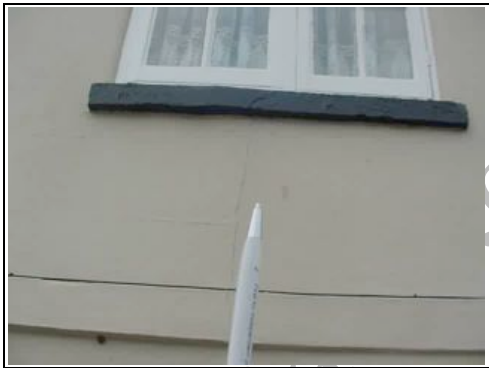
There is cracking in the render which can be caused by differential movement as you have a timber structure trying to move and it is being straight-jacketed with a cement render and modern gypsum plaster internally. In addition to this there may be other problems as indicated in the roof-spread item of this report.

Cracks in render

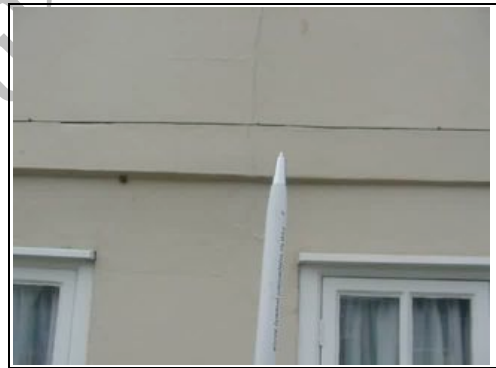
Cracking to render

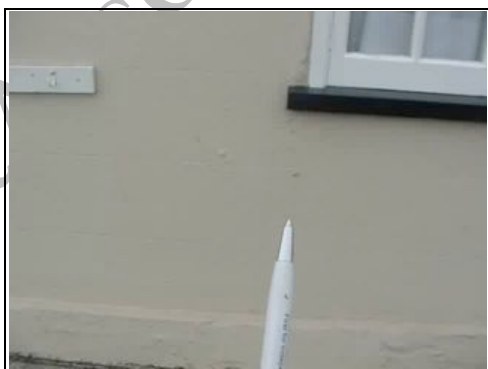
Cracking occurring to render

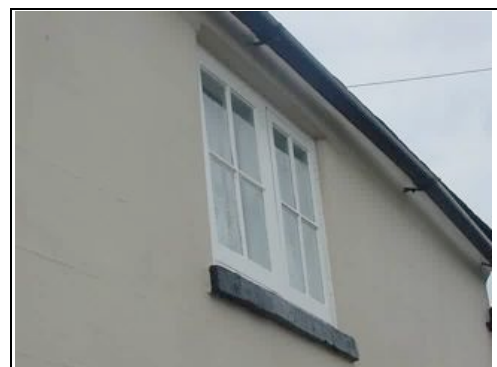
Render has cracking

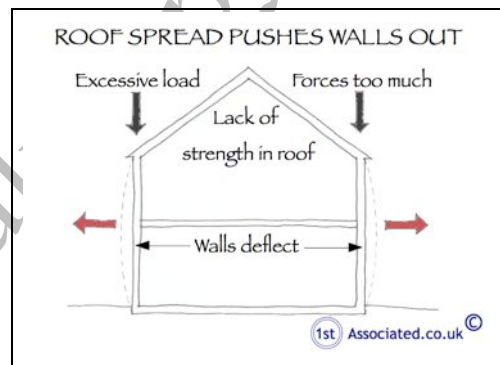
The original roof is likely to have been a clay Kent peg tile which then has been replaced with a heavier concrete tile which can cause roof spread. We could see hairline cracking in the cement render which is vertical indicating that the walls are moving out or down albeit relative minor.

Roof spread

ACTION REQUIRED: There may be an option of the existing owner placing an insurance claim which you would then take over (approved by your legal advisors of course) with regard to the potential roof spread and then the insurance company could monitor for at least a year which is the recommended timescale. However this still would not get over the problem of having the cement render on the outside of the property.

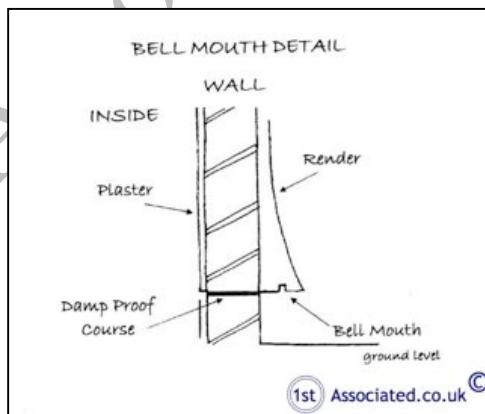
We also noted to the base of the render there was no bell mouth detail.

Bell mouth detail

ACTION REQUIRED: Removal of cement render externally and cement/modern gypsum plaster internally and replace with lime based render and plaster which would then allow the property to breathe. Add bell mouth as this would help with the dampness.

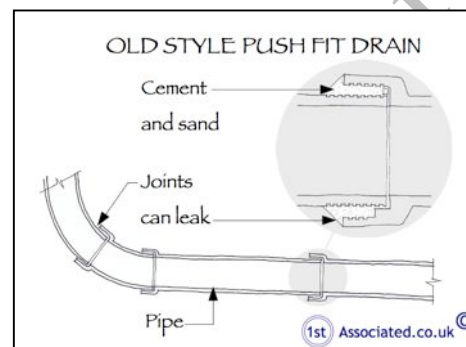
In older properties, such as this, drainage was often push fitted together rather than bonded together which means that they may leak over the years. Whilst we ran the tap for 15 minutes without any build up or blockages the only way to be 100% certain of the condition of the drains is to have a closed circuit TV camera report.

Push fit drain

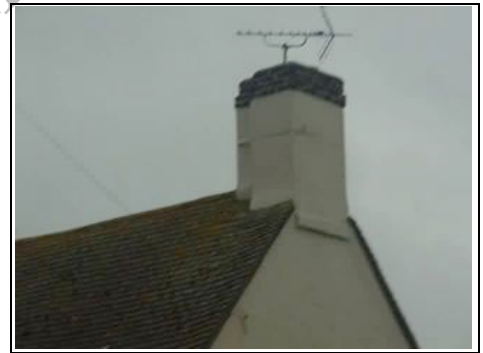
This chimney is render finished with a cement flashing and no chimney pots. From what we could see from ground level it looked in slightly below average condition considering its age, type and style due to the cement flashing.

Chimney from front of the property

ACTION REQUIRED: Replace cement flashing with a lead flashing. Periodically inspect the chimney.

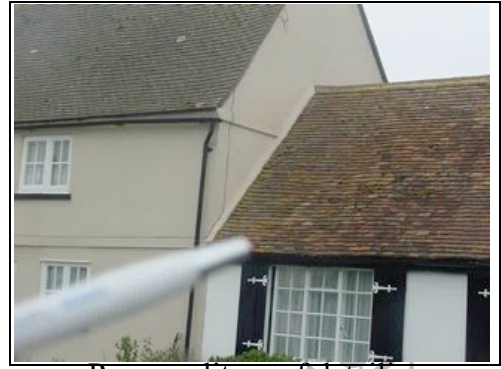
There is some poor quality roof detailing with cement mortar etc, which ultimately will crack one way or another and allow rainwater in. We would much prefer to see a lead flashing which moves with the structure rather than fighting against the structure. It could be argued that this is next doors detail but it is likely to affect this property first.

Poor quality roof detailing

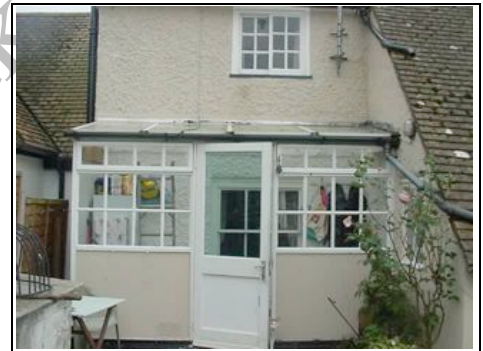
The property has a rear polycarbonate low level roof with poor detailing. This is very shallow pitched and we could not be certain that it is watertight. We can see that repairs/flashband has been used around it

Flashband is a sticky backed felt which is best used for temporary repairs only.

Rear low level roof

ACTION REQUIRED: You need to decide whether this area is useful or whether you wish to renew it. If it is to be kept we would recommend replacement of the roof and an increasing of the height.

ANTICIPATED COST: In the region of £750 - £1,500; quotations required

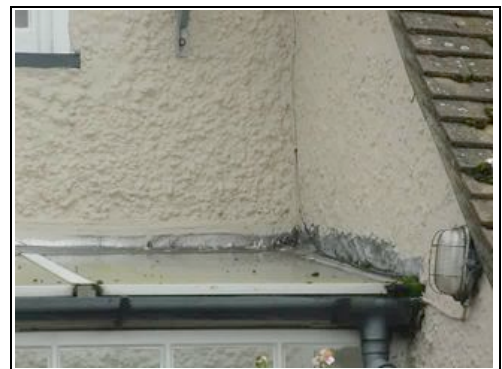
Poor detailing to rear low level roof

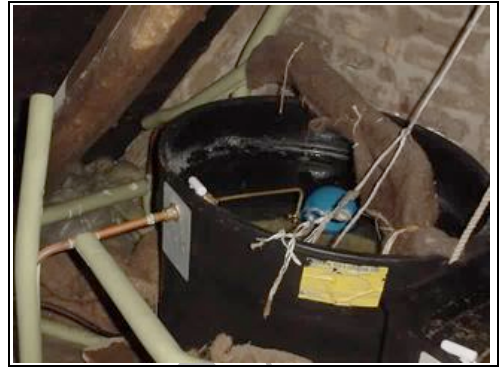
Un-insulated water tank

We would always recommend that water tanks be drained down and cleared of any debris etc. (we have seen dead birds and other unmentionable things in these tanks). As you are often cleaning your teeth with this water it is best that it is as clean as possible!

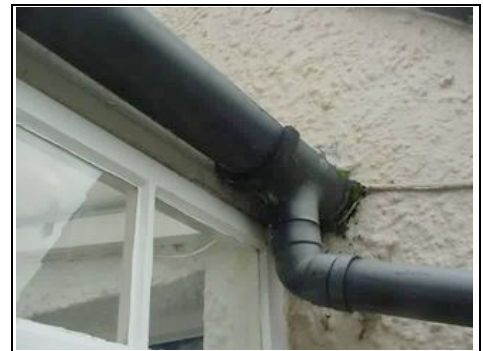
There may be some minor leaks but most people would be happy to live with these providing repairs are carried out within the next six to twelve months.

Awkward gutter and downpipe detail

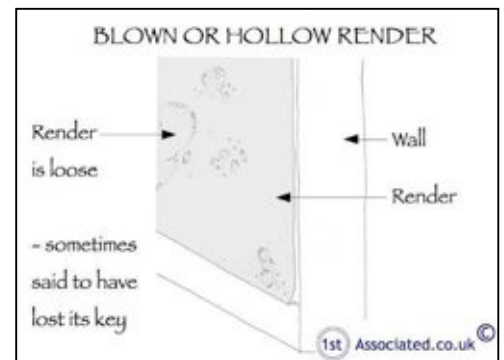
Blown or hollow render

ACTION REQUIRED: Please see our comments in the Executive Summary.

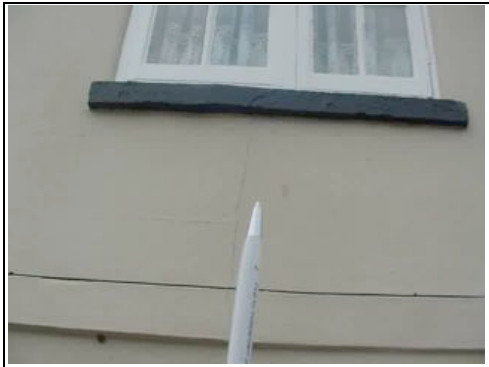
There is cracking in the render.

Cracks in render

Please see our comments in the Executive Summary.

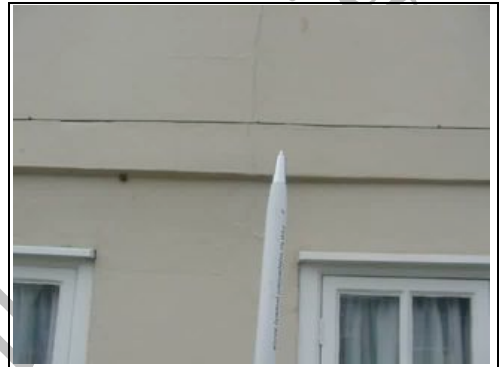
Cracking to render

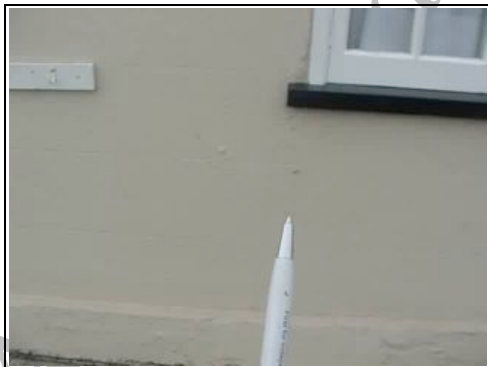
Cracking occurring to render

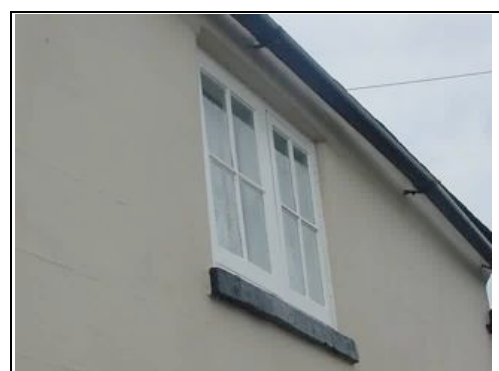
Render has cracking

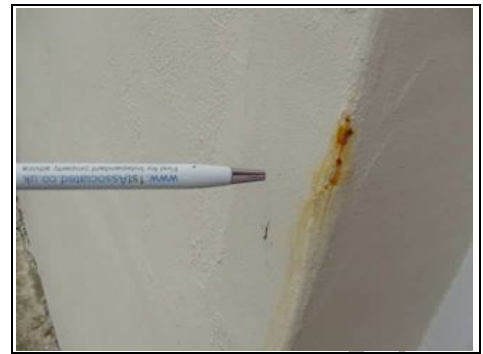
We noted rusting due to the wrong angle bead being used.

Rusting

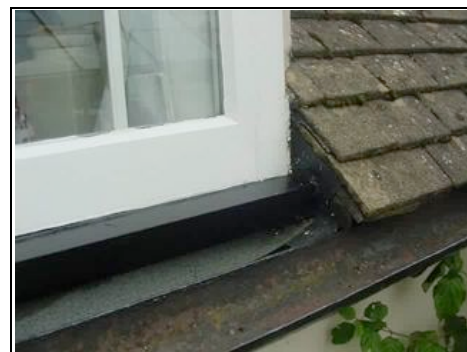
From what we understand Listed Building Consent was not obtained or sought. You will need to be aware that you will become liable for replacing these with appropriate windows if the listed building/conservation officer was made aware of them and felt them inappropriate.

Modern replacement timber window

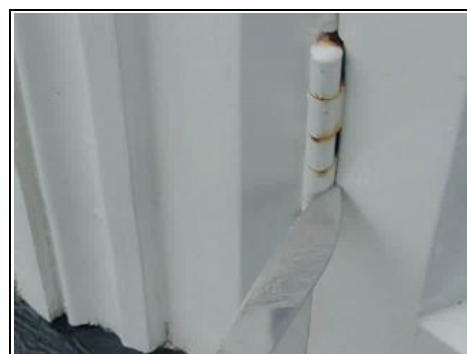
Rusting to hinges

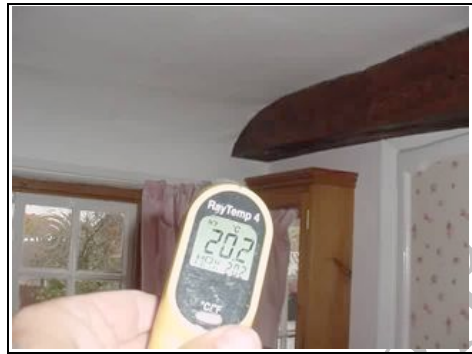
Slightly rounded ceiling in rear bedroom indicates the possibility of cold bridging

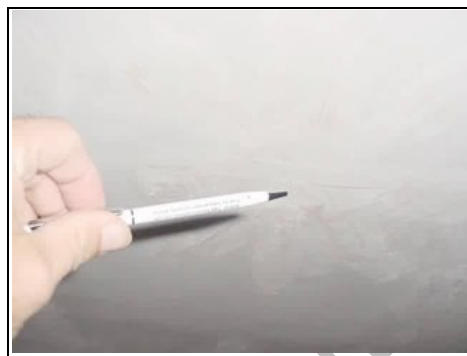
Cracking is due to a mixture of old and new plasters.

Hairline cracking

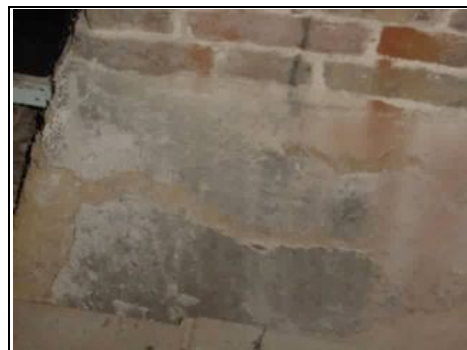
Dampness to chimney breast in roof

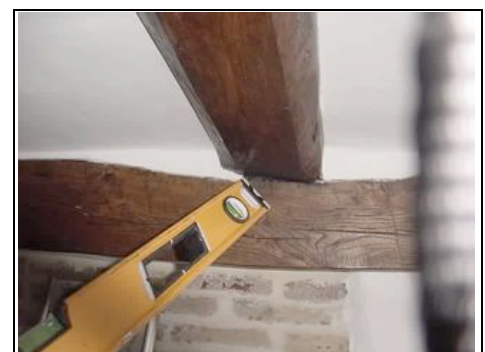
Spine beam that does not tie in

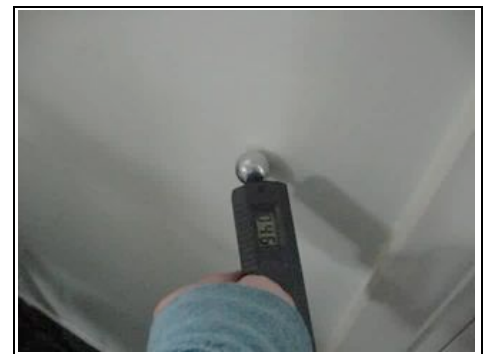
A visual inspection and tests with a moisture meter have been taken to the perimeter walls. In this particular case we have found significant rising damp.

Testing for rising damp

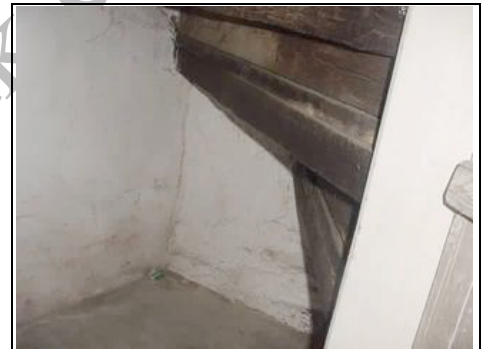
We noted that the underside of the staircase was exposed. It is more normal today to have a half hour fire barrier to stop fire spreading from the ground floor to the first floor in a worse case scenario. You may wish to take a view on whether you add this.

Unlined staircase

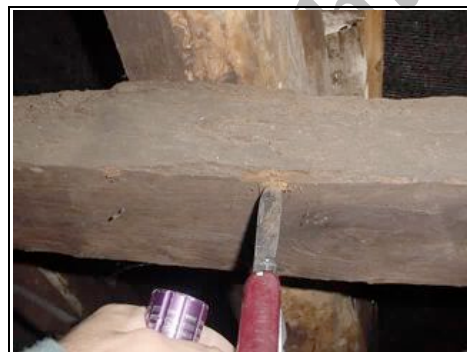
The roof is the main area that we look for woodworm as well as the actual traditional timber structural frame. Within the roof we found visual signs of significant woodworm activity or indeed signs of significant past woodworm activity that has caused what we would term 'structurally significant' damage.

Frass indicating woodworm

ACTION REQUIRED: Whilst we do not consider that the woodworm is structurally significant that is present it does need to be monitored. We generally recommend the environment is changed to an environment that woodworm are unhappy to live in. We would be happy to return in the Spring of 2015 to give a further opinion.

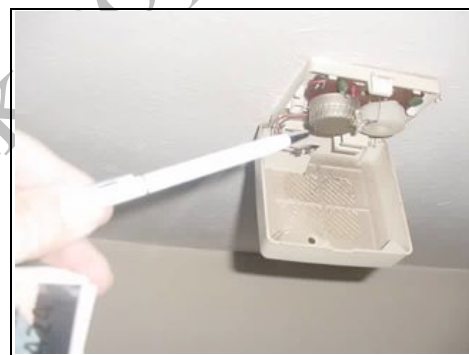
Some smoke detectors were noted, some without batteries. The current Building Regulations require that they be wired into the main power supply. Obviously in a property of this age this is difficult, as it would mean having surface mounted wires or cutting wiring into the plaster.

Smoke alarm without battery

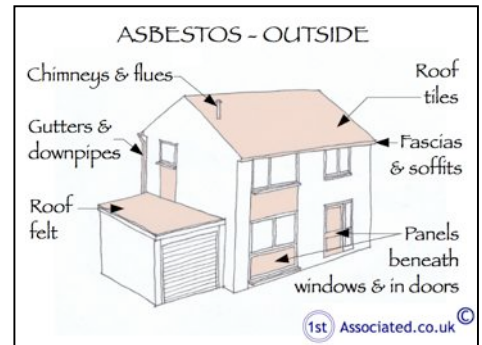
Asbestos externally

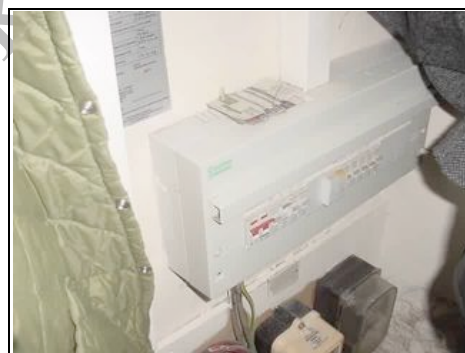
The electric fuses and consumer units were located in the entrance hallway. The fuse board looked dated 1970s/1980s and better are now available. In an older property a defective fuse board can be particularly dangerous.

Fuse Board
