## RESIDENTIAL BUILDING SURVEY

XXXXXXXXXXXX

INDEPENDENT CHARTERED SURVEYORS

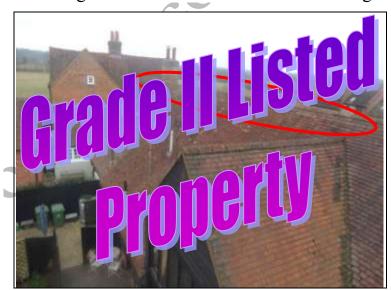
We noted gaps in the ridge tiles of the roof that need re-bedding.

Gaps in ridge tiles

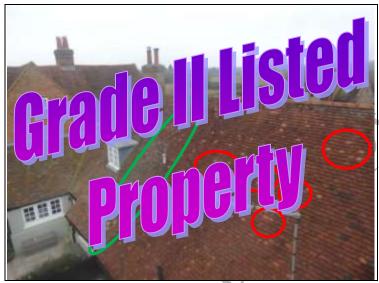
From our inspection we believe there are a fair number of roof tiles that are spalling, as per the high level photo below. You can see that it almost stops in a line where next door's property starts.

Spalling tiles (lighter tiles – every circle represents a spalling tile – there are many more than are circled) and 'line' in tiles between this property and next door's (green oval)

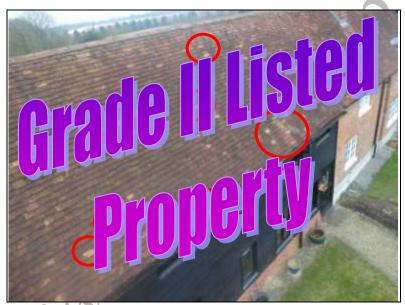
We can also see that many of the original clay tiles have been replaced with more modern manmade machine cut tiles of several different varieties. This gives us cause for concern and we believe indicates that there will be fairly major repairs in the next five to ten years.

Spotted dog effect with spalling tiles to front (different colour tiles – there are many more than are circled)

**ACTION REQUIRED:** Ideally open up an area of the roof before you commit to purchase the property; we suggest to the rear right hand side where there has been previous repairs, preferably above the rear right hand en-suite shower room.
