## RESIDENTIAL BUILDING SURVEY

Lincolnshire XXXXXXXX

INDEPENDENT CHARTERED SURVEYORS

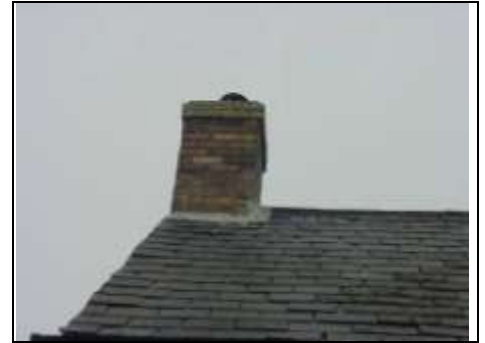
Rear left chimney

All four chimneys are weathered and require repair and repointing.

**ACTION REQUIRED:** Repair and repoint as necessary, check flashings and also check flaunchings (the top of the chimney).

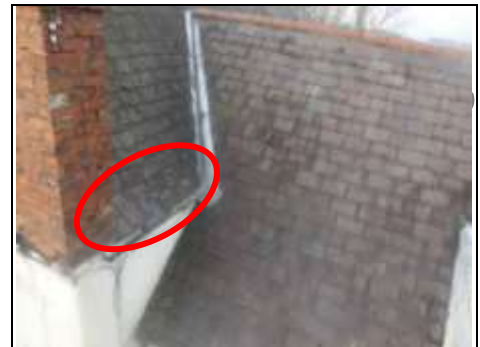
When you carry out the roof cover / slate roof repairs you must carry out repairs to the roof structure. There are various timbers that are split or are bending and need replacing particularly to the valley gutter to the rear and to the roof to the front right side.

Slipped slates and lead tingles to the front right roof  
Aerial view – 360 photo

**ACTION REQUIRED:** We believe several of the roofs will require repair and or re-slating within the next five to ten years.

**ANTICIPATED COST:** Depending on which roofs are carried out £5,000 - £15,000 (five thousand pounds to fifteen thousand pounds) (per large roof). When the roof work has been carried out we would also carry out any associated wall and window work etc. utilising the scaffolding that will be needed for the roof repairs; please obtain quotations.

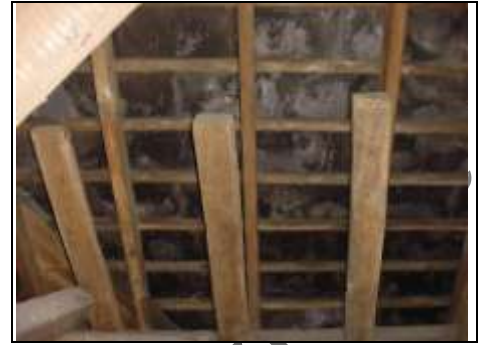
It should be noted that in some areas of the roof it has an older style of construction with no protective underlayer. This means that when the rain gets through and remember you have a lot of tingles holding the slates so there is no secondary protection.

No protective underlayer to older style construction

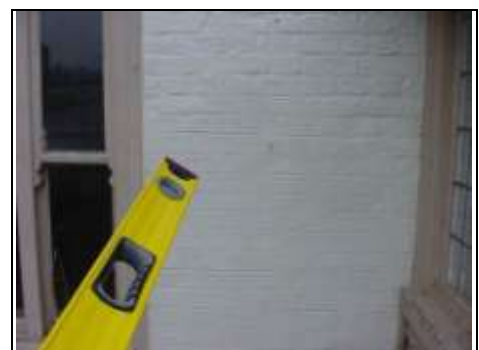
The brickwork is deteriorating considerably in some areas, to the point where it has had repairs. Unfortunately, these have been carried out wrongly in cement mortar which can cause more damage than good. Also there looks to be cement mortar to the front that has been painted over and made to look like bricks.

Cement mortar to look like bricks

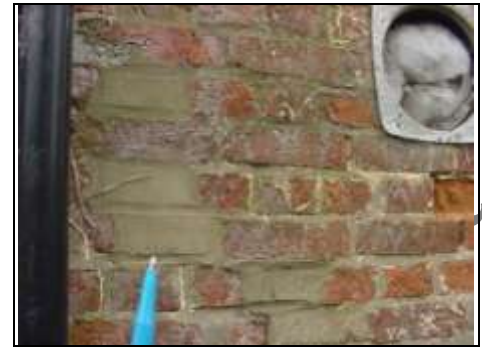
Ad-hoc pointing in cement mortar

**ACTION REQUIRED:** Remove all the cement mortar and replace with lime mortar and repair the bricks as necessary.

**ANTICIPATED COST:** £2,500 - £5,000 (two thousand five hundred pounds to five thousand pounds) this work will be carried out over a long period of time. Work is best carried out over the summer months. You need to find a good bricklayer that is experienced in using lime mortar; please obtain quotations.

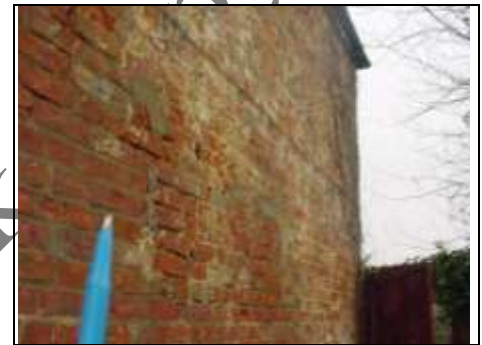
Whole bricks replaced with cement mortar

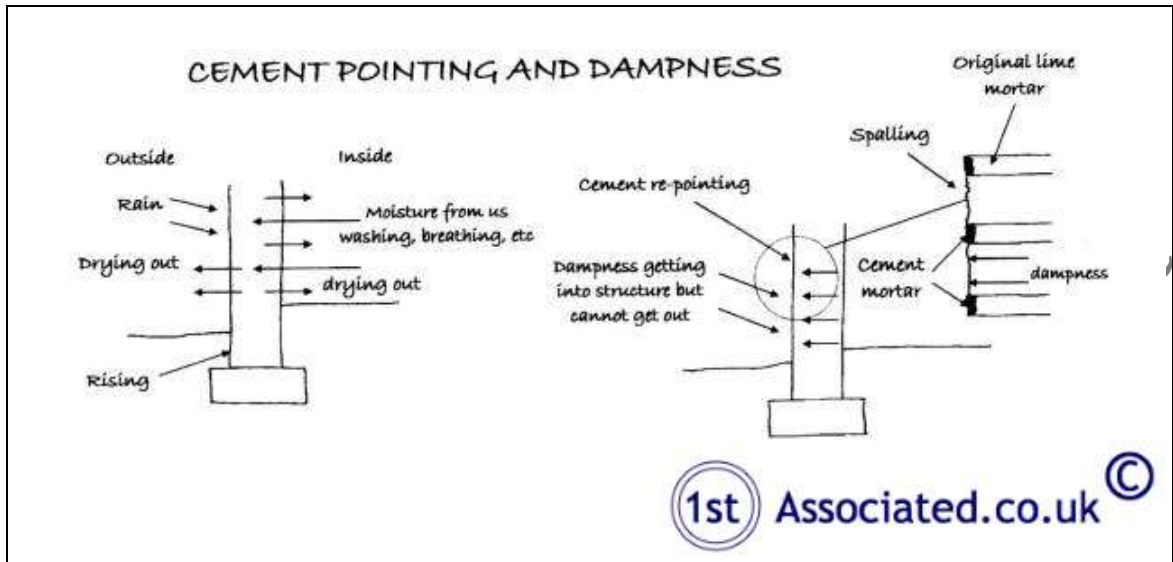
Unfortunately, the re-pointing, whilst well meaning, is not appropriate for this type of construction. A cement mortar has been used rather than a lime based mortar. We recommend you use lime mortar in any future repairs regardless of what the builders say! Using lime mortar will limit further damage to the brickwork, which is almost impossible to repair successfully. However, we would add that many, if not most, of the properties that are re-pointed are re-pointed wrongly; it is only in recent years that we have discovered the problems that can occur from it.

Cement pointing and dampness

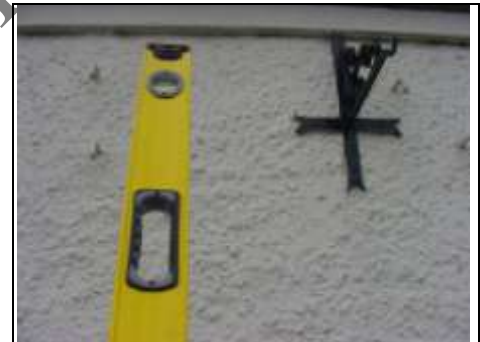
The bracket that looks like it is for a hanging basket may also be a tie bar.

Crack and possible tie bar

To the left side of the property we can see cracking. Unfortunately, they are very difficult to see in the photos. It does mean that movement is going on to the right side extension as tie bars are added to stabilise walls and offer cross bracing to them.

**ACTION REQUIRED:** We would recommend that you open up sections of the wall to see what the wall is constructed from and also to check if the tie bars are giving support to the structure.

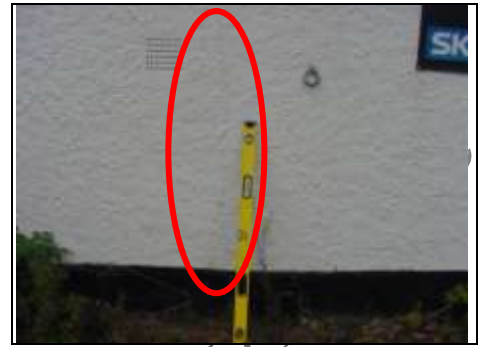
Vertical cracking to the right side render

The cracking needs monitoring. Before you legally commit to purchasing the property we would recommend the existing owners take out an insurance claim, advising that the cracking has been noted by a structural surveyor (this should cost them nothing other than time to write the letter).

This usually means that the insurance company will carry out a monitoring exercise (the Building Research Establishment recommend monitoring any cracks for a minimum of one year) to establish if there is any progressive movement. Your future liability will be limited to the cost of the excess on the insurance providing the insurance company is happy for you to take over the insurance claim.

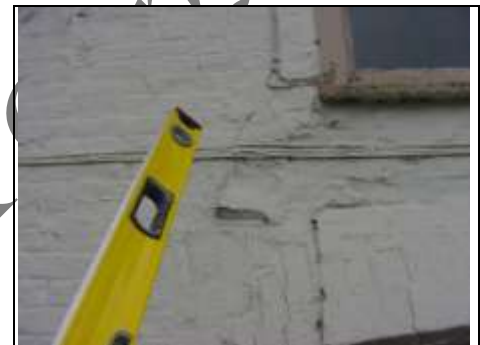
We would like to draw your attention to the cracking to the front windows and doors.

We suspect that there has been water discharging down the left side of the building which has caused deterioration.

Cracking to the window

**ACTION REQUIRED:** Stop dampness from roof and guttering. Stop rainwater draining from the roof and guttering down the walls. Check and repair lintels (they maybe timber). Check and repair walls which may involve removing of the cement render externally and the modern plasters internally and allowing the walls to dry.

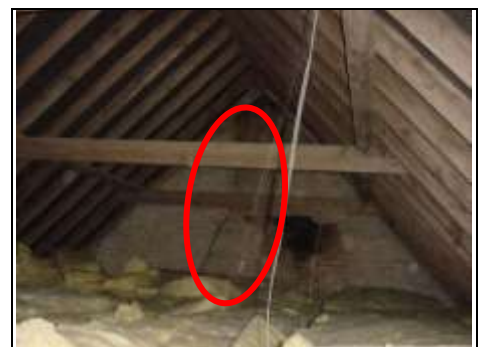
Crack on the front right, hidden within the function room roof

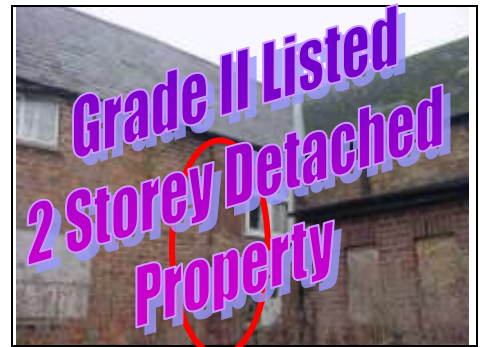
We can see movement to the rear of the property which we believe is due to poor ground conditions, possibly a flooding or swampy area to the rear and possibly peat.

Having said that, the movement looks to have been repaired for some time without any obvious signs of recent movement. We would however like to have the movement monitored.

Vertical buttress

We feel probably the best way forward is before you legally commit to purchasing the property, we would recommend the existing owners take out an insurance claim advising that the cracking has been noted by a structural surveyor (this should cost them nothing other than time to write the letter). This usually means that the insurance company will carry out a monitoring exercise (the Building Research Establishment recommend monitoring any cracks for a minimum of one year) to establish if there is any progressive movement. Your future liability will be limited to the cost of the excess on the insurance providing the insurance company is happy for you to take over the insurance claim.

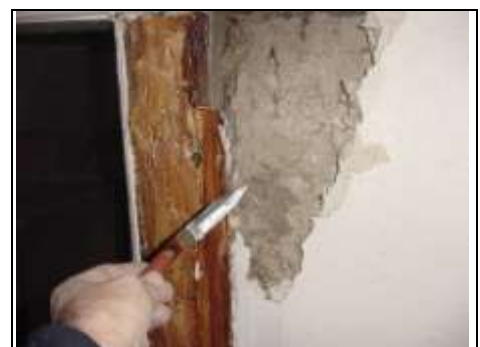
Wattle and daub in the walls

**ACTION REQUIRED:** We recommend opening up sections of the wall both internally and externally. You may well find some nice timber frame that enhances the look of the building.

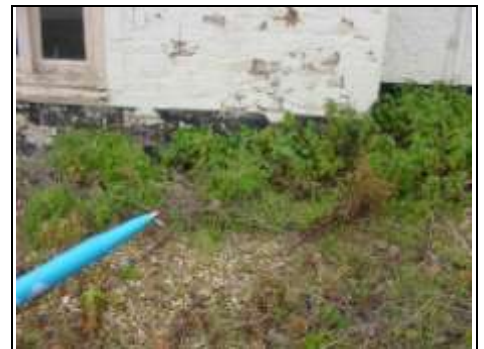
Ground level is high to front left

**ACTION REQUIRED:** Lower the ground level around the property and we would also recommend you add a French drain.

**ANTICIPATED COST:** £2,000 - £4,000 (two thousand to four thousand pounds); please obtain quotations.

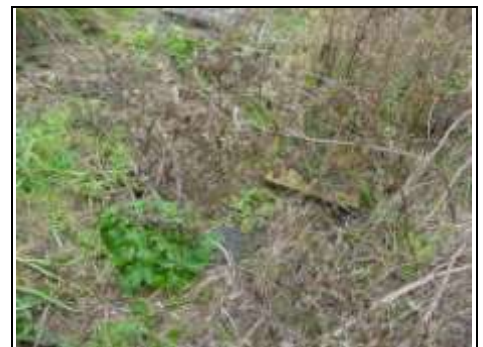
Swampy area

**ACTION REQUIRED:** We recommend soak aways are added to the entirety of the rainwater drainage, which will need to discharge as far away from the building as possible.

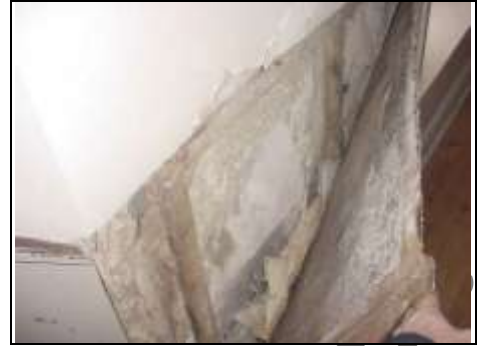
Perks of the dry lining / false wall is to hide the dampness coming through into the property which is considerable. Even with the repair work that we have mentioned you may get an element of dampness coming through. You have to consider part of the character of this building.

Dry lining internal walls

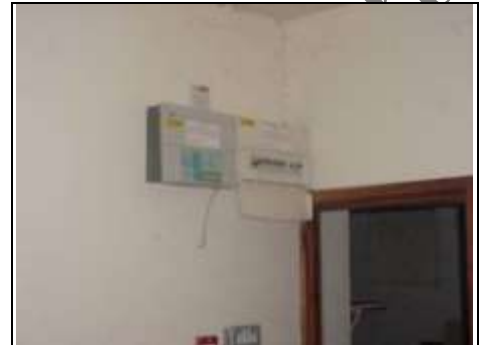
Electrics in the function room

**ACTION REQUIRED:** It may be worth having a new system installed. We recommend an Institution of Engineering and Technology (IET) test and report to be carried out by an NICEIC registered and approved electrical contractor or equivalent.

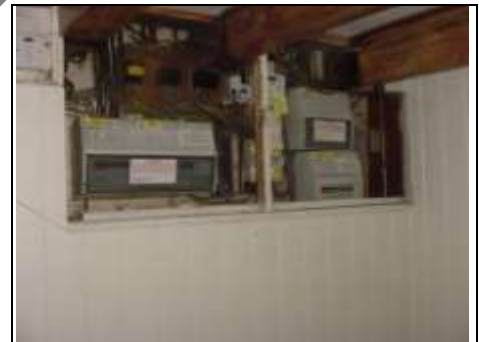
Electrics in the bar area

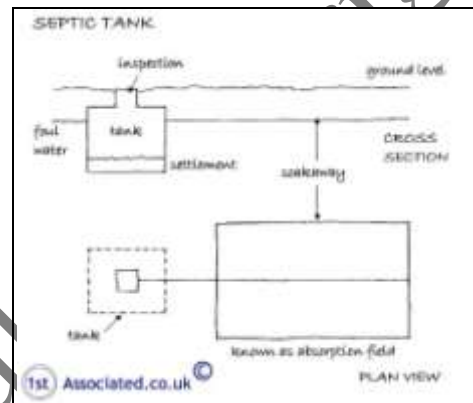
Septic tank

**ACTION REQUIRED:** We recommend you pump out the well with a sump pump or get a company to drain it to see how it is constructed and put a new septic tank in depending upon the capacity etc.

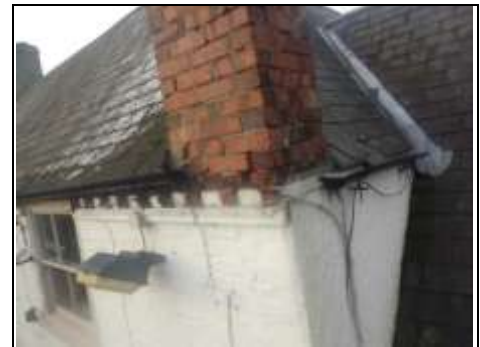
Chimney in below average  
condition  
Aerial view -360 photo

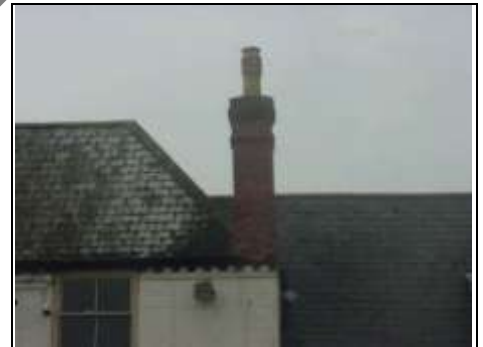
Front middle chimney

This is a large slender chimney which is brick finished with a cement flashing and one chimney pot. From what we could see from ground level we could see areas where there was no mortar and again from ground level it looked in below average condition considering its age, type and style.

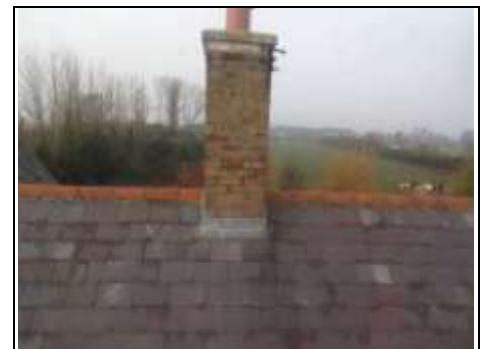
Front right chimney

This chimney is brick finished with a lead flashing and one chimney pot. From what we could see from ground level it looked in below average condition considering its age, type and style.

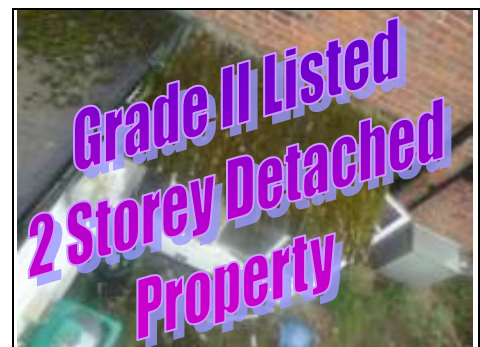
We believe you have had discussions with the Conservation Officer and have agreed to remove this entrance. We personally like these entrance areas as it means you do not walk directly into the house and it also helps retain heat, as well as security.

Rear entrance roof  
Aerial view- 360 photo

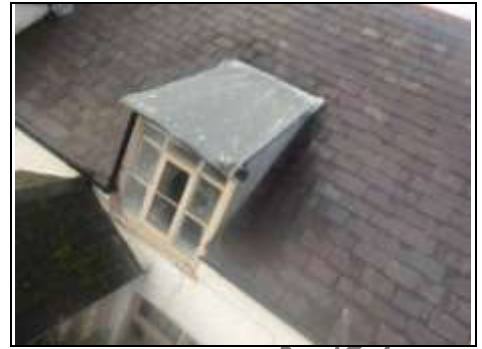
Dormer window  
Aerial view – 360 photo

**ACTION REQUIRED:** Repair the roof, reposition the guttering and downpipes and repair and redecorate the window and side areas.

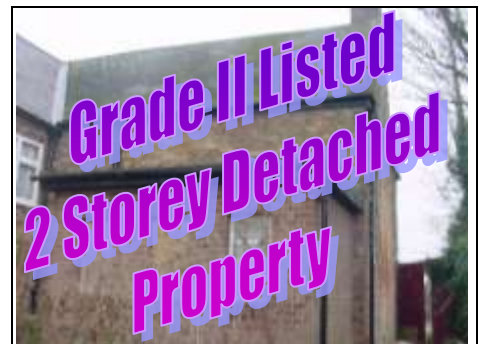
Far left flat roof

The far left flat roof is over the ladies' toilets. It is covered with felt and from ground level, this looks in below average condition considering the roofs age type and style.

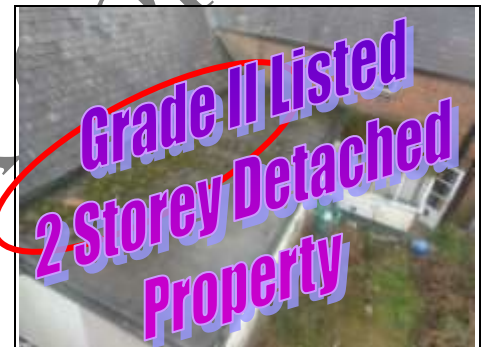
Rear middle flat roof

The rear left flat roof is covered with felt and again a lot of moss sitting on it indicating water is not draining away where the pitch meets the flat roof. Again from ground level, this looks in below average condition considering the roofs age type and style.

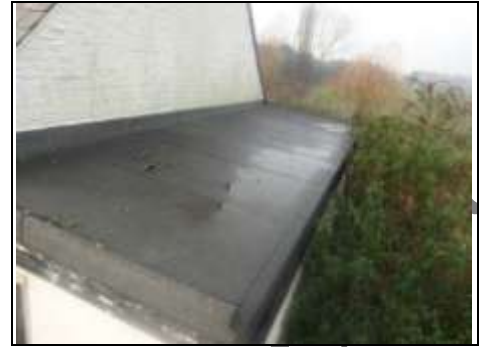
The right flat roof is covered with felt with water sitting on it. From ground level, this looks in average condition considering the roofs age type and style.

Right flat roof  
Aerial view- 360 photo

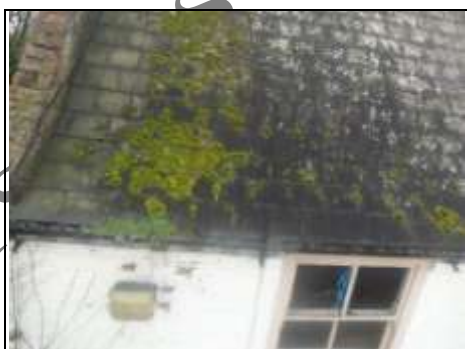
In addition, this building has been left over the years with a general lack of maintenance which all leads to the need to replace the guttering and downpipes and ensure the water is taken away from the building using soak-aways.

Grass growing in the gutter

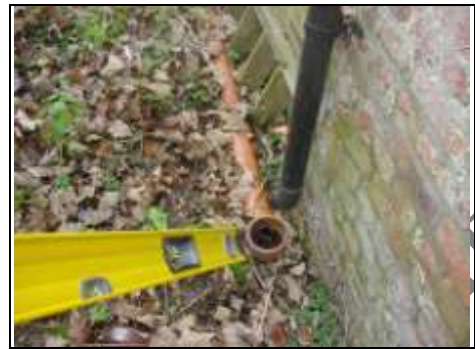
Far left side gutter not joined

**ACTION REQUIRED:** We recommend you repair the gutters and downpipes as soon as possible to stop water discharging down the building and damaging it. You will need to chat to the Conservation Officer.

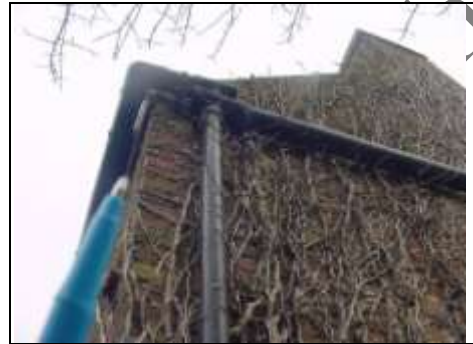
Ivy causing deterioration

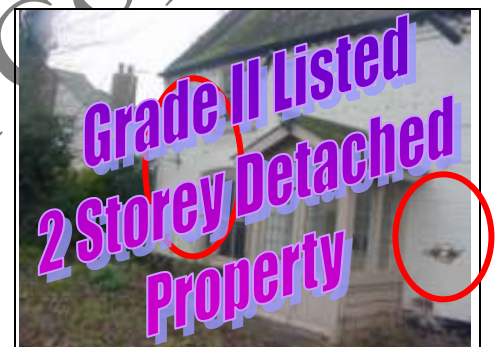
Bricks re-created to left and right in we believe a cement mortar

We believe this section needs to be opened up very carefully with a builder/historic buildings expert who can then advise you on the best way to repair historic brickwork.

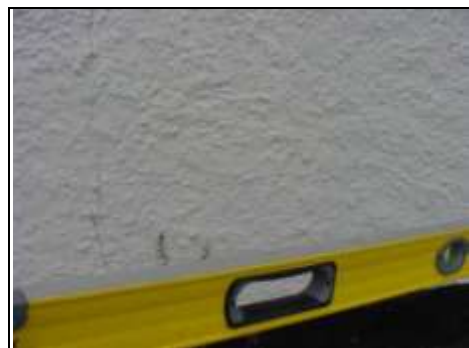
Horizontal hair line cracking

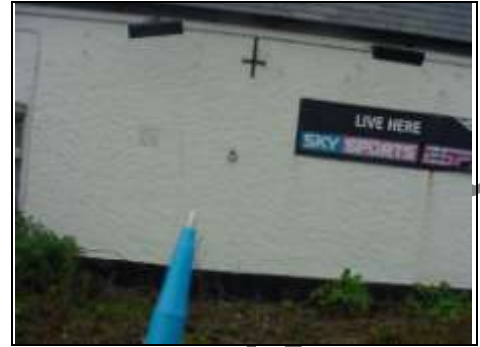
Horizontal cracking and the black area to the base where the drip is

**ACTION REQUIRED:** We would again recommend a section of the render is opened up, particularly bearing in mind the cracks that are in the building and we suggest the opening up is around these.

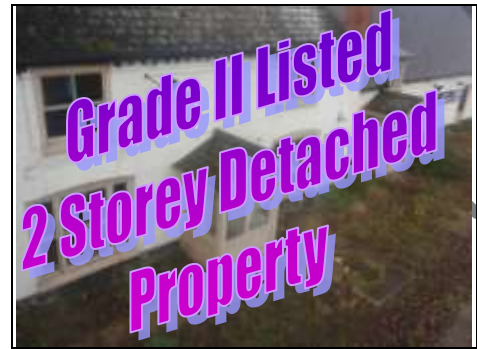
It looks like the brickwork has been painted and looks like the brickwork has also been formed in cement particularly to the front of the property. Ideally these areas need repairing with the cement that they are made of being removed from the building. It is particularly difficult as you will need to either saw or have made older style bricks. We do feel that working with the Conservation Officer in time, this could greatly be improved.

Painted brickwork to the front  
Aerial view – 360 photo

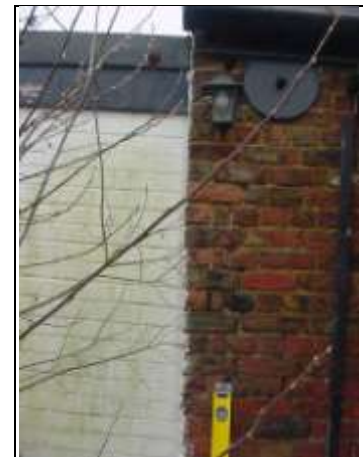
Brickwork with problems  
to the rear right

We would leave this area to better understand how to carry out brickwork repairs.

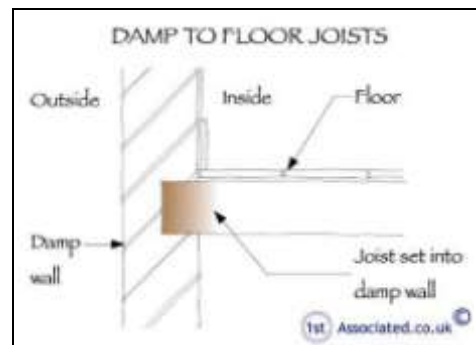
There are some deflections in the upper floors which we sometimes find, particularly within embedded timbers and there may be some rot where there are damp walls.

Embedded timbers

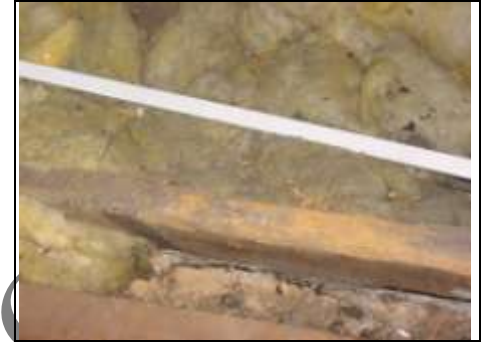
Woodworm in the roof

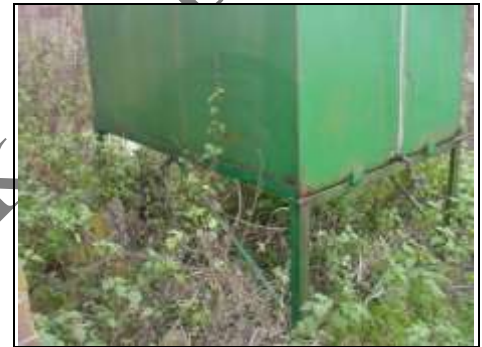
Current regulations may require it to be sighted further away from the property, although we are not experts in this area.

Oil tank
