RESIDENTIAL BUILDING SURVEY

London W7 xxx

INDEPENDENT CHARTERED SURVEYORS

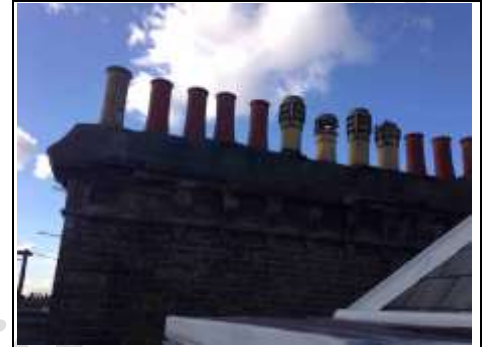
The property has three substantial chimneys. We can see repair work is required as dampness will be getting into them.

Chimney to front right hand side

ACTION REQUIRED: Ad hoc repair work to chimneys.

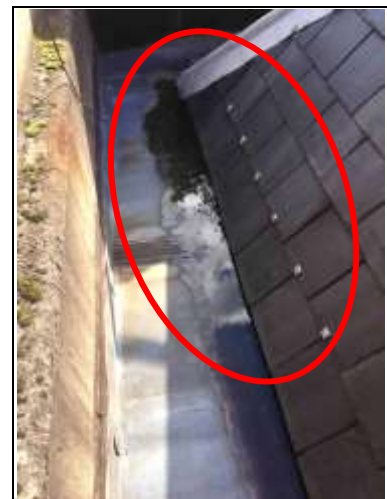
Rear left hand corner – more lead tingles and also ponding within the box gutter

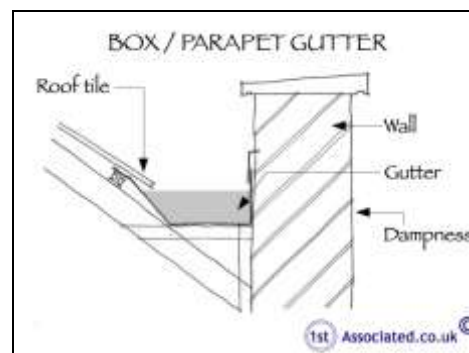
We also believe there are problems with the double pitched slate roof to the rear due to the staining we can see on the box gutter. This is the roof you are looking to extend upwards, so again it depends upon how quickly this work can be carried out as to whether repairs are necessary.

Box gutter meets a pitched roof

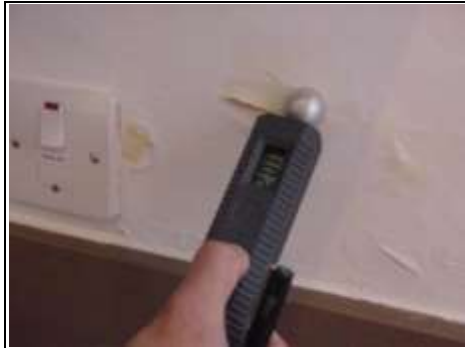
Two particular areas where there are definitely problems are to the front parapets/balustrades where dampness was found coming in on the fourth floor, and also to the rear parapets/balustrades where we could literally see plants growing from it.

Damp meter readings indicate dampness is coming into the fourth floor via the front parapet wall

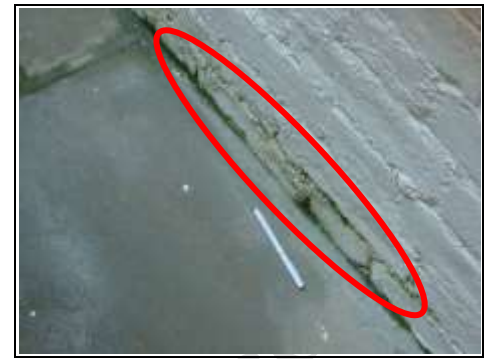
As is relatively common in this age, type and style of property we found dampness at lower ground floor level. We think it is worse than is apparent when first looking around the lower ground floor as we believe it is hidden by dry lining, also known as a false walling.

Mould around outside of walls in void area indicating

ACTION REQUIRED: Further investigation recommend, but from our initial findings we would feel that the adding of a French drain to give the rainwater a path away would be the best option.

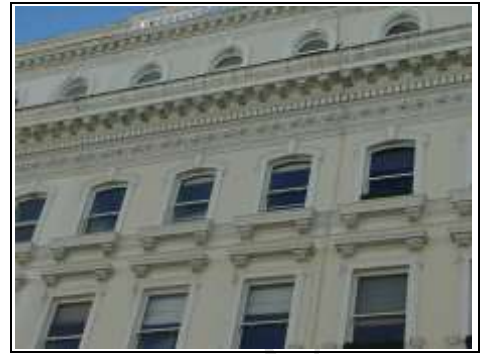
Render to front of property where hairline cracks can lead to dampness coming in

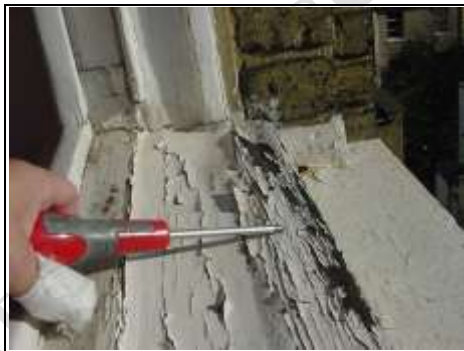
Timbers deteriorating

ACTION REQUIRED: Splice in new timbers, make general repairs and repair, prepare and redecorate.

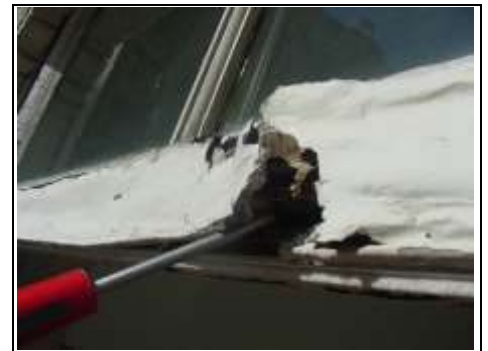
Window sills and ledges allow water to sit on them

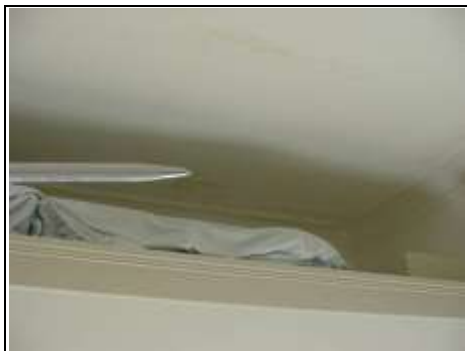
We have already mentioned the leaks within the lower ground floor. There are also various leaks throughout the property which can be seen coming from the plumbing in the areas above.

Staining in second floor bedroom
from bathroom above

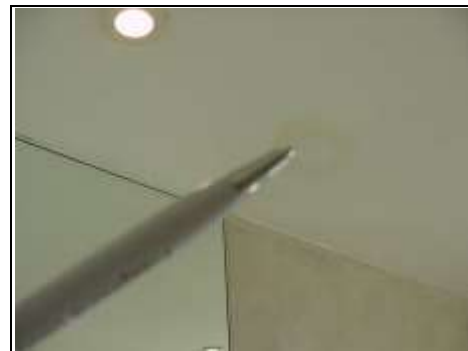
Staining in second floor
bathroom from apartment above

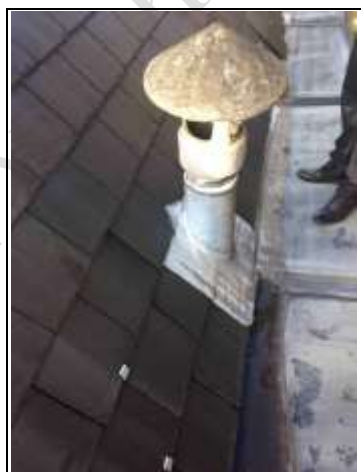
We find that properties of this Era that have been modernised it is common to find asbestos. In this case we noted asbestos flues to the main/loft conversion roof and to the rear roof.

Asbestos flue to main/loft conversion roof on left hand side

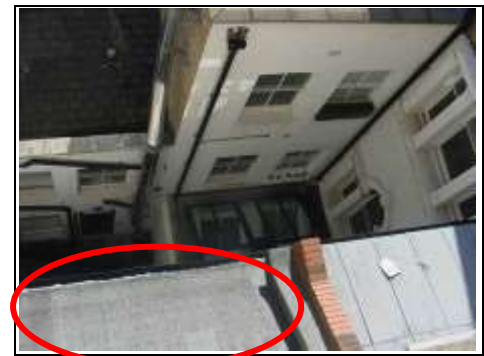
3. Also as a general comment, we would say that the standard of repair is below average and cheaper materials have been used. A good example is the small rear roof at first floor level. To the right side is next door's lead finished flat roof, to the left side is your patched mineral felt flat roof.

Your patched mineral felt roof to left hand side is in poor condition compared with next door's lead finished roof to the right

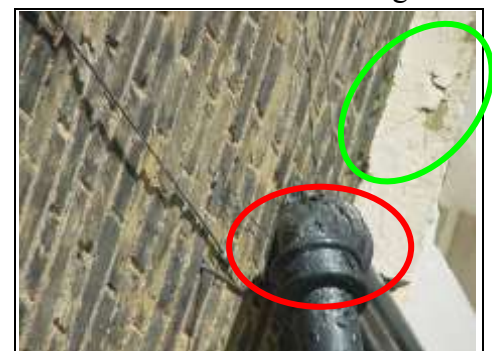
There is also the general need for redecoration. The adjacent photo shows a cast iron pipe and moulding around the window in need of redecoration.

Cast iron pipe (red circle) and moulding (green circle) in need of redecoration

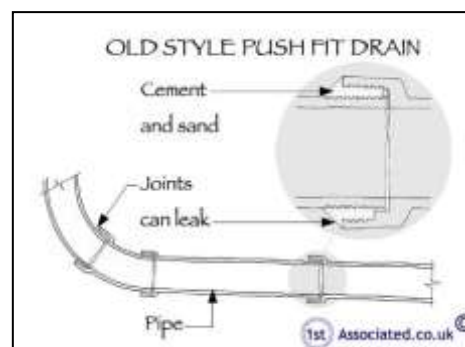
We would also advise that in older properties, such as this, drainage was often push fitted together rather than bonded together which means that they may leak over the years. Whilst we ran the tap for 15 minutes without any build up or blockages the only way to be 100% certain of the condition of the drains is to have a closed circuit TV camera report.

Push fit drain

ACTION REQUIRED: We recommend a closed circuit TV camera report.

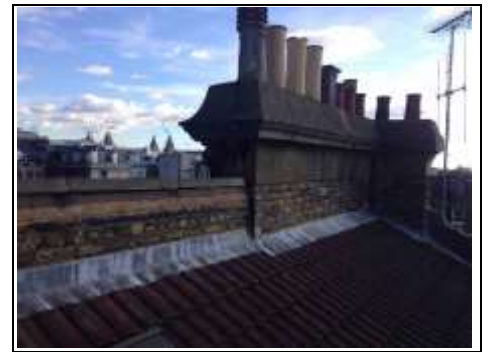
Chimney to rear left side

The chimneys are weathered and there are areas of hairline cracking, therefore we suspect dampness is getting into the structure, although we cannot physically see this and have no evidence, however it is a typical problem relating to this age, type and style of property.

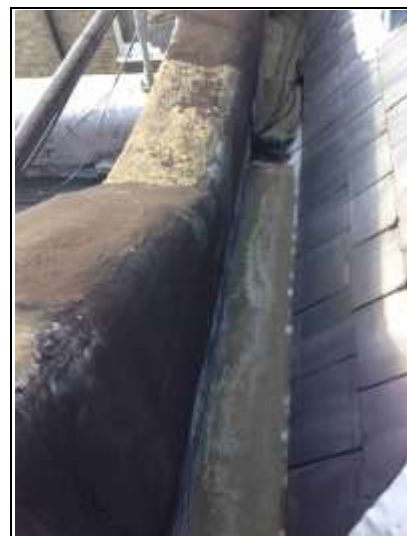
We noted this parapet wall has a bitumen covering, indicating that dampness has been getting into it over the years.

Bitumen covered parapet wall

ACTION REQUIRED: We recommend a lead coping is added.

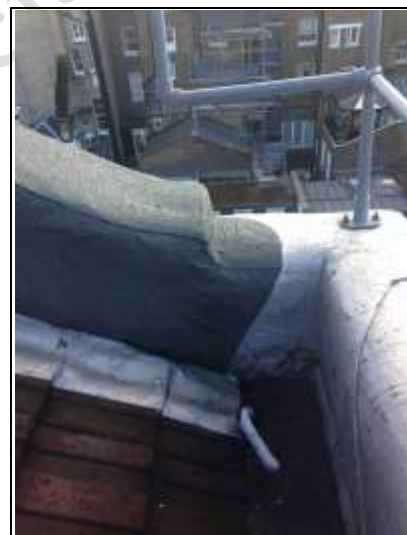
Mineral felt to rear parapet wall

ACTION REQUIRED: Again, we prefer to see a lead capping is added as well.

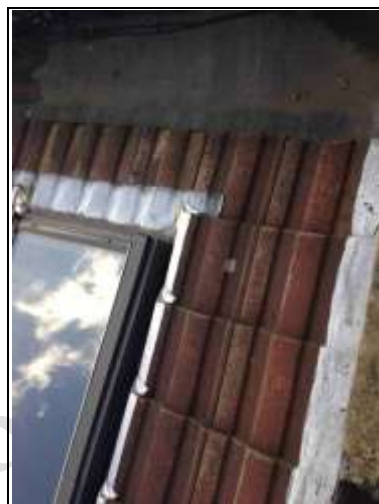
The property has roof windows to the fifth floor. Flashband repairs around the rear window indicate there have been problems with the roof window.

Roof window to rear left hand side with Flashband repair, which we always consider to be a temporary repair

ACTION REQUIRED: We consider Flashband to be a temporary repair and a proper flashing should be added to make it watertight.

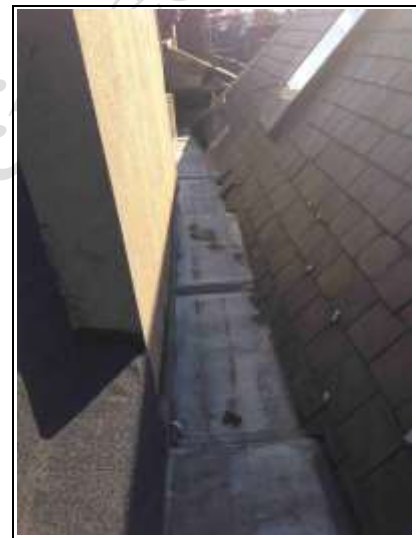
The main roof is pitched and clad with a manmade slates and from roof level this looks in below average condition considering the roofs age type and style.

We assume this to be a relatively modern roof (last 50 or so years) due to the loft conversion and as such we were surprised to see the excessive number of lead tingles and some displaced slates.

Main roof to left hand side

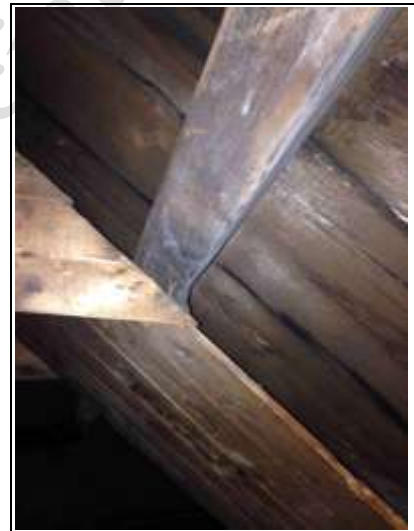
We believe we could see some dampness within the left hand side which relates to the ponding seen on the box gutter to the left hand side.

Vertical close boarding, we normally see this horizontally

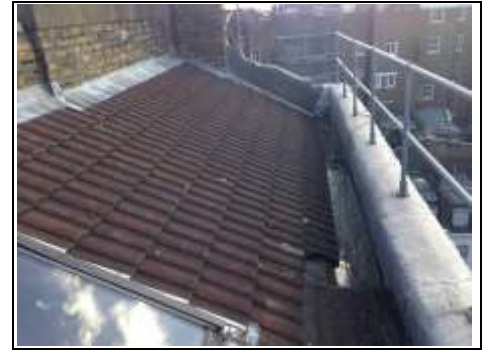
There is a single pitched roof to the rear of the property. It is covered with concrete tiles and a box gutter. There is some slight deterioration to the surface of the concrete tiles. We are finding this on several of our surveys and the jury is still out as to what problem this will cause and we simply do not have long enough experience of concrete tiles.

Single pitched concrete tiled roof

ACTION REQUIRED: We would leave them if you do anticipate carrying out work in the near future otherwise we would recommend re-roofing work is carried out. In the short term you do need to re-bed the lead flashings to the rear single pitched roof.

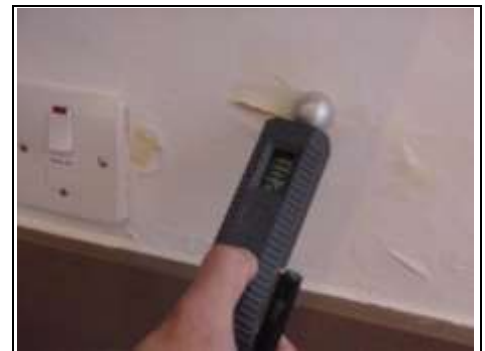
Dampness internally caused by box guttering to front wall

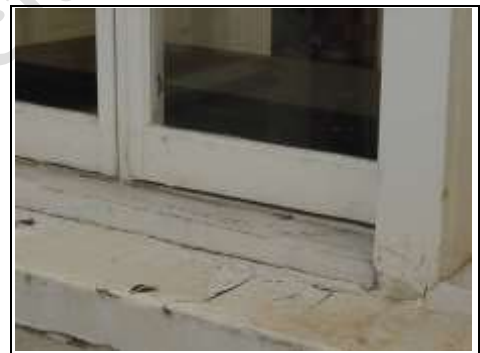
The property has single glazed timber sliding sash windows. We would specifically comment the timber is in below average condition and will need repair. We would expect new timbers to be spliced in.

Windows generally need repair

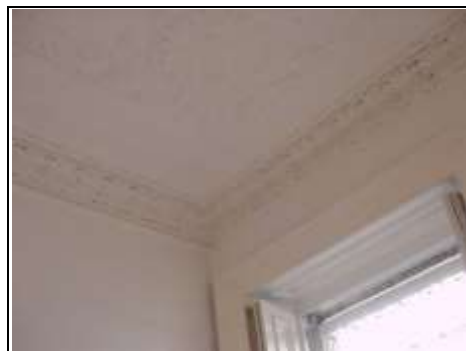
There are mouldings throughout the property. These have been over painted and have lost their detail.

Over painted moulding
on ground floor

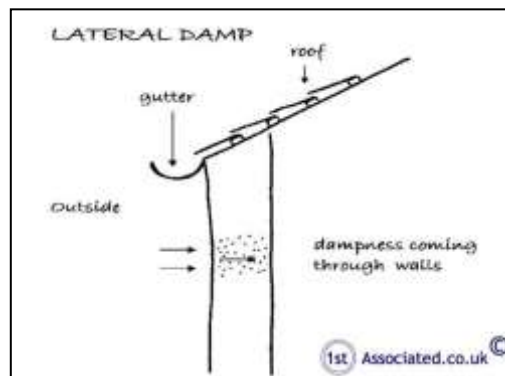
We used a damp meter on the external walls. We have found lateral dampness.

Lateral dampness

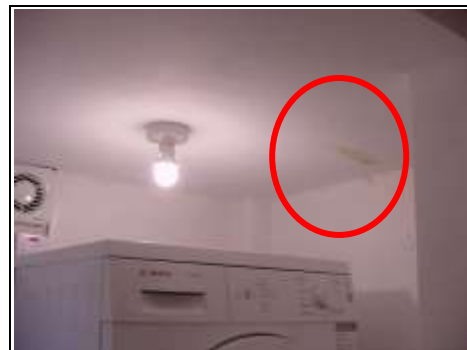
At the time of the inspection there were obvious signs of condensation. However, there was staining in the utilities cupboard on the lower ground floor which could relate to leaks above or to condensation.

Staining on ceiling in utilities room
on lower ground floor

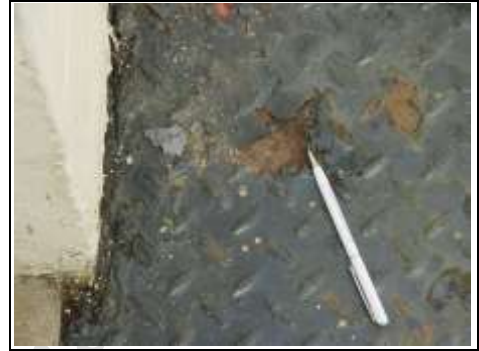
Close up of rusting stairs

If this staircase remains with the new plans it will need redecorating and a rust stop agent used.
