HERITAGE STATEMENT

XXXX

XXX, Hertfordshire.

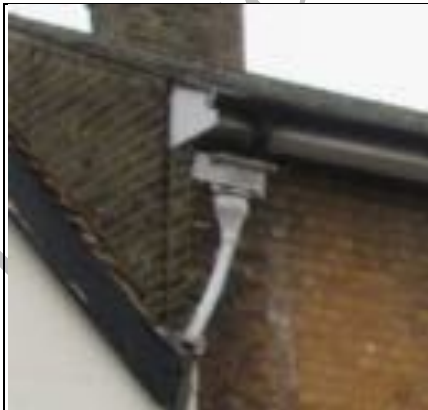
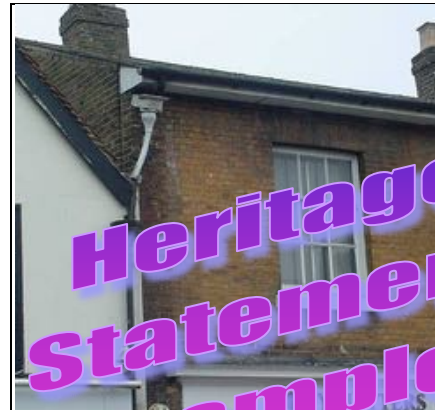
(Fig.7)

Images of hood showing date of 1833 as approximate date of construction of building

House, now shops with flat above. 1833, dated on rainwater head. Built for XXXXXXXXXXXX Company, ground floor rebuilt 1954. Yellow stock brick, Welsh slated roof, with 2 brick chimneys with square terracotta pots. 2 storeys. 3 first floor sash windows with glazing bars in reveals under flat arches. Ground floor has Neo-Georgian shopfront with entablatures, central pediment above Doric pilasters enclosing recessed entrance, with twin leaded glazed doors under semicircular fanlight with radiating glazing bars and moulded archivolt. Site of The Checker Inn, first recorded 1509. The C19 rebuilding incorporates some reused timber, as indicated by a moulded beam, used as a purlin in the roof of the rear outshoot. (Perman D: XXXX UD. List of buildings of special arch or historic interest: 1993-: 35).
