HERITAGE IMPACT STATEMENT

**Masonic Hall
XXXX
XXX
Monmouthshire
NP25 XXX**

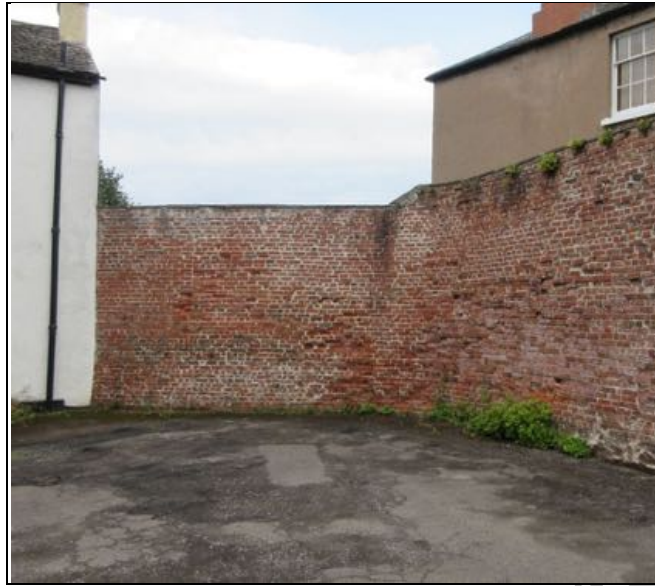
(Figure 4) Wall at front right side

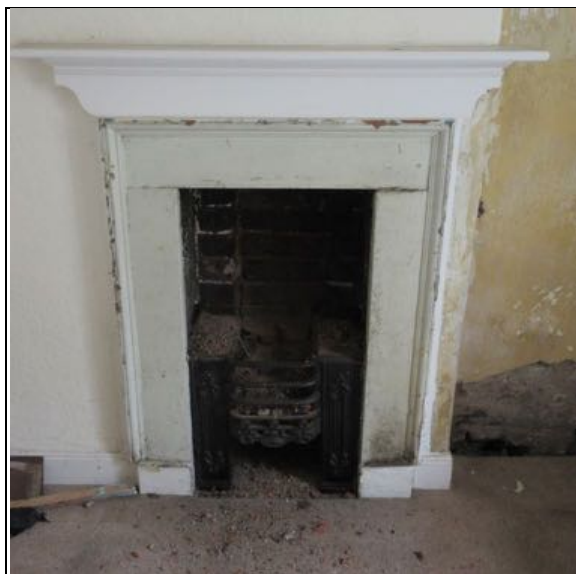
(Figure 8)

The small room to the front, right, has an original sash window and fireplace (Fig. 8). The side cupboard has an original door with contemporary ironmongery (Fig.10).

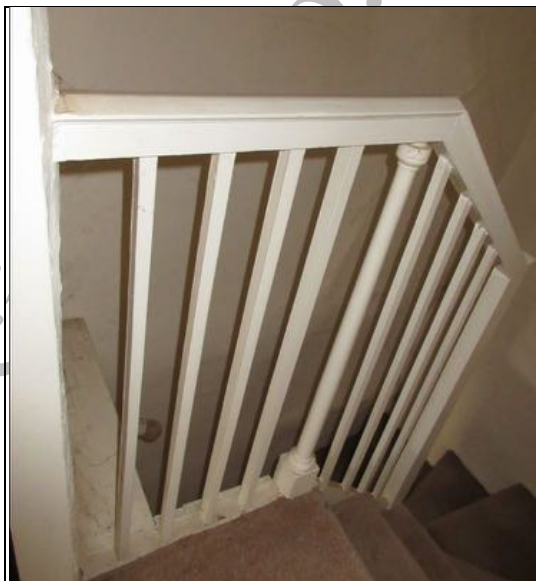
(Figure 9)

The stairs to the top floor are of a style consistent with the period (Fig. 9) as are both the

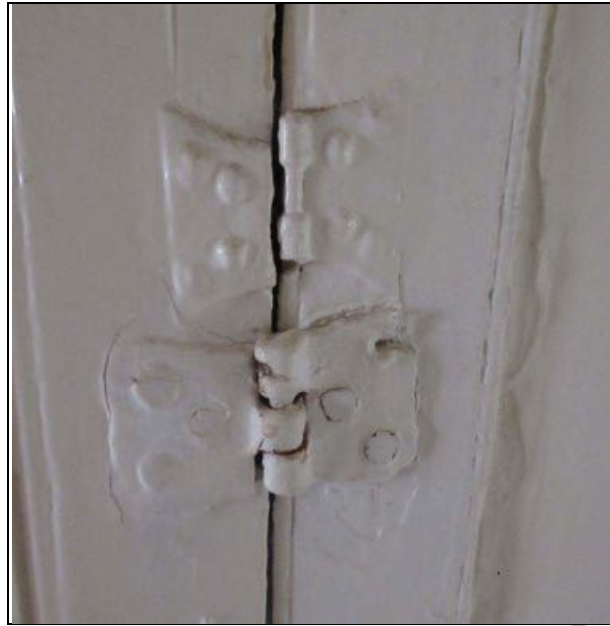
(Figure 12)

The sliding sash window at the front, ground floor, of the flat appears original in being a style consistent with the known age of the building; importantly the internal shutters and ironmongery are correct also. The fireplace is a later replacement, a style used in the mid c20th reminiscent of the earlier art deco style in shape but lacking certain stylistic features of that period. The doorcase to the lower ground floor kitchen is period in style and may be original. Other than that, the wrought iron hand beaten hinge to the understair cupboard door is of historic interest and is a replacement for the older, broken hinge which remains above and thought by the Monmouthshire Conservation Officer to be c16th. (Fig.12)

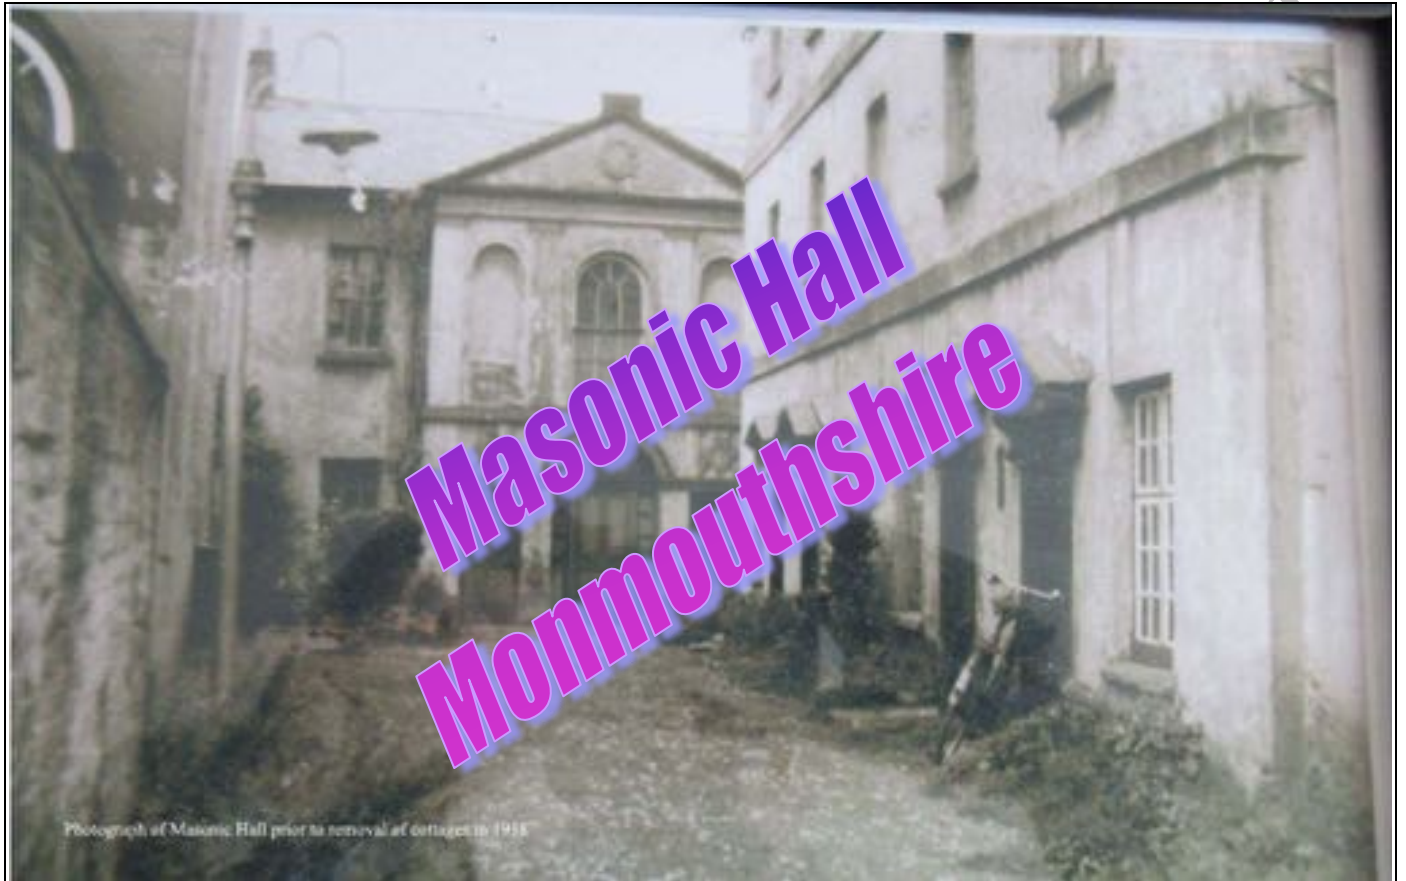
It is known that the row of cottages at the front, converted by Maddox in the 1840s from a wool store were demolished in 1938.

(Figure 19) View from front taken before demolition of cottages at right in 1938
(Photograph on display in Masonic Hall)
