RESIDENTIAL BUILDING SURVEY

Kent

Mr & Mrs X

INDEPENDENT CHARTERED SURVEYORS

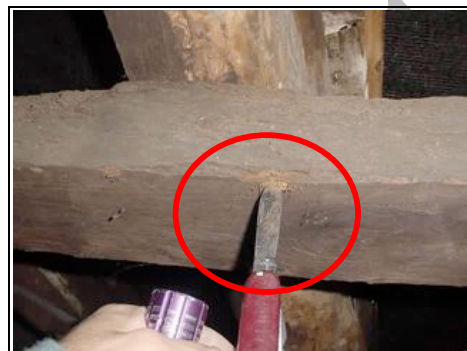
We found signs of frass, which are the chewed up remains of wood in the roof. We would have expected woodworm in a property of this age, unfortunately it appears that the woodworm may be active.

Woodworm frass

ACTION REQUIRED: Whilst we do not consider that the woodworm is structurally significant that is present it does need to be monitored. We generally recommend the environment is changed to an environment that woodworm are unhappy to live in. We would be happy to return in the Spring of 2015 to give a further opinion.

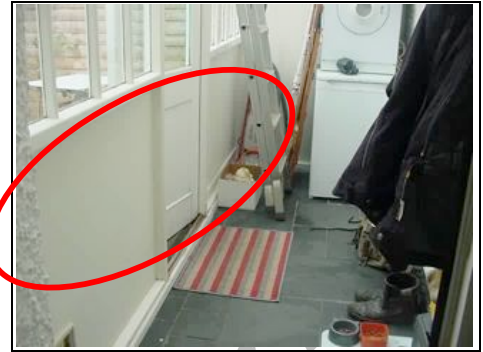
There is possible asbestos to the rear covered area (with polycarbonate roof).

Base of rear lean to area with possible Asbestos

ACTION REQUIRED: The only way to be a hundred per cent certain with regards to Asbestos in a property is to have an asbestos survey carried out by a specialist asbestos company.

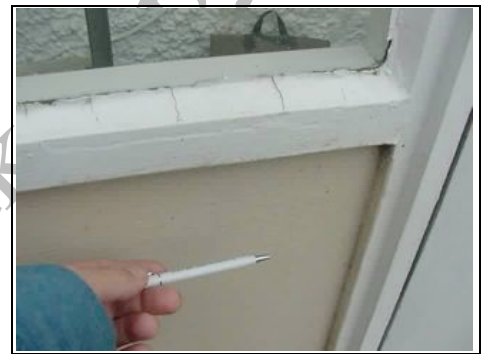
Possible asbestos to base

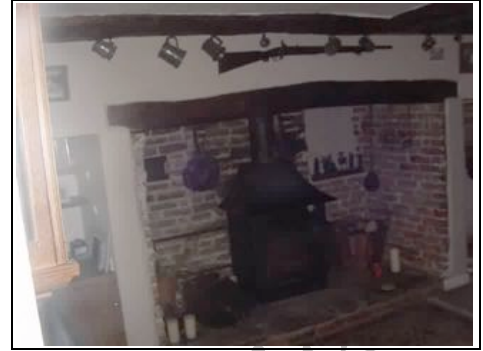
Whilst a real fire can be a feature of a house it can be problematic where it also heats the radiators. From what we understand you have to have the fire alight to heat the radiators which can mean there is a time lag between the property being cold and warm as the fire is lit.

Inglenook fireplace

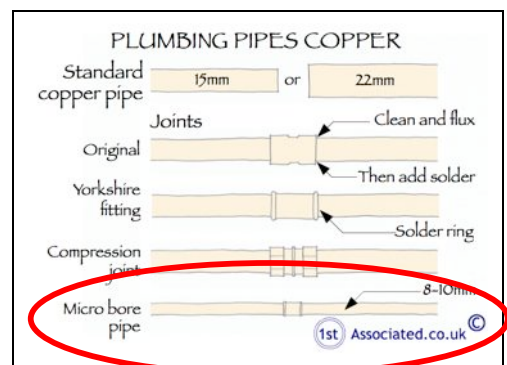
Plumbing pipework

ACTION REQUIRED: We would recommend that the micro-bore is replaced. We would also change any single panel radiators to double panel convection radiators.

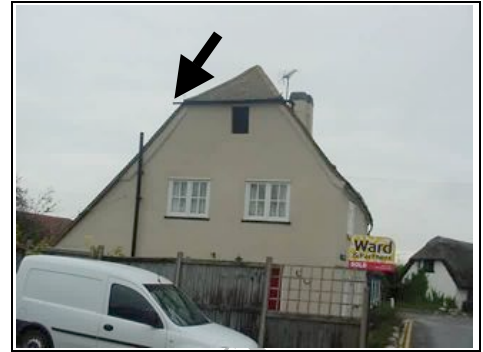
The original roof is likely to have been a clay Kent peg tile which then has been replaced with a heavier concrete tile which can cause roof spread. We could see hairline cracking in the cement render which is vertical indicating that the walls are moving out or down albeit relative minor.

Main roof

ACTION REQUIRED: There may be an option of the existing owner placing an insurance claim which you would then take over (approved by your legal advisors of course) with regard to the potential roof spread and then the insurance company could monitor for at least a year which is the recommended timescale. However this still would not get over the problem of having the cement render on the outside of the property.

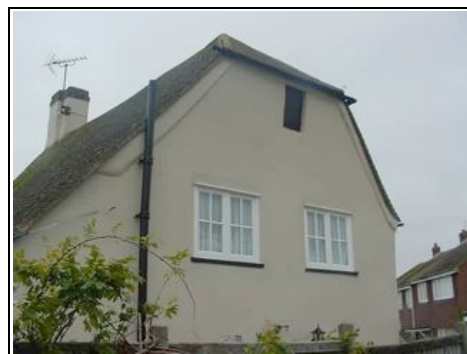
It can be seen that the gable end is out of vertical by approximately 15 degrees. We could also see within the roof that attempts have been made to tie the gable end in.

Gable end out of true

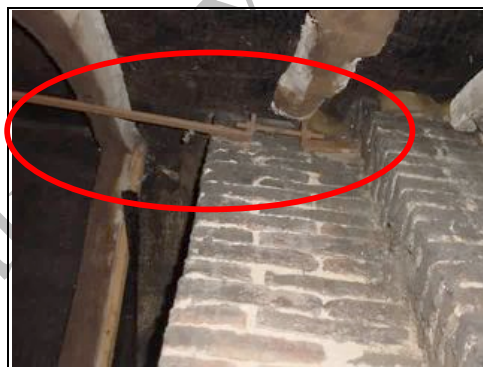
We could see some old iron bracing to the front of the property, which indicates there has been an attempt to tie-in the structure, which appears far older than the concrete small roof tiles that are likely to have been added in the 1970s.

Bracing running from front to rear

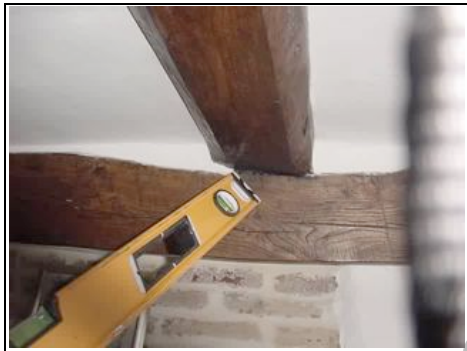
We could see a spine beam within the roof which is an essential beam that you need as the name implies which we could not see how this was tied in. There is also a beam which we could not see how it was tied in within the bedroom. These timbers may form part of the modernisation in years gone by.

Beam does not look to be tied into the frame

ACTION REQUIRED: Open up the structure to check and confirm. We would be happy to return and comment further.

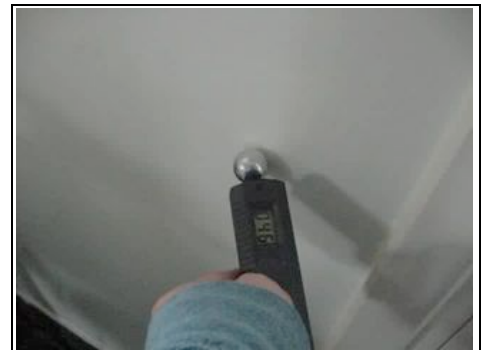
We have taken damp meter readings, which indicate that there is rising damp to the walls. We are not surprised with this given the modern material construction on an older property, which is stopping the property from breathing.

Damp meter reading indicating rising damp

ACTION REQUIRED: Removal of cement render externally and cement/modern gypsum plaster internally and replace with lime based render and plaster which would then allow the property to breathe. Add bell mouth as this would help with the dampness.

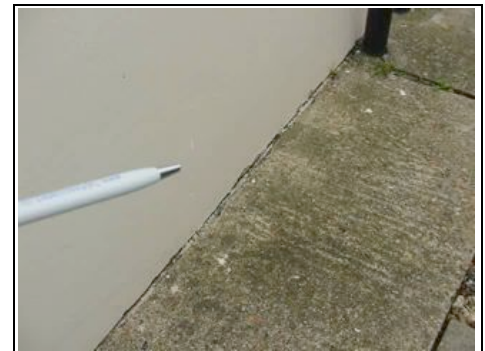
We also noted to the base of the render there was no bell mouth detail.

No bell mouth detail

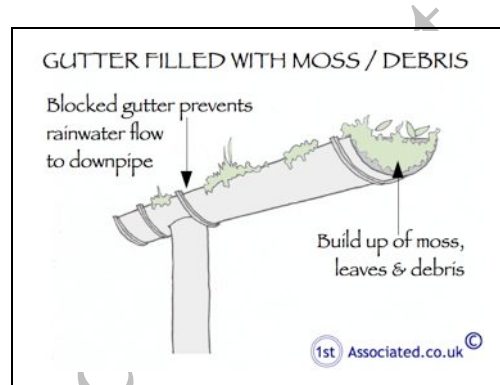
Clear gutters regularly

We would recommend in the short term that the ground level around the edge of the property is reduced slightly and an effort is made to ensure that all gutters and downpipes are watertight and discharge rainwater away from the property.

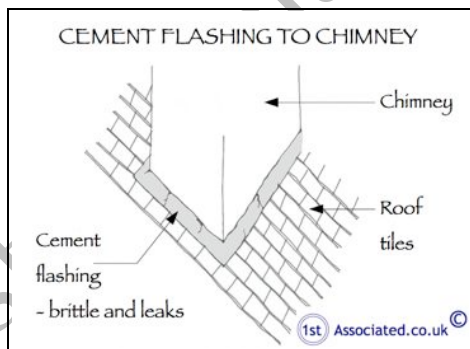
This chimney is render finished with a cement flashing and no chimney pots. From what we could see from ground level it looked in slightly below average condition considering its age, type and style due to the cement flashing.

Cement flashing

ACTION REQUIRED: Replace cement flashing with a lead flashing. Periodically inspect the chimney.

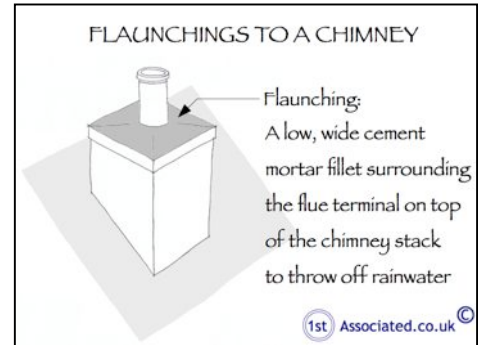
Flaunchings

Unfortunately we were unable to see the top of the chimney properly known as the flaunching, we therefore cannot comment upon them.

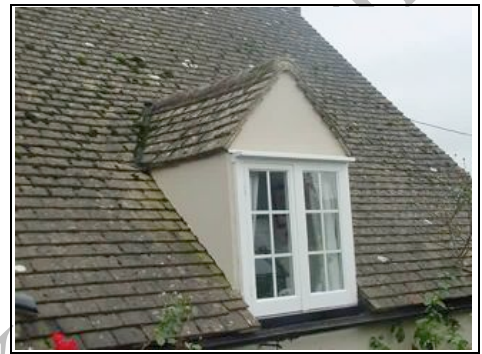
Dormer window

The dormer window roof is made from the same material as the main roof, the cheeks of the dormer are made in render and the windows are made in painted timber. Generally we could comment for their age, type and style they are in average condition. This is a new window – please see our comments in the Window Section regarding new windows and listed buildings.

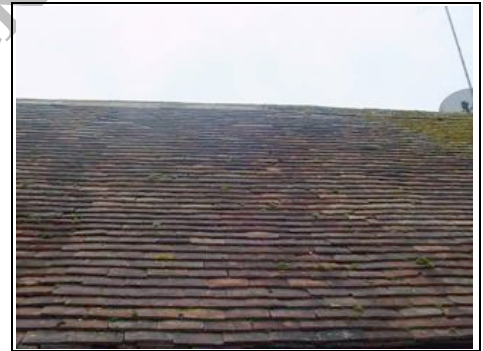
Main roof

The roof is pitched and clad with small concrete tiles and, from ground level, this looks in average condition considering the roof's age, type and style other than we would not have put a concrete tile roof like this onto this age of property. There is moss gathering on the roof as there often is with concrete tile roofs which you need to sooner or later remove.

ACTION REQUIRED: Please see our comments regarding the roof in the Executive Summary. Carry out periodic inspections and maintenance of the roof, as required.

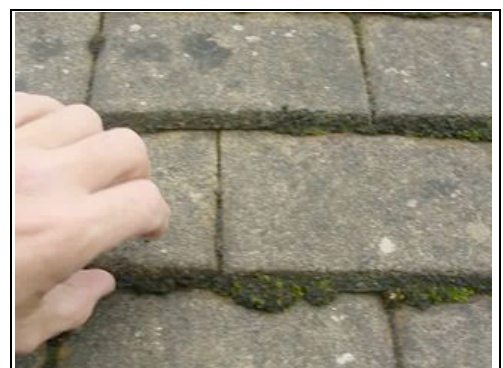
Moss gathering on roof tiles

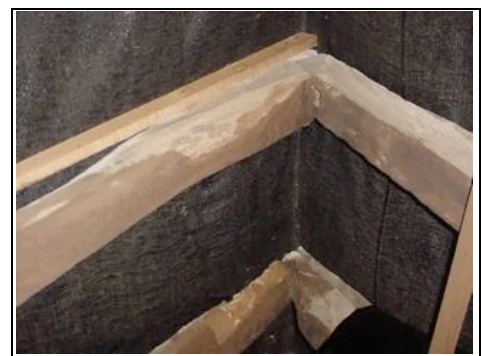
When we inspected the loft space we found a Hessian base Bitumen membrane. This type of membrane has been used since the 1960s. We generally found it to be in average condition, with damage in some areas, which is what we typically find.

This photo shows the common rafters (the ones that form the pitch of the roof) and the dark area between is the underlayer.

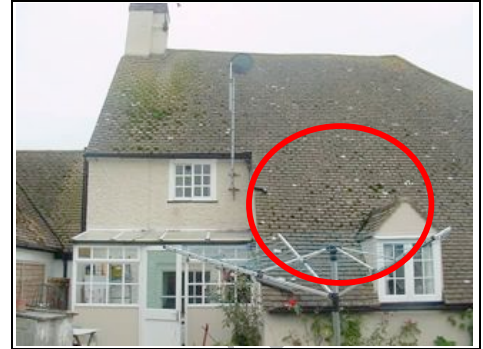
Rear cap slide roof

The roof is a cap slide roof with concrete tiles as the main roof. The cap slide is an extension of an existing roof which was fairly common in years gone by. This was added to allow the kitchen extension. We would add that it may be this cap slide roof and the extension that are limiting the movement in the building. Unfortunately it would take a years worth of monitoring as recommended by the Building Research Establishment to be certain of this.

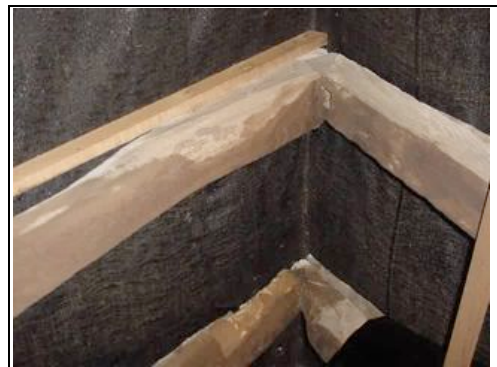
Coupled roof

- 1) The woodworm
- 2) We do not believe the roof is tied sufficiently with collars although obviously it has stood for many years.

The combination of factors such as the cement floor and the cement render to the walls mean that the building as a whole cannot move and cope with additional movement found in a timber framed property.

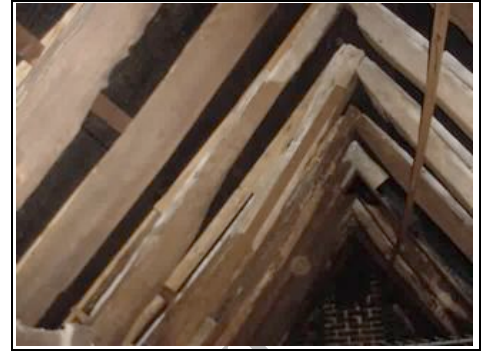
General view of roof

Our examination was limited by the general configuration of the roof, the insulation and stored items. What we could see was generally found to be in slightly below average condition considering its age. It is, however, feasible that there are problems in the roof that are hidden.

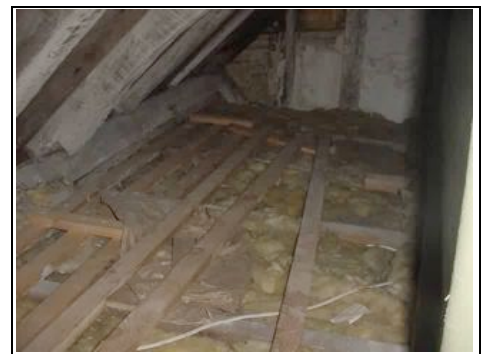
We could see that there have been repairs to the timbers which is quite common in older properties to have replacement timbers. Many of these have been re-used in other constructions. Or, the adding of additional timbers in what is known as back to backing, where timbers are strengthened by timbers being added back to back.

Back to backing of timbers

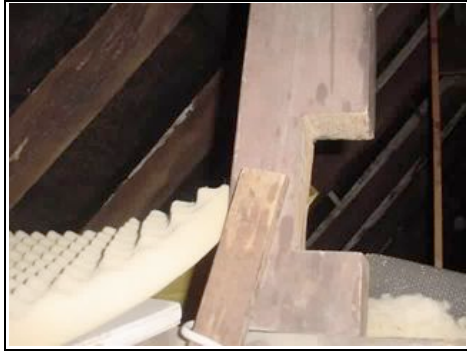
Re-used timber and
approximately half of it cut

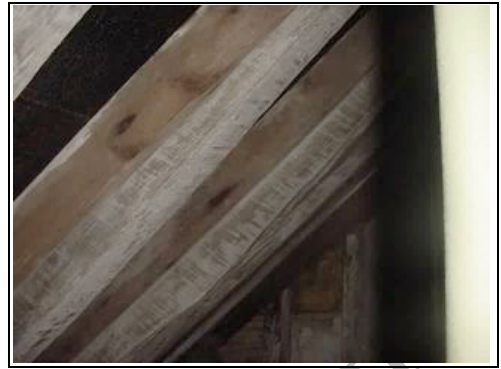
Close up of backing of timbers

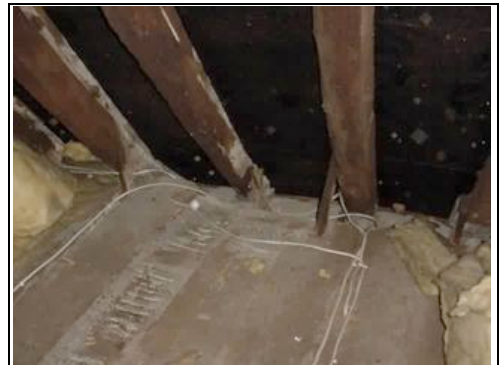
We can often identify the age of an electrical installation by the age of wiring found in the roof. In this case we could see a number of these, some of which were old.

Wiring in the roof

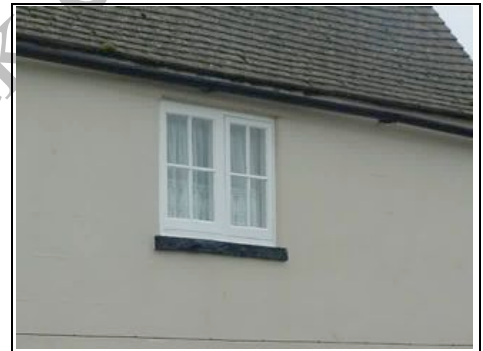
Guttering

The property has older cast iron gutters and downpipes. The condition is fairly typical of what we see; they are in average condition for their age, type and style. Cast iron of this age will need maintenance. If regularly maintained it lasts longer than plastic, in our experience.

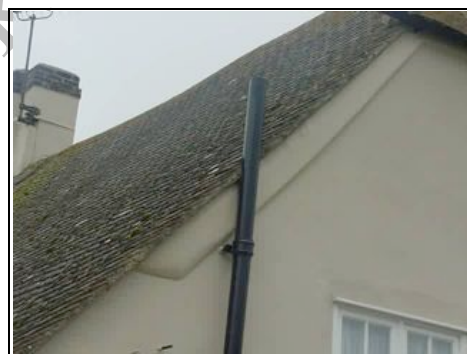
The property has two cast iron soil and vent pipes one used located to the left of the property which aligns with the bathroom and one unused located to the right of the property which does not align with anything in this property; we assume it may be used by next door. Cast iron of this age can crack and rust and needs regular maintenance.

Soil and vent pipe to left of property

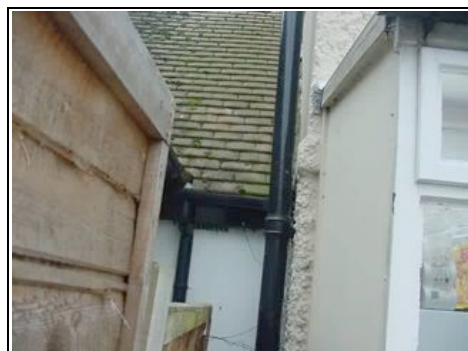
Unused soil and vent pipe to right of property

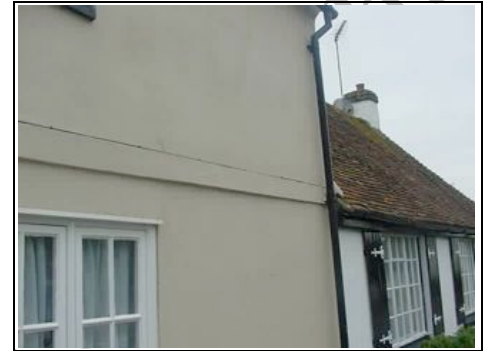
Painted cement rendered walls covering timber frame

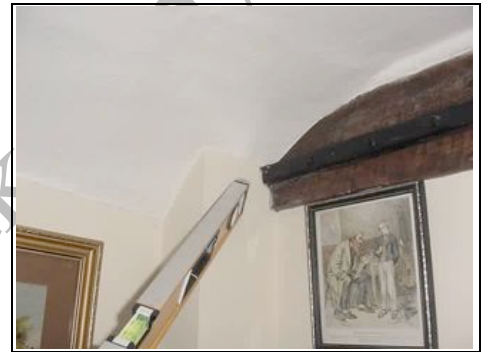
Bracing straps

We could see bracing straps. We would refer you to our comments with regards to collars in the Roof Section. All of these are to stop movement to the front and rear walls. This type of bracing we would suggest is pre-war however it may have been added as part of the refurbishment programme.

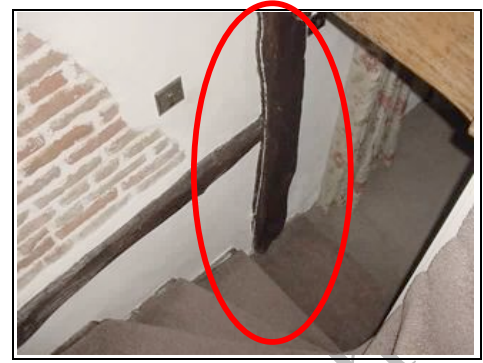
This timber did not fall in with the pattern of the structure and during our question and answer session the owner confirmed that he had added it. Unfortunately he had not remembered to mention it earlier until we pointed it out.

Fake timbers

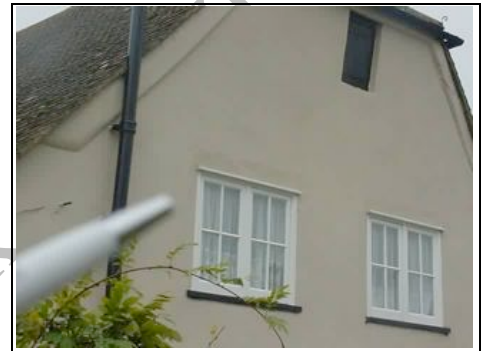
Render at gable end

We have carried out a tap test (literally hitting the render with the back of a hammer). We found it to be in average condition. The problem is it is a cement render.

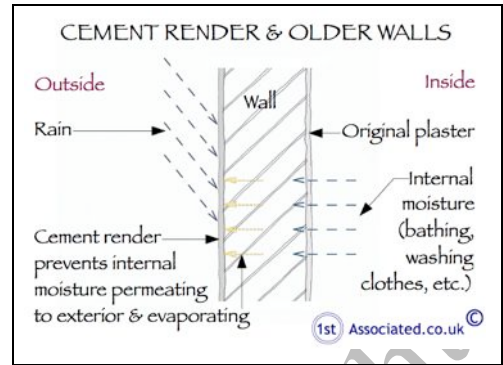
There is cracking in the render.

Cement render

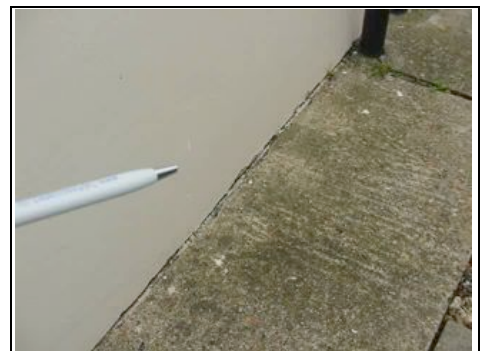
To the base of the render there was no bell mouth detail.

No bell mouth detail

ACTION REQUIRED: Add bell mouth as this would help with the dampness. Please see our comments in the Executive Summary.

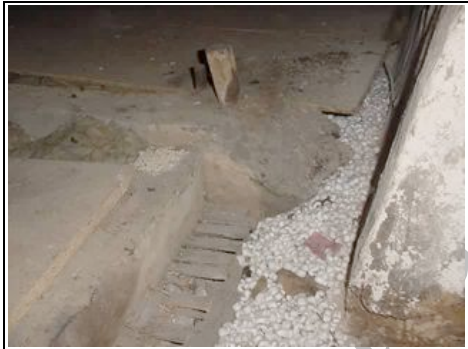
Often these timbers are re-used timbers, used sideways as it was more practical but this leads to higher levels of deflection than usual in modern properties.

Spine beam that does not tie in

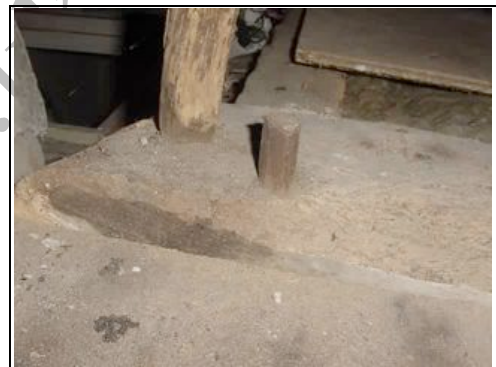
Peg fixing spine beam not tied in

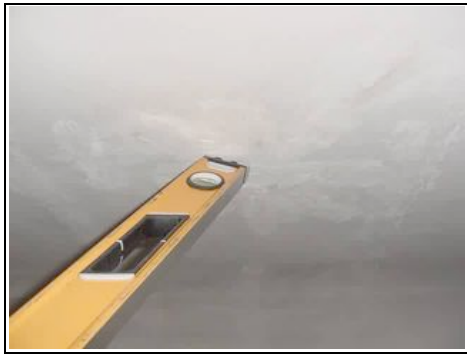
Advised by owner the mark in ceiling was due to wife's poor decorating skills rather than roof leak

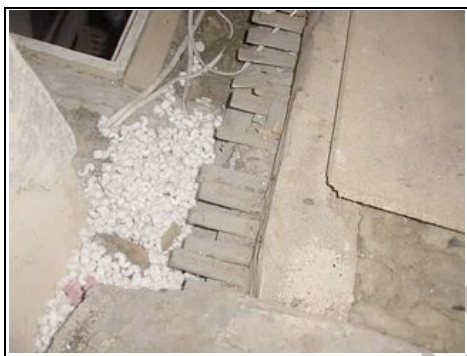
Lath in ceiling overclad

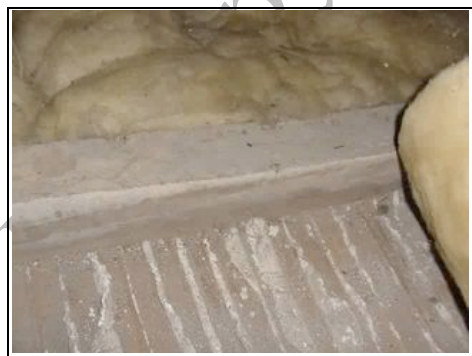
Where we could see the ceilings from the roof space we could see that they were lath and plaster. There is plasterboard/gypsum plaster to the newer areas such as the kitchen.

Lath and plaster ceiling

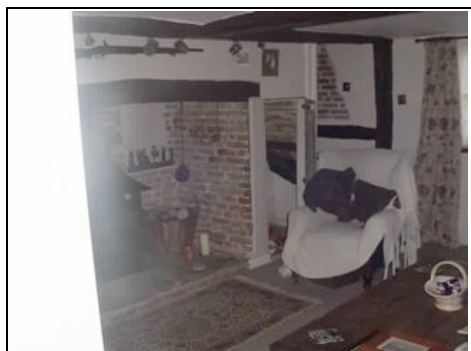
Inglenook fireplace

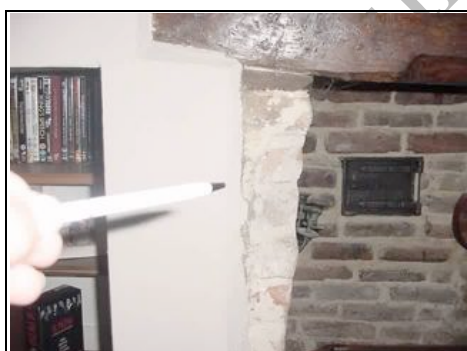
Mark on fireplace where knives were sharpened according to current owner

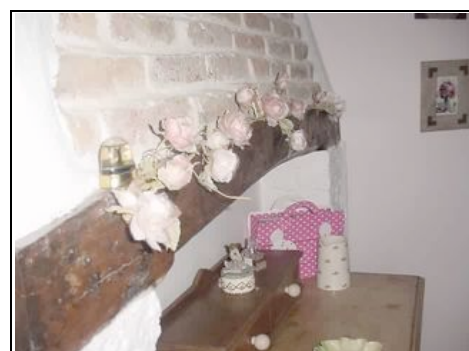
Fireplace in master bedroom

It is strongly recommended that flues be cleaned and checked for obstructions prior to use to minimise the risk of hazardous fumes entering the building.

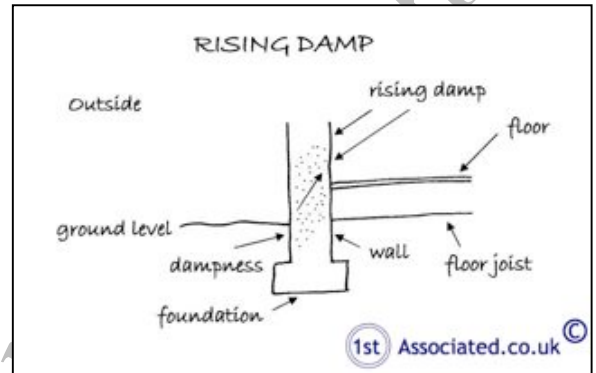
Rising damp

A visual inspection and tests with a moisture meter have been taken to the perimeter walls. In this particular case we have found significant rising damp.

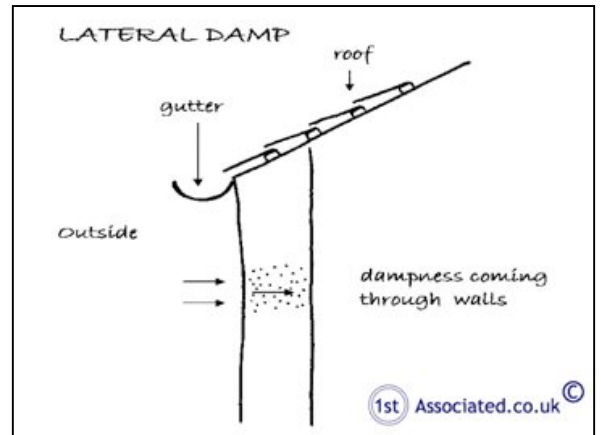
We used a resistance meter on the external walls. We have found dampness in line with what we typically see for this age, type and style of property.

Lateral dampness

ACTION REQUIRED: Please see our comments in the Executive Summary and in the Render Section.

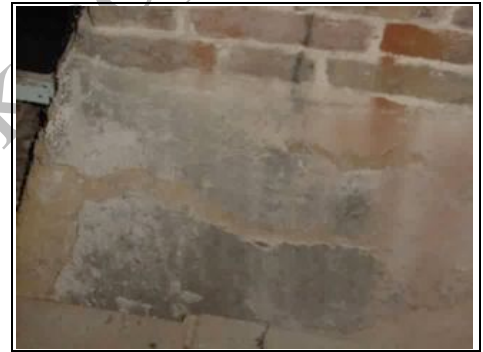
Damp plaster to chimney breast

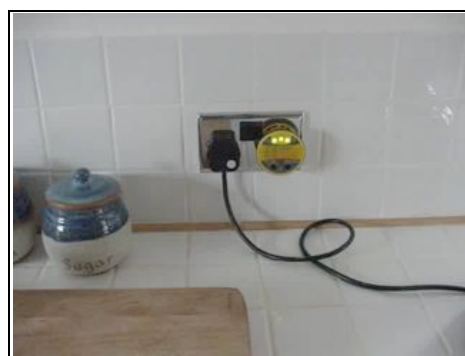
We carried out an earth test in the kitchen area to the socket point that is normally used for the kettle, this proved satisfactory.

Earth Test

ACTION REQUIRED: As the property is changing occupancy an Institute of Electrical Engineers (IEE) test and report is required, carried

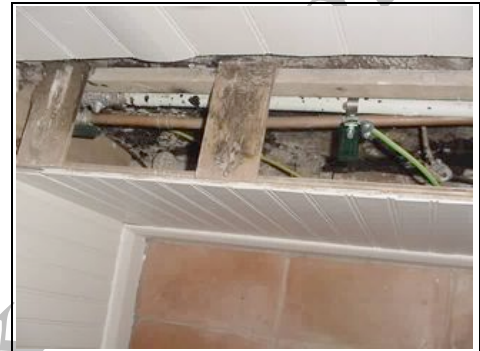
We were advised by the owner that the controlling stopcock is located in the bathroom next to the bath.

Stopcock

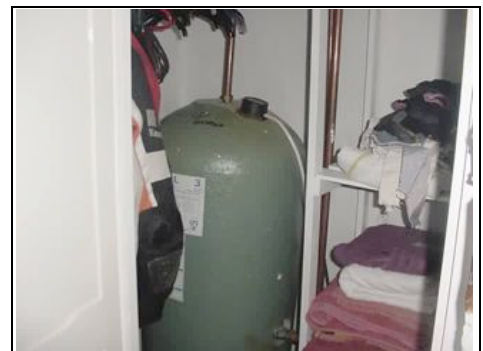
There is a factory insulated hot water cylinder located within the bedroom cupboard. This cylinder will therefore have a good thermal efficiency, although not as good as the more modern hot water cylinders.

Hot water cylinder

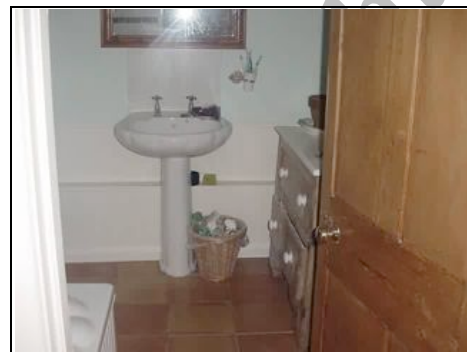
The property has a four piece bathroom suite, consisting of a bath, wash hand basin, shower and WC, which looks in average condition, subject to some day-to-day wear and tear, as one would expect.

Bathroom

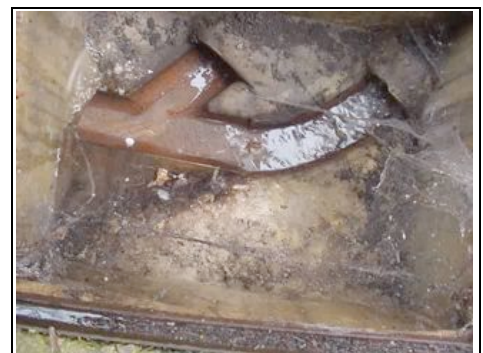
We duly lifted the cover and found it to be free flowing at the time of our inspection.

From what we could see it is brick built.

Manhole

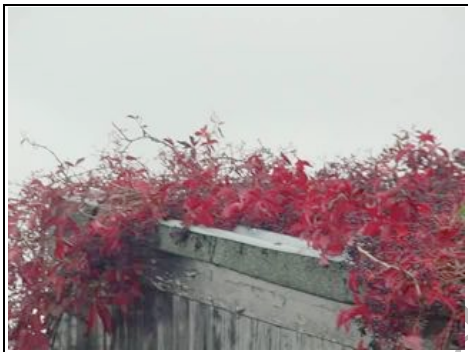
Overgrown plant on garage roof

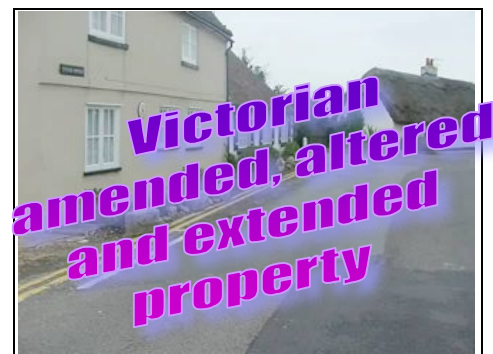
Front of the property sits close to the road
