## RESIDENTIAL BUILDING SURVEY

XXXXXXXXXXXX

INDEPENDENT CHARTERED SURVEYORS

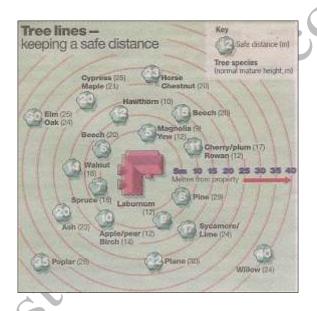
Tree cut down to rear right side of property

**ACTION REQUIRED:** Your legal adviser needs to specifically ask when this tree was cut down and also to ask if there have been any others cut down and when, as these will affect the long term performance of the building.
