## RESIDENTIAL BUILDING SURVEY

Lincolnshire XXXXXXXX

INDEPENDENT CHARTERED SURVEYORS

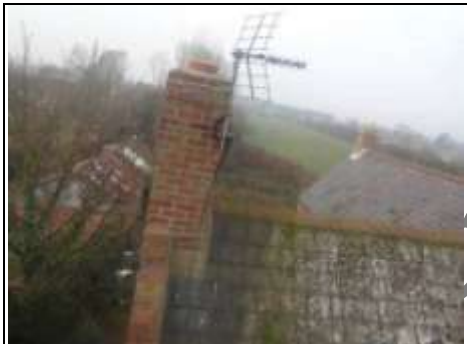
All four chimneys are weathered and require repair and repointing.

Front left chimney  
Aerial view – 360 photo

**ACTION REQUIRED:** Repair and repoint as necessary, check flashings and also check flaunchings (the top of the chimney).

**ANTICIPATED COST:** £3,000 - £5,000 (three thousand pounds to five thousand pounds); please obtain quotations.

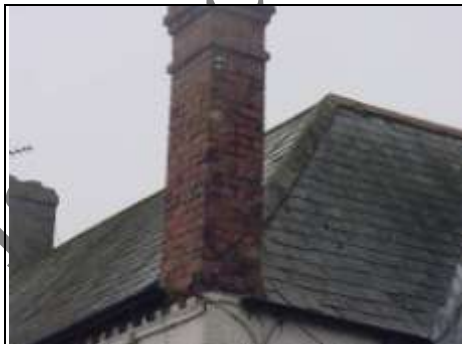
Front middle chimney

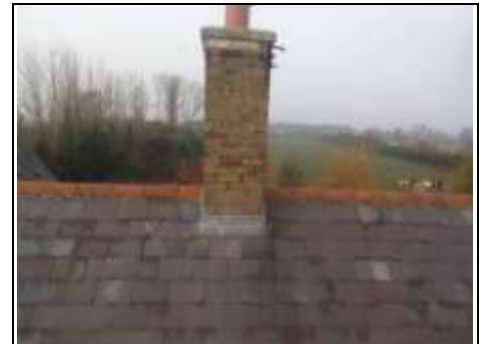
Front right chimney needs re-pointing at the base  
Aerial view – 360 photo

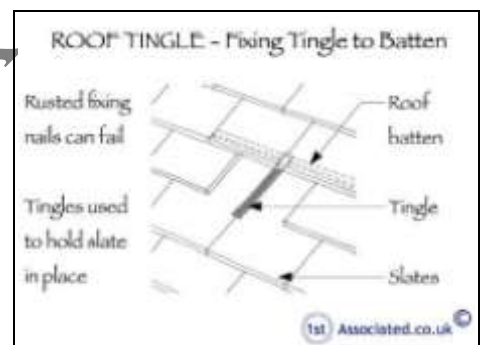
Tingles are a way of repairing a slate roof where the nails have deteriorated.

Roof tingles

**ACTION REQUIRED:** We believe several of the roofs will require repair and or re-slating within the next five to ten years.

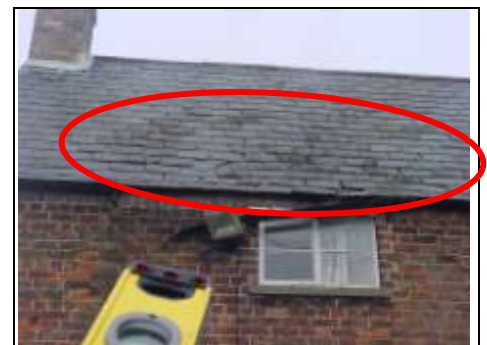
Slipped slates to the rear left

**ANTICIPATED COST:** Depending on which roofs are carried out £5,000 - £15,000 (five thousand pounds to fifteen thousand pounds) (per large roof). When the roof work has been carried out we would also carry out any associated wall and window work etc. utilising the scaffolding that will be needed for the roof repairs; please obtain quotations.

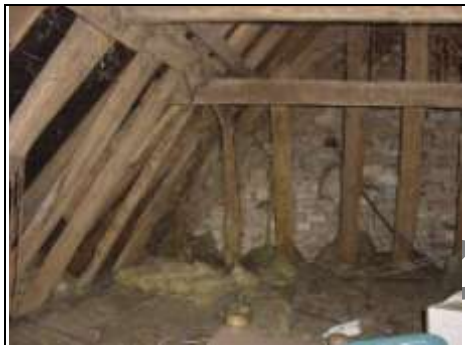
Within this roof we could see old timbers and some peg fixings and also deterioration and woodworm. Rather than replacing the timber it may be better to add additional timber in this way you keep any historic timber and improve the structure. This is the system that has been used over the years and we can see it being used in this roof.

Old roof structure to the left  
of the property

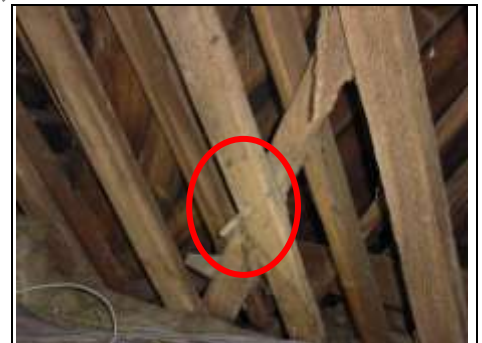
Peg fixings in the roof

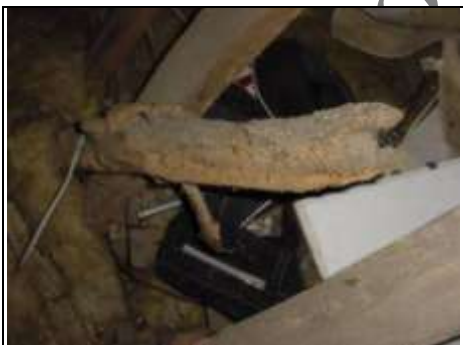
Old timbers

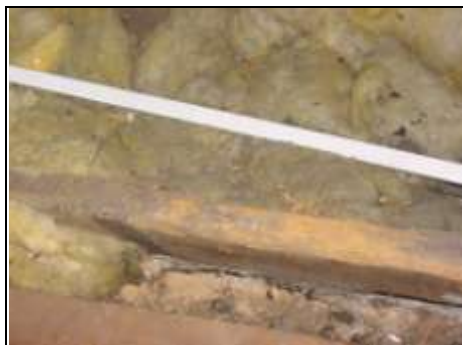
Woodworm in the roof

We would strongly advise against using chemicals or any other sprays to treat woodworm as we feel there are far better ways of dealing with woodworm in the long term.

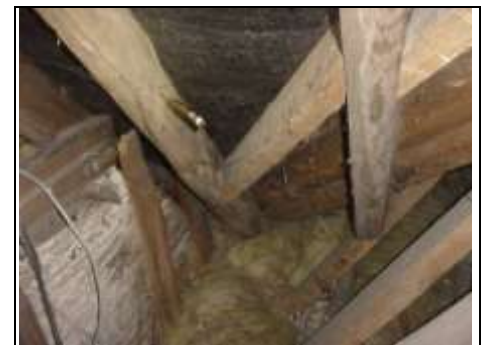
When you carry out the roof cover / slate roof repairs you must carry out repairs to the roof structure. There are various timbers that are split or are bending and need replacing particularly to the valley gutter to the rear and to the roof to the front right side.

Split timbers to the rear valley

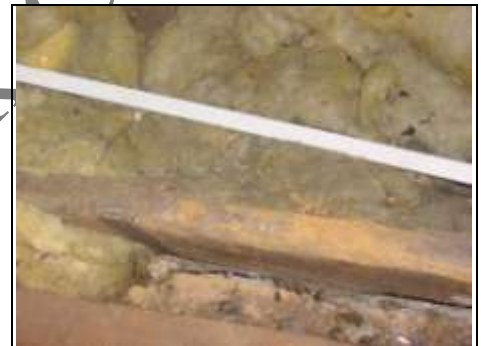
You will also notice there is some woodworm in the roof structure which we believe is active although there is a fair proportion of old woodworm.

We think the woodworm activity will be reduced if not stopped all together once the roof is made water tight moving the dampness (woodworm like dampness) and also getting air ventilation in to the roof and heating to the building.

Woodworm in the roof

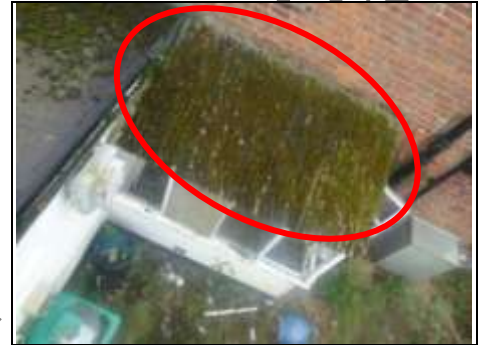
The rear entrance roof is asbestos and is deteriorating. We believe you have already agreed to remove this area. There also looks to be a manmade slate to the left side roof (in a blue oval) which may contain a small amount of asbestos as it was fairly common in older manmade slates (all directions given as you face the property).

Asbestos roof to the rear entrance

**ACTION REQUIRED:** If you wish to confirm you are 100 percent free of asbestos, you need to have an asbestos survey carried out.

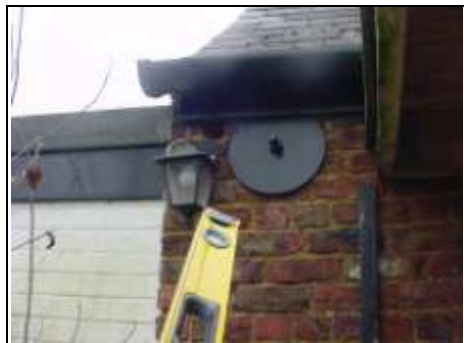
To the left side of the property we can see cracking. Unfortunately, they are very difficult to see in the photos. It does mean that movement is going on to the right side extension as tie bars are added to stabilise walls and offer cross bracing to them.

Tie bar to the function room

**ACTION REQUIRED:** We would recommend that you open up sections of the wall to see what the wall is constructed from and also to check if the tie bars are giving support to the structure.

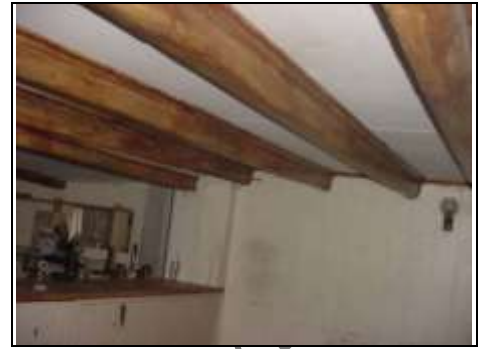
*the modern timbers within the right side bar which have been painted with a smoke stain type colour which was popular in pubs years ago (particularly when smoking was allowed).*

Timber beams to the right side of the main bar

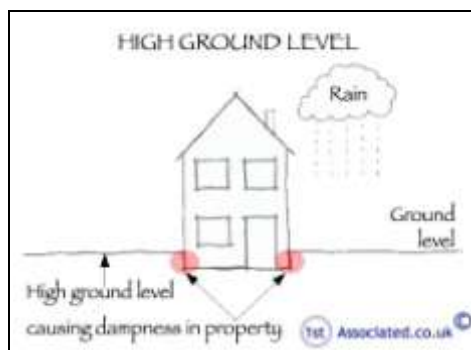
The ground level around the property is relatively high leading to dampness getting in particularly where the building is built from the soft red brick.

High level ground

**ACTION REQUIRED:** Lower the ground level around the property and we would also recommend you add a French drain.

**ANTICIPATED COST:** £2,000 - £4,000 (two thousand to four thousand pounds); please obtain quotations.

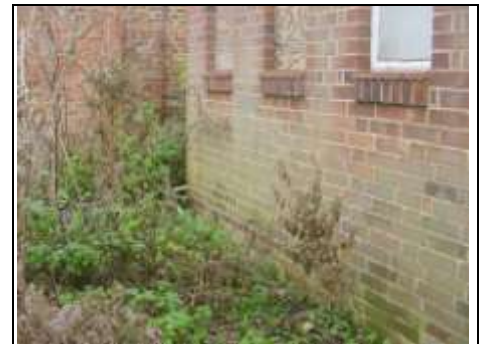
Rear of the ladies' toilets

To the rear left side of the property there is what we would describe as an over grown swampy area. We had our best view from the flat roof at the back of the property.

When we were looking down to this area from the flat roof it looked like the ground had been washed away. You advised that you were going to level the ground, you do need to make sure there is not a natural collection of water in this area or even a spring. If there is you need to get the water away from the building

**ACTION REQUIRED:** We recommend soak aways are added to the entirety of the rainwater drainage, which will need to discharge as far away from the building as possible.

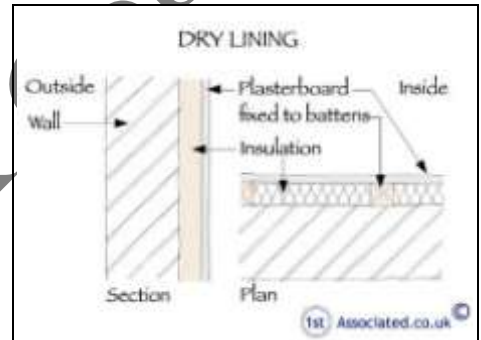
Perks of the dry lining / false wall is to hide the dampness coming through into the property which is considerable. Even with the repair work that we have mentioned you may get an element of dampness coming through. You have to consider part of the character of this building.

Dry lining

**ACTION REQUIRED:** You need to decide exactly what sort of finishes you want internally, but we think you will probably end up dry lining some of the property.

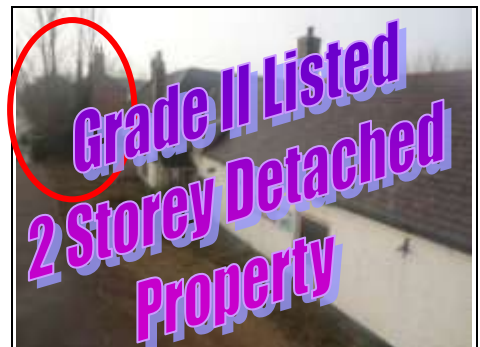
Trees to the left

There are trees around the building particularly to the left side where there are larger and mature trees and smaller trees to the rear. We can also see that some large trees have been cut back on the left side as well.

**ACTION REQUIRED:** You need to regularly maintain the trees.

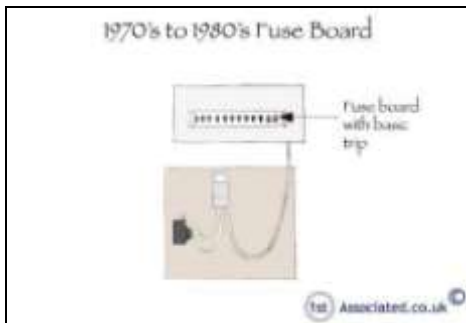
The electrics are dated and were not working at the time of our survey.

1970's Fuse board

**ACTION REQUIRED:** It may be worth having a new system installed. We recommend an Institution of Engineering and Technology (IET) test and report to be carried out by an NICEIC registered and approved electrical contractor or equivalent.

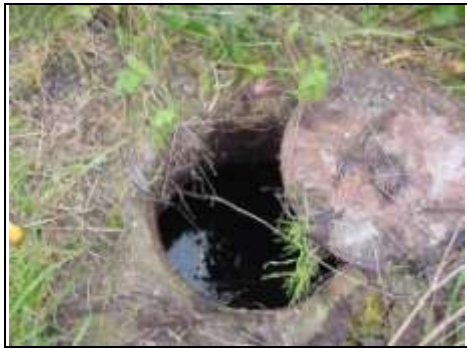
We believe there is a well in the garden, we would put a sump pump into this to see if it is a well, a septic tank or something similar. Place the sump pump into this and pump out what is in there to see if we can see the size and construction of the septic tank.

Well in the garden

**ACTION REQUIRED:** We recommend you pump out the well with a sump pump or get a company to drain it to see how it is constructed and put a new septic tank in depending upon the capacity etc.

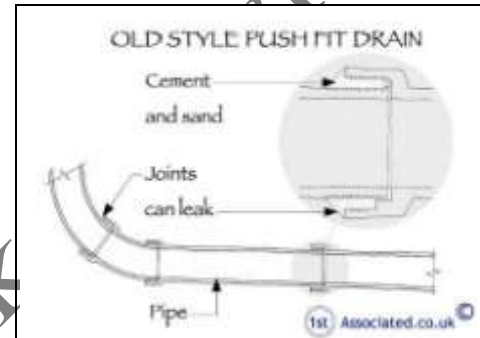
In older properties, such as this, drainage was often push fitted together rather than bonded together which means that they may leak over the years. Whilst we ran the tap for 15 minutes without any build up or blockages the only way to be 100% certain of the condition of the drains is to have a closed circuit TV camera report.

Push fit drain

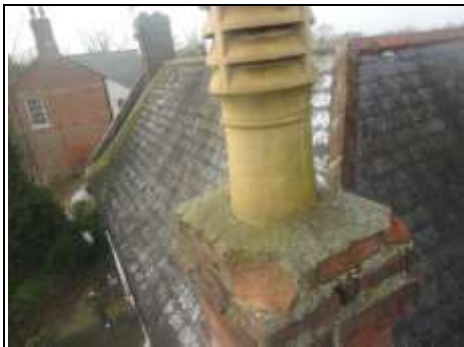
Chimney in below average  
condition  
Aerial view -360 photo

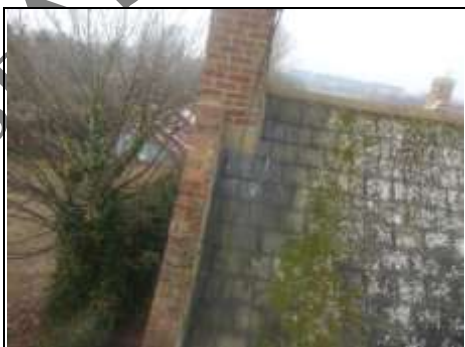
Moss on roof  
Aerial view -360 photo

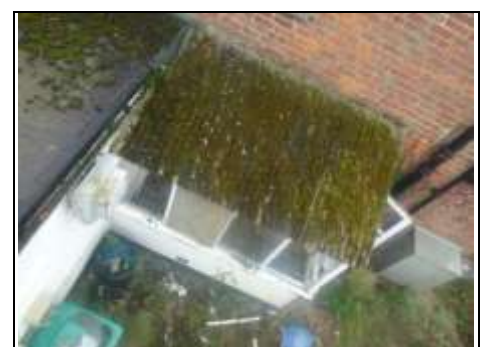
Asbestos roof to the rear  
Aerial view -360 photo

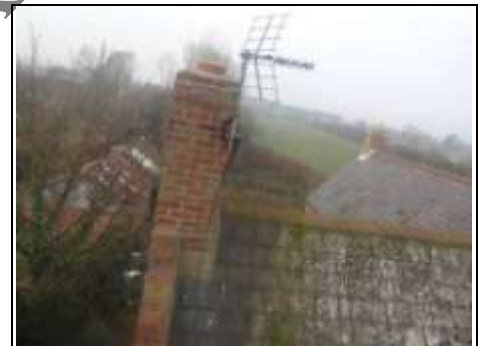
Front left chimney

We noted an aerial attached to the chimney which we are not keen on as it cuts into the brickwork rather like a cheese wire cutting into cheese.

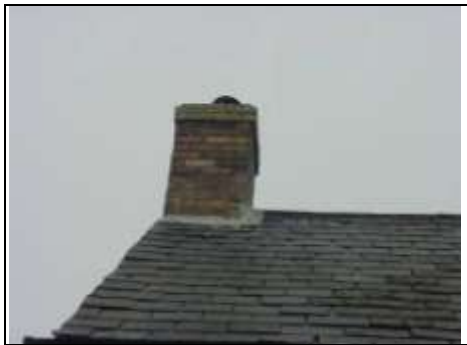
Rear left chimney

This chimney is brick finished with a cement flashing and one chimney pot. From what we could see from ground level it looked in below average condition considering its age, type and style.

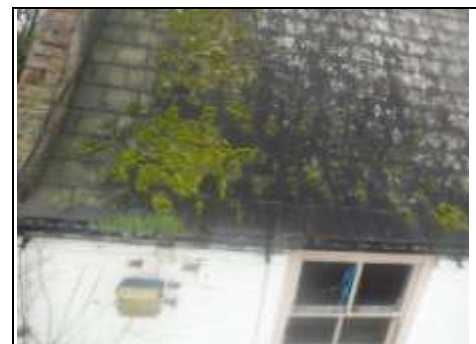
Moss on roof and grass growing  
in gutter to main roof front left

**ACTION REQUIRED:** We recommend re-roofing. At the very least we would clear the moss.

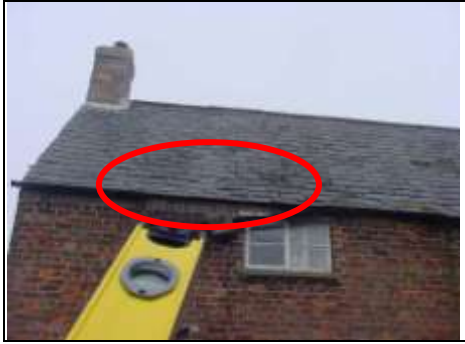
The natural slate shows an area that has slipped slates to the rear left side, tingles are holding the roof in place and some of the gutters are coming away.

Slipped natural slates to main roof rear left

**ANTICIPATED COST:** If you can re-use the existing slates then we would expect costs to be in the region of £5,000 to £10,000 (five thousand pounds to ten thousand pounds). If not, and we think it is likely that these are already second-hand slates, then the bill would increase by about £5,000 to £10,000 (five thousand pounds to ten thousand pounds). Please obtain quotes.

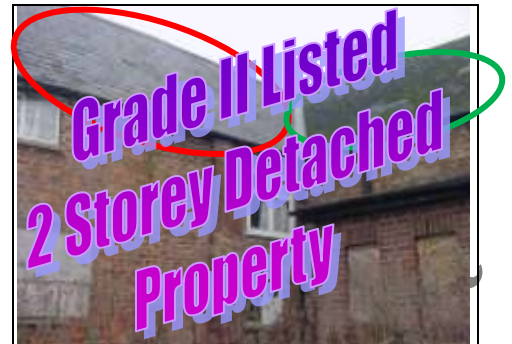
Main rear left roof to rear showing mix of natural slates (red oval) and manmade (with moss on it) (green oval)

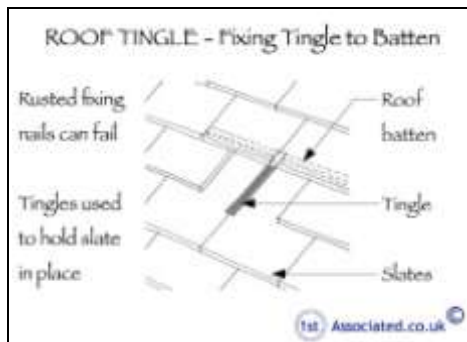
Lead tingles

There are over 50 tingles on the roof and we consider the roof needs re-roofing.

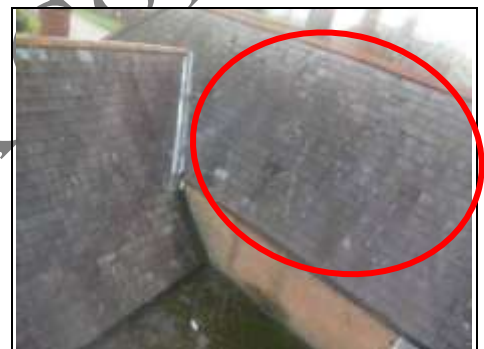
Around 50 lead tingles on main roof

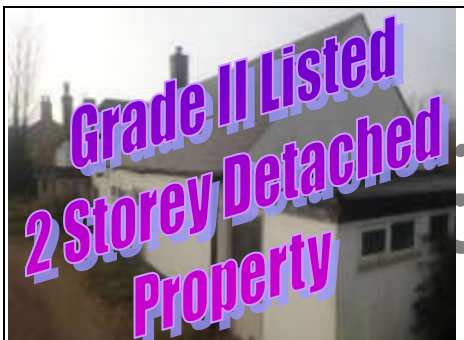
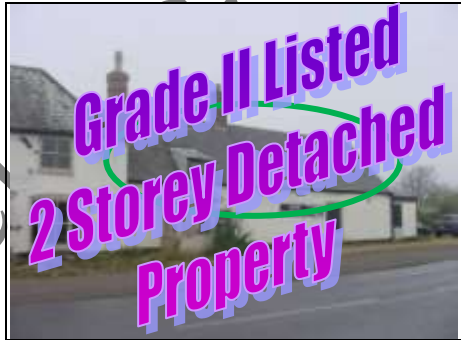
The main roof right side is pitched and clad with a manmade slate and, from ground level, this looks in a much better condition than the left main roof although we can still see some tingles to it. We believe this to be a relatively recent re-roofing (in surveying terms in this instance the last 30 years).

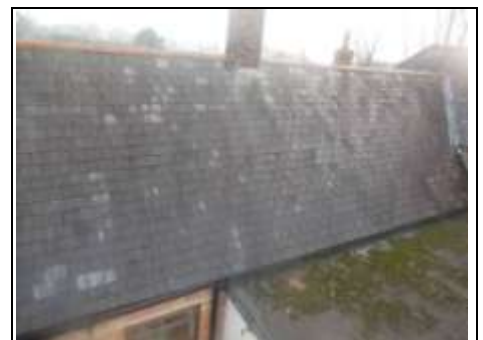
Main roof rear right  
Aerial view – 360 photo

**ACTION REQUIRED:** Ad hoc repairs to slates to make watertight for the oncoming winter.

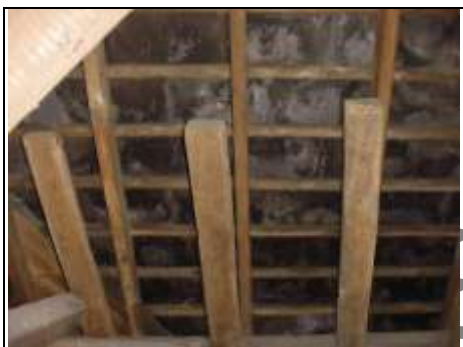
They range from having no protective underlayer on the left side, to having 1960's style Hessian base underlayer (bitumen) to part of the front of the property, to having what looks like a breathable underlayer to the right side, which generally started to be used from about the year 2002.

No protective underlayer to the left side of the roof

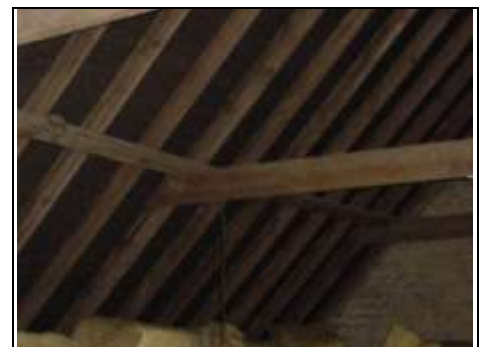
2002 breathable underlayer to the front right side

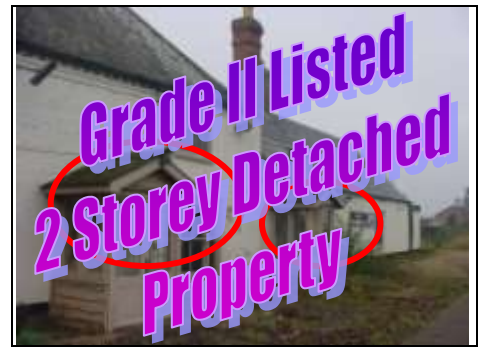
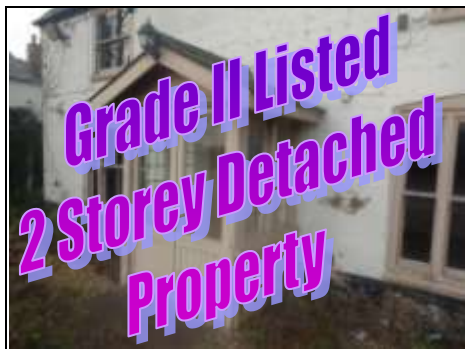
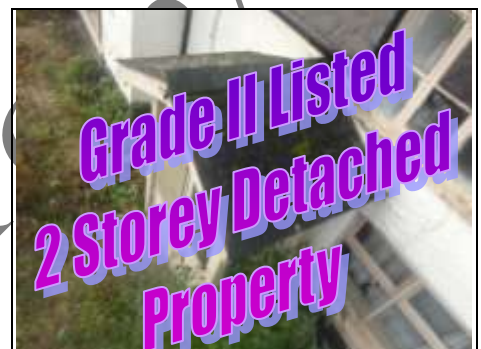
There are two small front entrance roofs to the property. Both of them are pitched with a manmade slate with a lot of moss of them. From ground level they look in below average condition considering the roofs age type and style.

Front entrance roof

Left entrance roof  
Aerial view – 360 photo

Right entrance roof  
Aerial view – 360 photo

**ACTION REQUIRED:** Ideally in both cases we would replace the manmade slates (remembering they may contain some asbestos) with a natural slate. We would also add gutters as well.

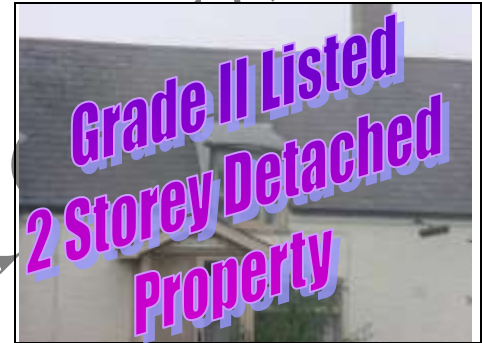
Dormer window

Generally, we could comment they are in below average condition for its age, type and style.

**ACTION REQUIRED:** Repair the roof, reposition the guttering and downpipes and repair and redecorate the window and side areas.

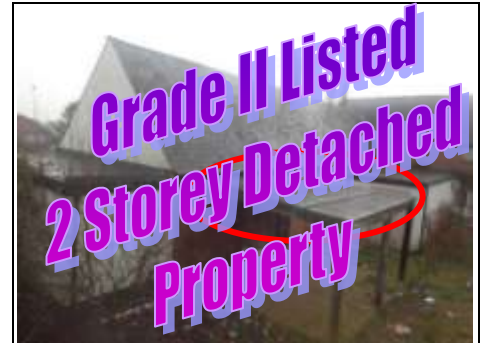
The rear flat canopy roof is the only roof we have not been on top of. We assume from our discussions that this roof is being demolished. If this is not the case, please contact us and we will advise further.

Rear flat canopy roof  
Aerial view- 360 photo

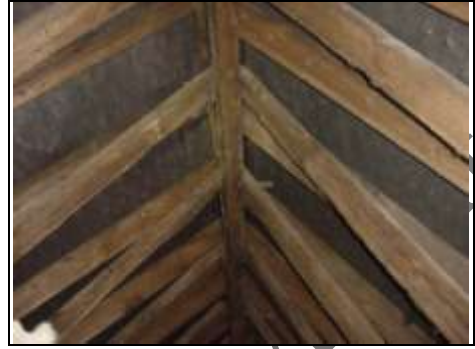
General view of inside of roof

Our examination was limited by the general configuration of the roofs, the insulation and a few stored items. Generally, we found the older roofs in below average condition, the modern old roof in okay condition and the newer cut timber roof in average condition.

We would particularly draw your attention to the older roof and older modern roof, both of which have woodworm to a greater or lesser extent. There is also some evidence of wet rot in these roofs. This we believe relates to the slipped slates externally and the detailing around the chimney, which should be mostly resolved if you carry out the work mentioned to the chimneys and roofs and associated guttering and downpipes work.

We would be able to comment further on these roofs if you cleared them of all stored items, insulation etc which is the only way to be 100% certain of their condition.

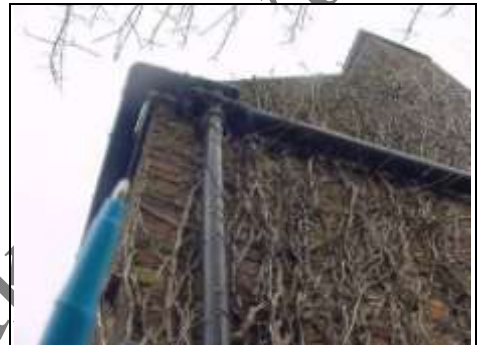
Generally, they are cast iron and are in poor condition.

Gutter and downpipe

We normally recommend keeping cast iron gutters and downpipes as much as possible, but in this case it does look like renewal will be the best way forward, subject of course to agreement with the Conservation Officer.

It is important you get the building as watertight as possible before wetter/winter months. We recommend using metal gutters and downpipes as we feel these last much longer than plastic, but it may be for speed that you use plastic and then at a later date exchange them for metal.

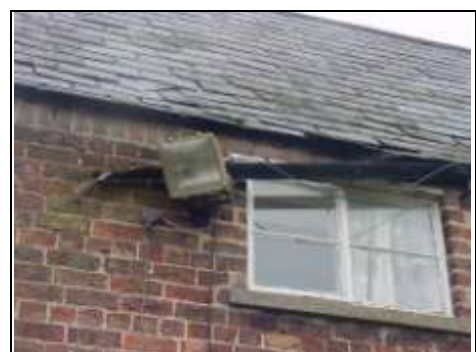
Gutter falling off

**ACTION REQUIRED:** We recommend you repair the gutters and downpipes as soon as possible to stop water discharging down the building and damaging it. You will need to chat to the Conservation Officer.

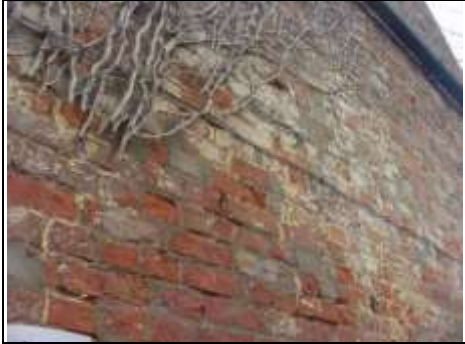
Unfortunately, the older brickwork has been wrongly repaired many times using cement to the joint and to cover whole bricks, which is such a shame. There are also areas where ivy has grown and causing deterioration.

Cement repointing, bricks replaced with cement mortar, lime wash and ivy

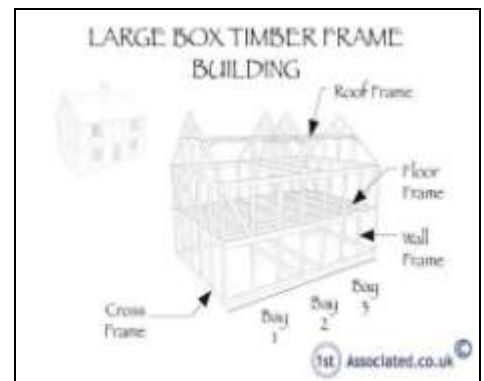
The question here is how much of this building was in a timber structure? From the Listing it would indicate it is probably just the left hand side of the property, but in our experience you may find more of the timber frame structure as work proceeds and if and when you open the property up.

Timber frame structure

**ACTION REQUIRED:** We recommend you open up several sample areas to see exactly what the construction is. We would specifically draw your attention to the front of the property to the left side (under Roof A in our roof plan), where the brickwork looks to have been re-created using a cement mortar or similar with the joints drawn into it.

We believe this section needs to be opened up very carefully with a builder/historic buildings expert who can then advise you on the best way to repair historic brickwork.

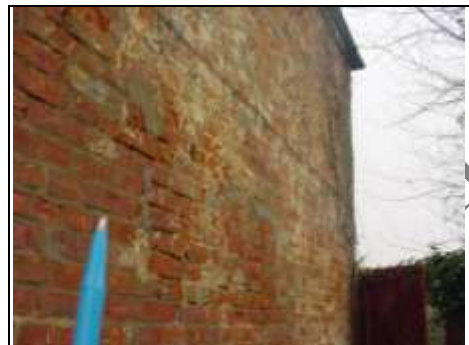
The gable end is a fine example of how not to maintain and look after a building. This looks to have had a combination of ivy growing off it with some still remaining and it has had cement repairs which unfortunately will cause more damage than good, however having said there is also considerable weathering on this gable end.

Gable end left hand side

In areas like you need to ensure that you have the right lime mortar mix to repair them once all cement is removed.

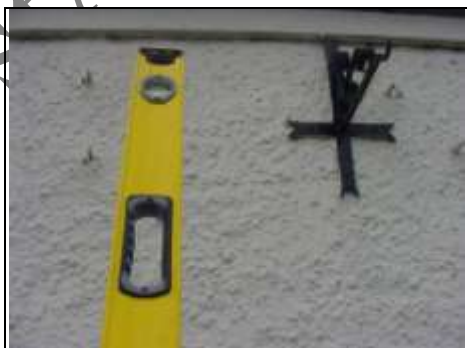
Vertical hair line cracking

**ACTION REQUIRED:** We would again recommend a section of the render is opened up, particularly bearing in mind the cracks that are in the building and we suggest the opening up is around these.

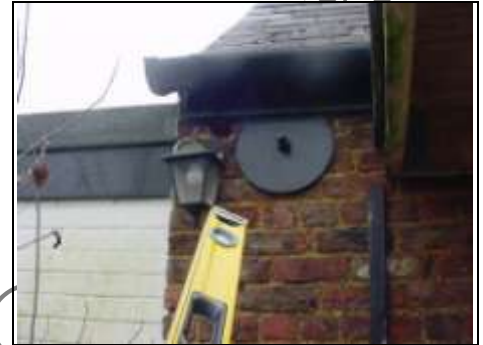
Also to the rear right side is a tie bar. There may be others in the walls that are well hidden, these were used for giving additional support to buildings. It is important that they are not just removed. This looks like a modern tie bar which may of replaced an older one that failed.

Tie bar to the right side

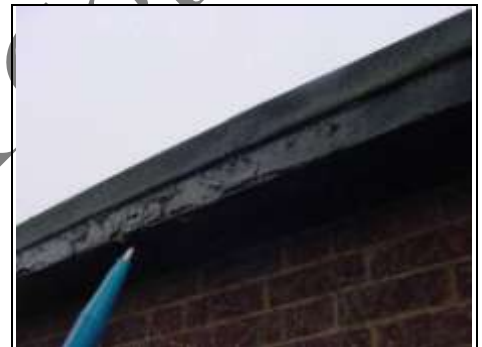
The fascias and soffits are timber. They are painted and we would comment they are in need of redecoration and repair once the works to the roofs and rainwater goods are completed.

Paintwork blistering to fascias and soffits

**ACTION REQUIRED:** Once the roof work has been carried out and the gutters and downpipes are water tight, then look at painting the fascias and soffits as they are relatively low in the priority list at the moment.

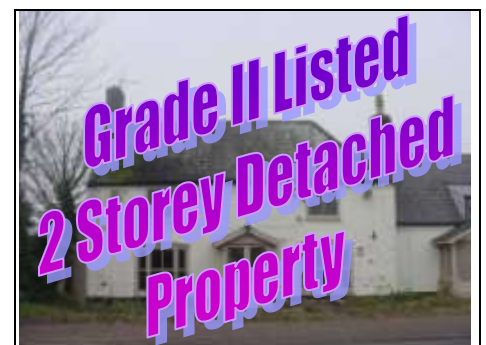
You have a good selection of older style windows and doors, with sliding sash windows and casement windows.

Sliding sash windows to the front

**ACTION REQUIRED:** Careful repairs need to be carried out to the windows. Once these have been carried out it is equally important to paint them in the right paint.

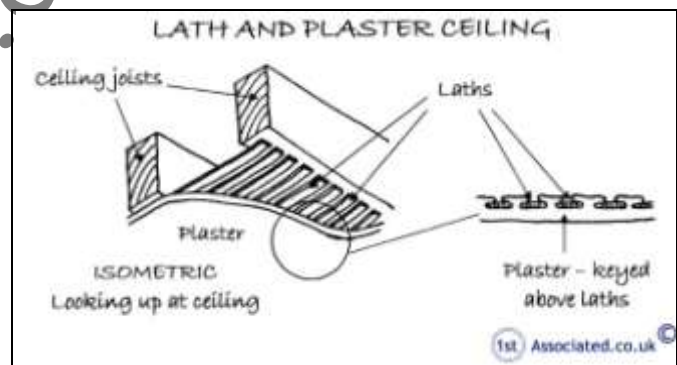
In the older part of the property you have a lath and plaster ceiling, we would always recommend wherever possible you keep lath and plaster ceilings particularly where the building is Listed. Lath and plaster tends to use a lime plaster which is a white chalky colour.

Lath and plaster ceiling

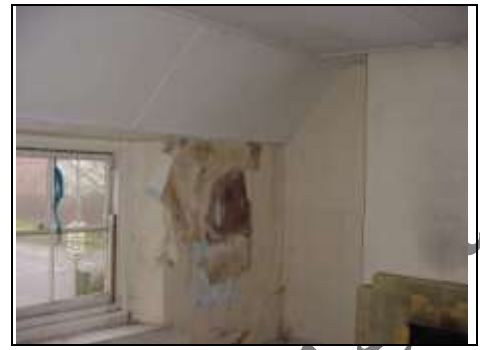
*The front left hand part of the property there is the old white lime plaster with the pink/red colour which is the gypsum plaster.*

Gypsum plaster to front left ceilings

**ACTION REQUIRED:** Where any repairs are needed in the older part of the building we would recommend keeping with lime plaster.

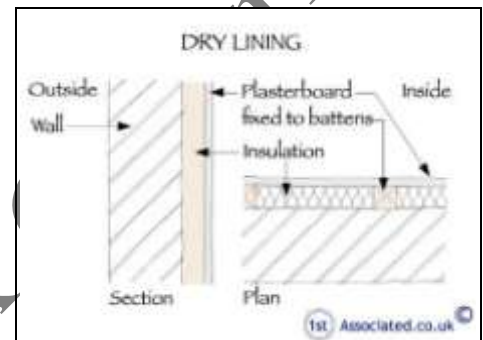
Dry lining

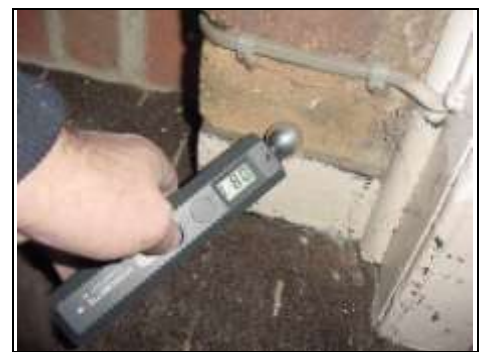
A visual inspection and tests were carried out with a moisture meter to the perimeter walls. In this particular case much of the dampness was hidden by the dry lining (please see our earlier comments), however where we could get back to the actual walls themselves there was damp. We believe this will be reduced considerably when the work is carried out to the exterior of the building that we have mentioned.

Testing for rising damp

Please do not deal with rising damp specialists, damp proof course insertion or anything like that on this age of building as these buildings need to breathe. This is what you need to do and is what has been explained in the External section of this report. Gradually and relatively slowly the building will start to dry out.

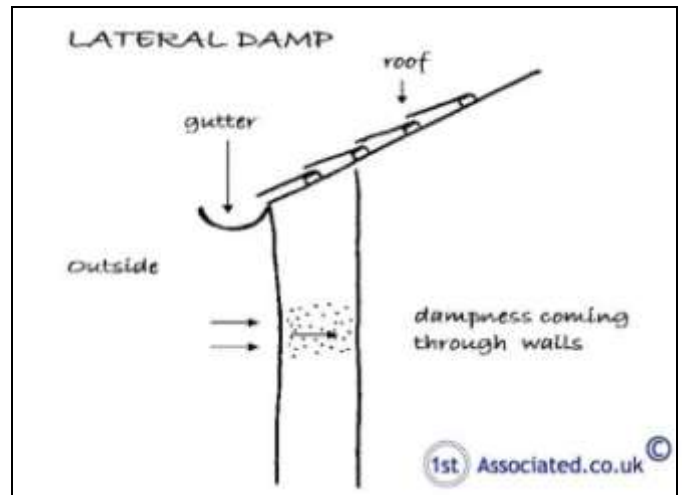
We used a resistance meter on the external walls. We found dampness but again the property has been empty for some time and we would advise if you carry out work on the exterior of the building, gradually the interior will dry out.

Lateral damp

**ACTION REQUIRED:** Please see our comments in the Executive Summary.

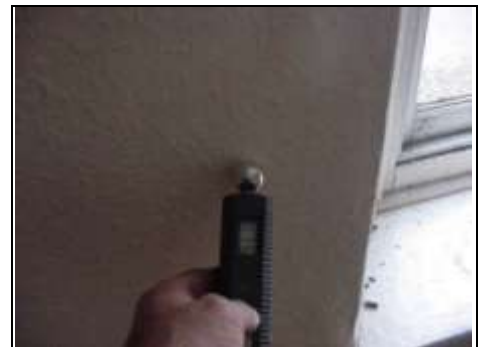
Testing for lateral dampness

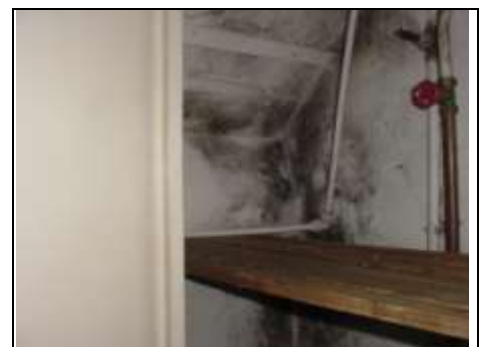
At the time of the inspection there were signs of condensation and black mould in the rear bathroom. We often find in older eras of property such as this where they have had modern facilities such as showers etc. added, there has been insufficient extraction and ventilation allowed which can lead to black mould.

Mould in the rear bathroom

**ACTION REQUIRED:** We would recommend large humidity controlled extract fans be added to kitchens, bathrooms and any rooms where you intend to dry clothes.

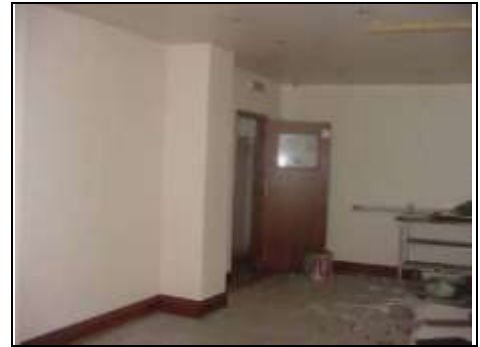
The property has a mixture of doors from what we would term as commercial veneer doors with vision panels, to modern egg box style doors.

Veneer with vision panel door

We personally would look at renewing all the modern style doors.

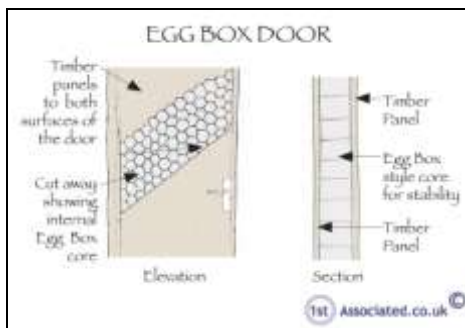
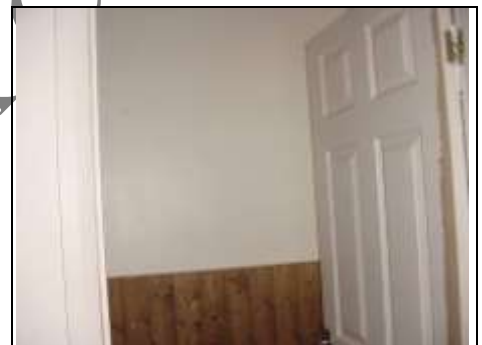
Egg box door

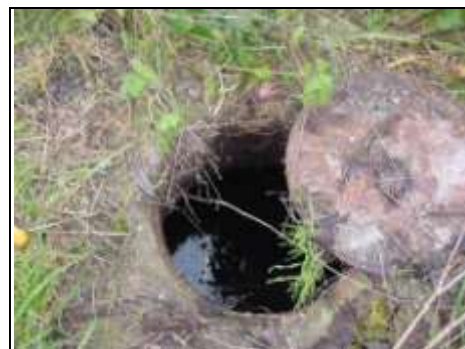
Most older properties would have had a well. In your back garden there is a circular manhole cover that is either covering over a septic tank or a well. We would normally be able to smell the difference but we assume that as the property has been unoccupied for such a long time that even a septic tank would just be full of water.

## Well in the garden

**ACTION REQUIRED:** We would pump out all the water in the septic tank / well to check out how it is constructed and what is in there. If it is a septic tank as we suspect, then there may still be a well in the garden. We have in the past used divining rods which are a metal devise for finding water to locate exactly where a well is.

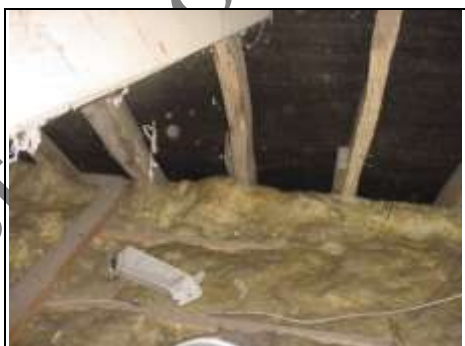
There were various levels of insulation within the roof ranging from 100mm to over 300mm. Current Building Regulations requirements of 300mm.

Insulation in the older roof

**ACTION REQUIRED:** We would take all the insulation out within the older roofs so you get a good look at the entire roof structure so you can best repair it.

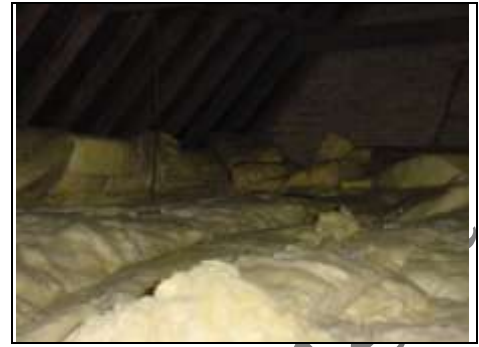
Mass of insulation in the modern roof over the function room

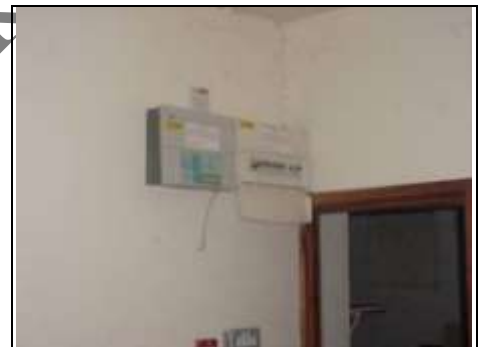
The electric fuses and consumer units were located in the function room and the bar and we would not be at all surprised if there are other fuse boards throughout the property. What tends to happen with pubs is the electric gets added to and added to over the years and unless there is a major extension carried out, the property rarely gets re-wired. For this reason, we recommend that you start again, all be it majority of the fuse boards are from the 1970's and 1980's and possibly even more recent than that.

Fuse Board in the function room

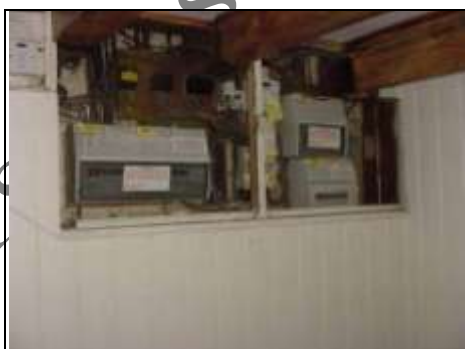
Fuse Board in the bar

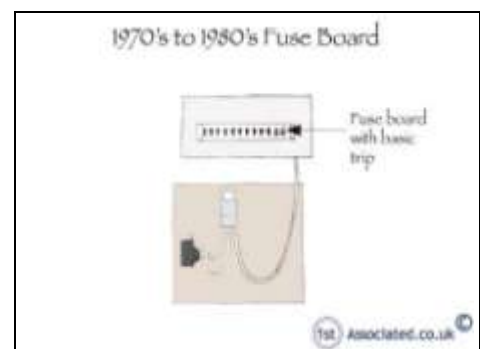
1970's to 1980's Fuse Board

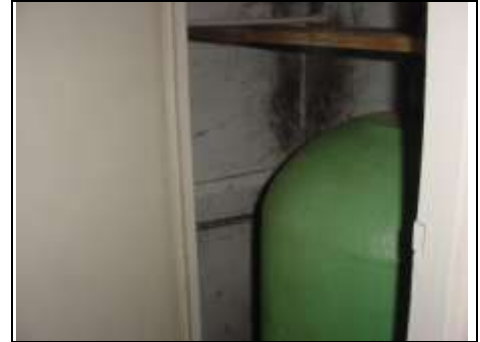
There is a factory insulated hot water cylinder located within the shower room. This cylinder will therefore have a good thermal efficiency, although not as good as the more modern hot water cylinders.

Hot water cylinder

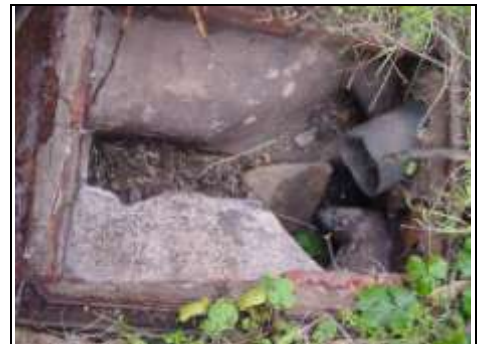
We duly lifted the cover and found it to be blocked and dry at the time of our inspection.

From what we could see it is concrete built.

Manhole to the rear

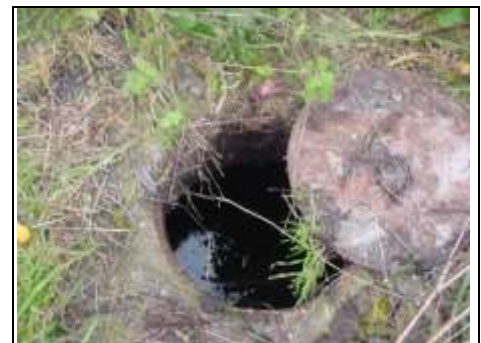
We found another manhole to the rear that maybe a well or maybe a septic tank. Please see our comments in the Well Section.

Septic tank / well

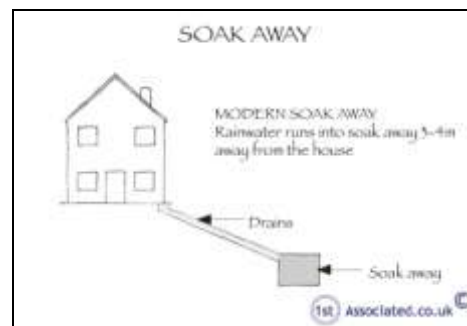
We have been unable to determine the ultimate means of rain/surface water disposal. The ones we could see where discharging directly onto the ground.

Soak-away

**ACTION REQUIRED:** We recommend soak-aways are added to get the water away from the building.

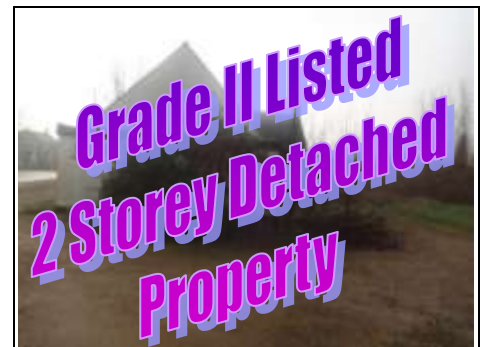
There is parking to the right side of the property.

Parking to the right

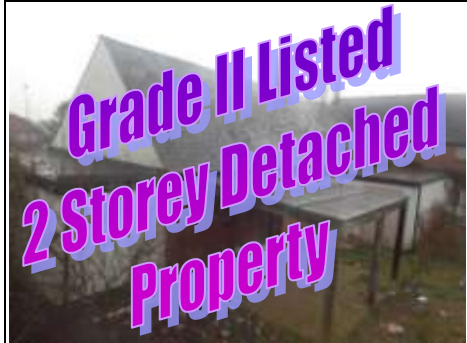
The rear garden is very overgrown and what we would term as quite swampy in some areas.

Rear garden

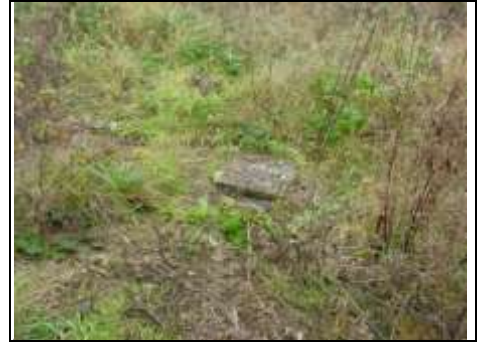
Swampy rear garden
