RESIDENTIAL BUILDING SURVEY

London W7 xxx

INDEPENDENT CHARTERED SURVEYORS

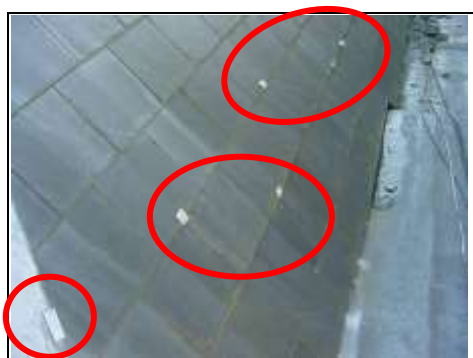
Surprisingly we noted lead tingles to the manmade slate roof over the loft conversion. We say surprisingly as we believe this to be a relatively new loft conversion (in building terms we mean the last 50 years).

The light coloured clips are the lead tingles to loft conversion roof on the right hand side

Depending upon how long before this work commences we would suggest some repair work be carried out. We believe you are not intending changing the main roof/loft conversion roof and therefore we feel it best to remove a portion of the slates, particularly to the left hand side, to check that they have been fixed correctly, as it is very unusual to have lead tingles being used on such a relatively new roof.

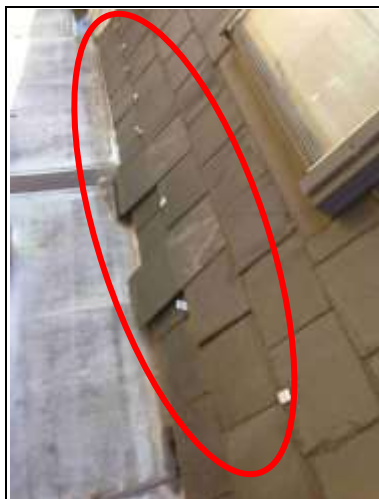
Left hand view of roof; far too many lead tingles and slates completely slipped

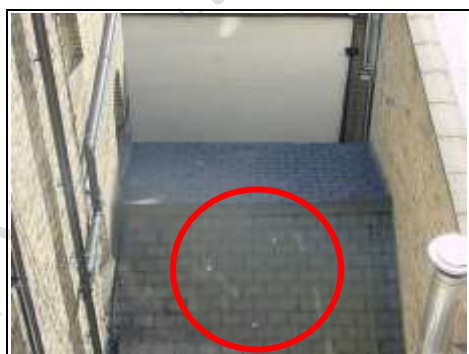
We can also see tingles to the rear roofs where you are proposing to carry out extension work, and in addition to this on the single pitched roof we can see there are lead flashing problems.

Lead tingles on double pitched lead roof to rear

ACTION REQUIRED: We would normally discuss the repair of the main loft conversion roof, the rear double pitched roof and the rear single pitched roof, but you have advised us that you proposed to carry out extension works in these areas in which case the roofs will be replaced.

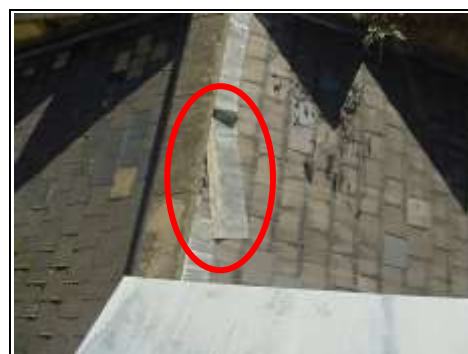
Lead flashing coming away on rear single pitched roof to your side

We would recommend that the flashing to the rear single slate roof is replaced/repaired.

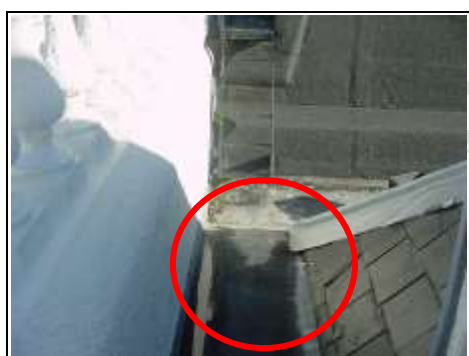
Box gutter to front

The problem with leaving box gutters is that unless detailed very well they will sooner or later let in rainwater. We will be able to advise you better when we know how quickly you wish to carry out extensions and refurbishments to the property. We would say they could be left in the medium term but not in the long term, i.e. more than a year.

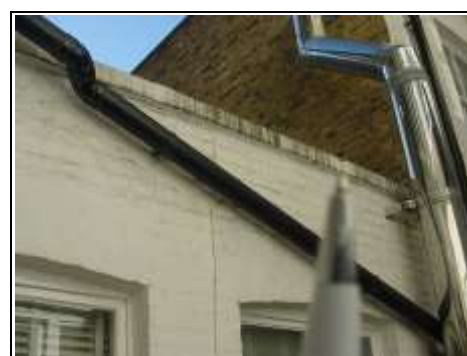
We also believe there are problems with the double pitched slate roof to the rear due to the staining we can see on the box gutter. This is the roof you are looking to extend upwards, so again it depends upon how quickly this work can be carried out as to whether repairs are necessary.

Problem with box gutter over this section which consists of lounge and boiler room

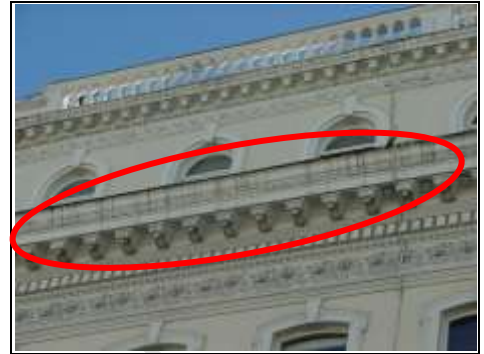
Balustrade and ledges

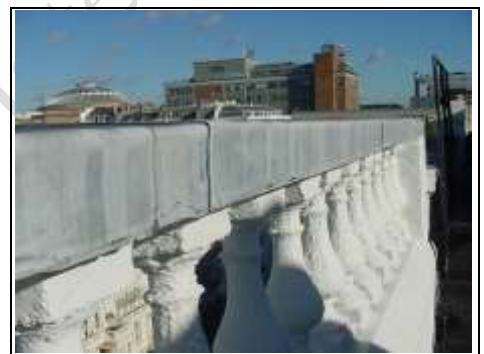
Balustrade/parapet to front
with its own capping

Two particular areas where there are definitely problems are to the front parapets/balustrades where dampness was found coming in on the fourth floor, and also to the rear parapets/balustrades where we could literally see plants growing from it.

ACTION REQUIRED: Check box gutters and make watertight.

ANTICIPATED COST: The front of this is high level work and is likely to require the lifting of the existing lead box gutter, as well as a close examination of the exterior of the property with a cherry picker and the difficulty of resolving this type of problem we would expect costs of between £5,000 to £20,000, depending upon what is found when high level viewing is carried out. Please obtain quotations.

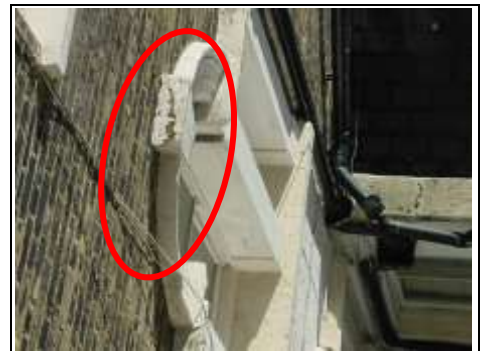
Dampness to the mouldings around
the window and the keystone where
there is a ledge

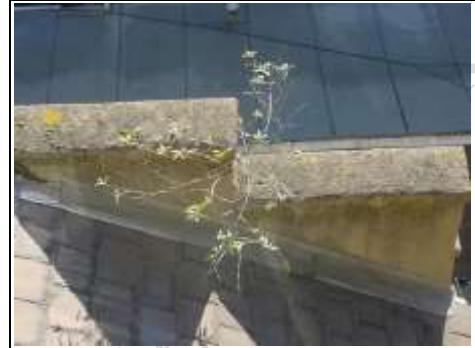
Rear parapet wall/balustrade without box gutter detail. Plants growing from it indicate that dampness is getting in to it

The first parapet/balustrade area is one that needs dealing with, the second area a tactical decision needs to take place as this is also an area you are looking at extending.

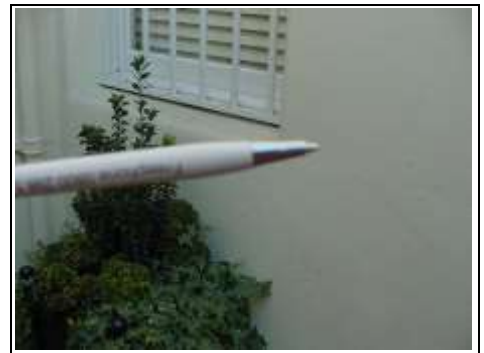
We can see from the change in the render on the outside of the walls that there looks to have been long term problems in this area and previous work has been carried out to try and rectify it.

Re-rendering has taken place to the front of the property

It may be that the work is under guarantee and we would suggest that the contractors come back to fix the problem, however in our experience it is very difficult to get good quality work carried out under guarantees and we think in this case it may well be the wrong solution.

Although further investigation is required we would recommend a French drain or re-rendering and re-plastering in a breathable lime based render/plaster as being a better solution.

ACTION REQUIRED: Further investigation recommend, but from our initial findings we would feel that the adding of a French drain to give the rainwater a path away would be the best option.

ANTICIPATED COST: Costs in the region of £15,000 to £30,000, particularly if the French drain leads into the drainage system. Please obtain quotations.

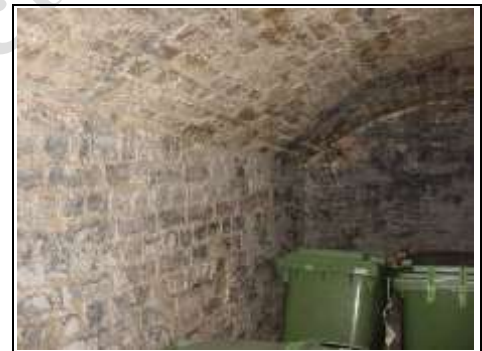
There are vaults to the front of the property under the road. This is a very good area to gain extra space, but they do have problems with dampness getting in them but they can be used as non-habitable spaces, such as shower areas, utility areas and kitchens at a push.

Vault under road

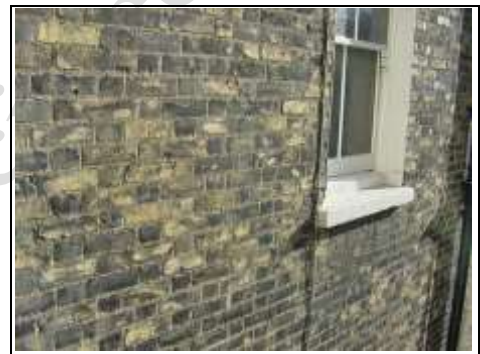
Flemish Bond brickwork at high level

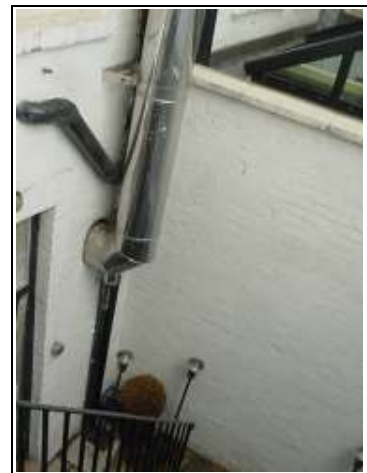
Painted brickwork at low level

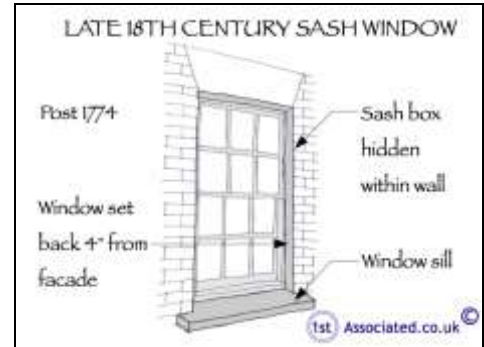
The windows are timber sliding sash windows. In many cases they are in need of complete redecoration and in most of these cases they are in need of not only redecoration but cutting in and splicing in of new timbers.

Sliding sash window

ACTION REQUIRED: Splice in new timbers, make general repairs and repair, prepare and redecorate.

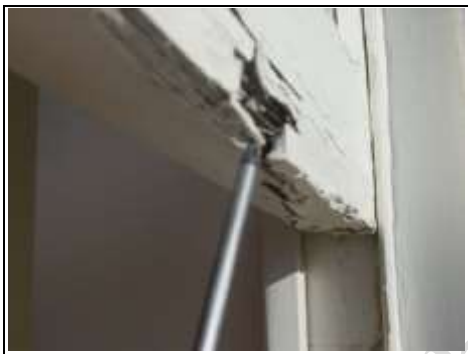
Rotting timbers

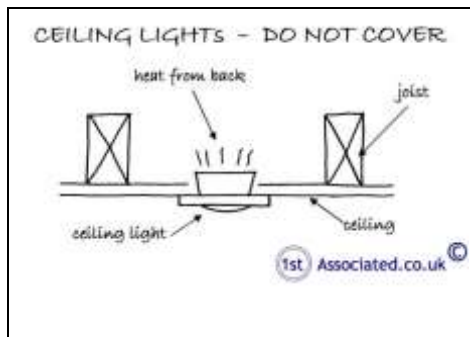
Some of the ceiling lights are an older style which may overheat and are therefore a fire hazard. We recently carried out a survey on a property that where there had been a fire due to overheating of ceiling lights.

Ceiling lights sketch

ACTION REQUIRED: As mentioned previously, you need to have an IEE test and report carried out on all the electrics by an NICEIC electrician or equivalent.

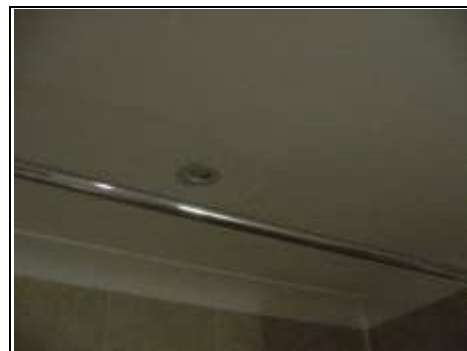
Ceiling light in lower ground floor apartment

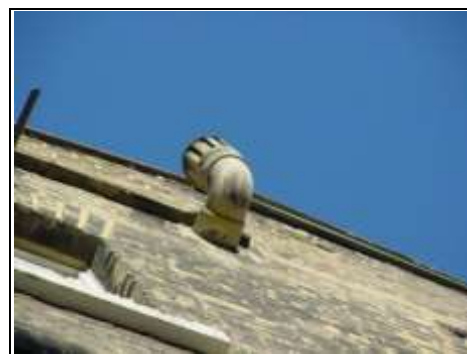
We find that properties of this Era that have been modernised it is common to find asbestos. In this case we noted asbestos flues to the main/loft conversion roof and to the rear roof.

Asbestos flue to rear

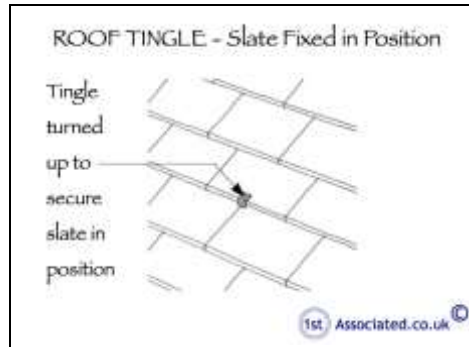
1. We were surprised about the condition of slates to the relatively new loft conversion roof and the fact that they were being held in place using lead tingles.

Lead tingles

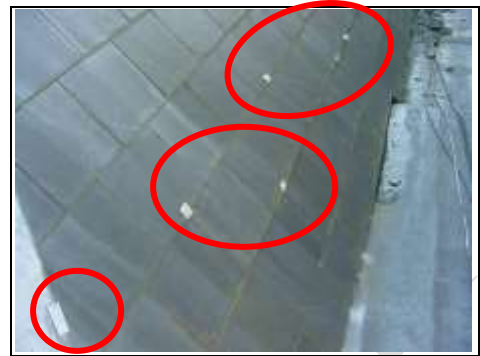
Lead tingles to manmade slate loft conversion roof

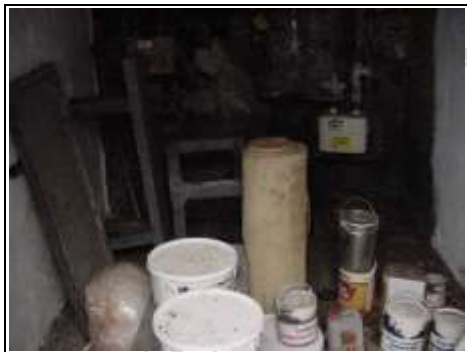
Left hand vault

The vaults under the road are currently used for bin storage and building material storage. They could be added into the design, although we would suggest due to the dampness in these areas that they are used for non-habitable rooms.

ACTION REQUIRED: Your solicitor needs to specifically request if there are details with regard to taking or waterproofing to the lower ground floor level as this can add considerably to costs.

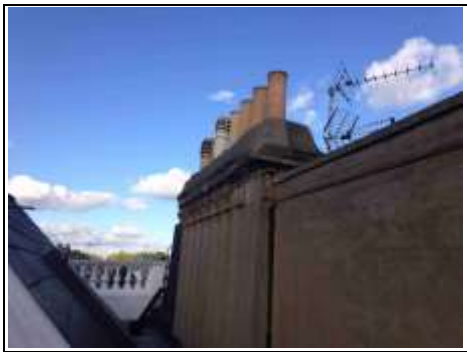
Chimney to front left side

The chimneys are weathered and there are areas of hairline cracking, therefore we suspect dampness is getting into the structure, although we cannot physically see this and have no evidence, however it is a typical problem relating to this age, type and style of property.

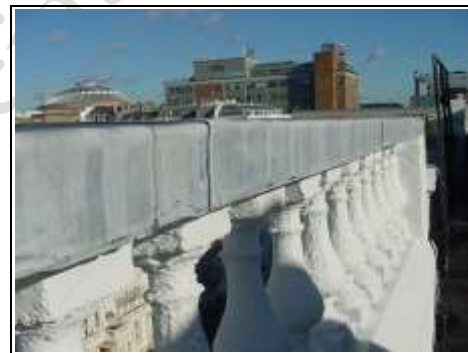
In this case there are parapet walls/balustrades to the front elevation of the property and to the rear. We believe they are allowing water into the structure. To the front we can see the balustrade has had a lead capping added but we obtained readings internally in the apartment below indicating dampness.

Lead capping to front balustrade

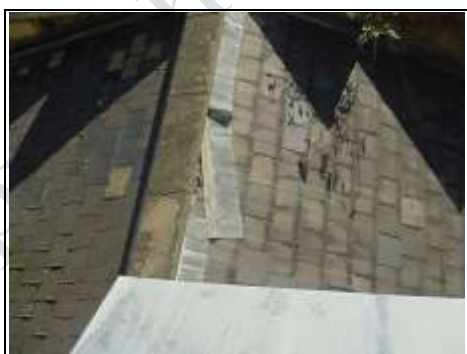
To the rear we could literally see that the lead flashing has been displaced and there are plants growing from the parapet wall/balustrade.

Parapet wall on rear pitched roof

ACTION REQUIRED: With regard to the rear issues it depends upon the length of time before you are carrying out the major works to the property. Please see our comments in the Executive Summary.

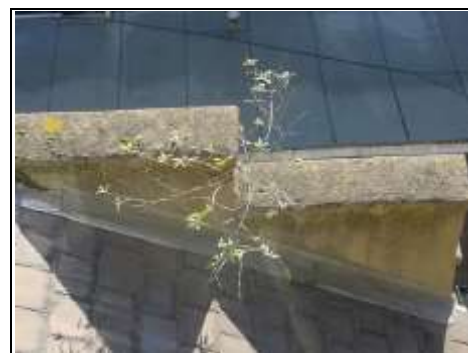
Plant growing out of parapet wall

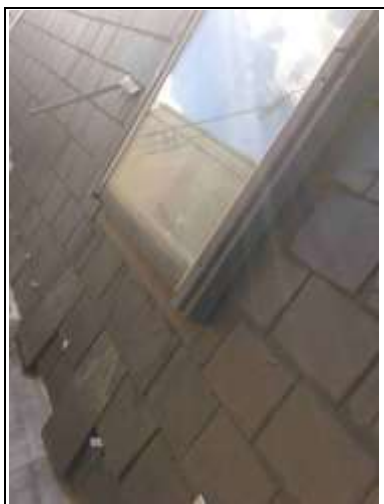
Roof window to front left hand side

The property has roof windows to the fifth floor. Flashband repairs around the rear window indicate there have been problems with the roof window.

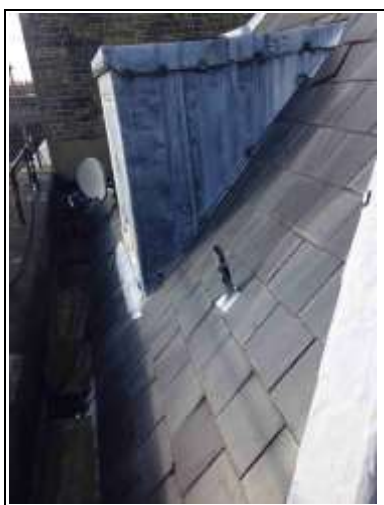
Dormer window

The property has a dormer window on the manmade slate roof. It is lead covered and looked in reasonable condition, with the exception of the timber window that needs repair and redecoration.

ACTION REQUIRED: Repair and redecorate timber window.

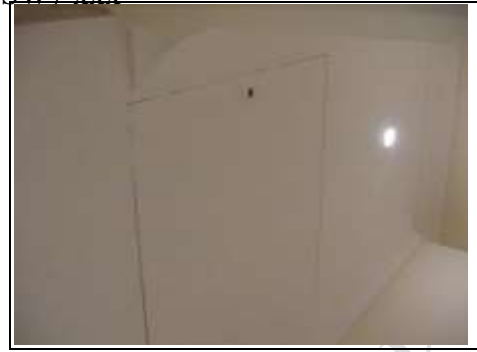
Also, the loft hatch on the lower ground floor was painted shut. Again, if this can be opened we would be more than happy to return and review.

Loft hatch painted shut on lower ground floor

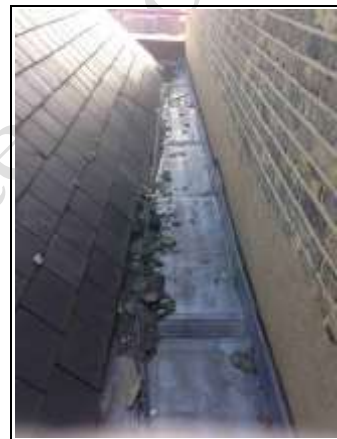
The main roof/loft conversion roof and rear roof are both drained via box gutters. We were pleased to see that in many areas these were lead. The lead looks to have a fall on it with steps in it (although you can only truly be sure if you are literally standing on the roof when it is raining) and they also have rubber expansion joints in the lead, which we particularly like, although you do need to check them to ensure they do not perish.

Stepped box gutter to right
hand side of main/loft
conversion roof

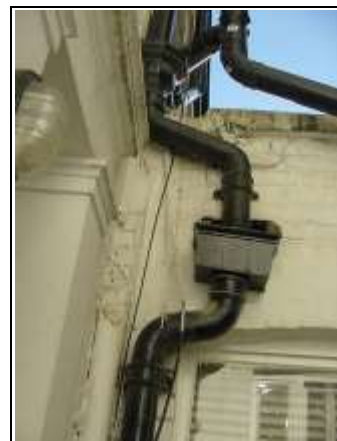
The hopper heads, gutters and downpipes that we can see are in need of redecoration and there may be some minor leaks.

Cast iron hopper head

ACTION REQUIRED: We would always recommend redecoration in the summer of 2014 or incorporating this work within the redevelopment work of the property.

We would also recommend that the gutters and downpipes are cleaned out, the joints are checked and the alignment checked to ensure that the gutters fall towards the downpipes.

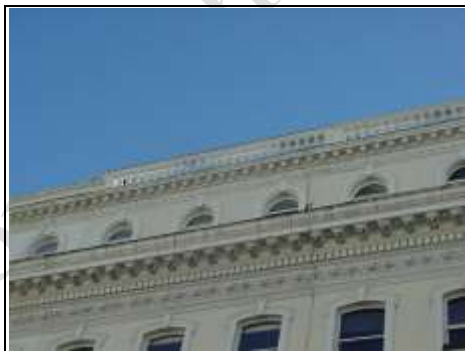
High level render

We believe the ledge on the frieze and the box gutter above is allowing dampness into the front wall.

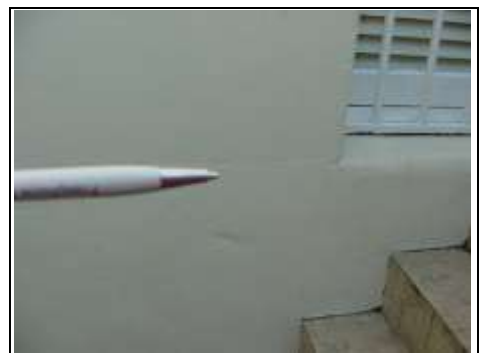
We note at lower ground floor level that repairs have been carried out to the render. These are typically carried out to try and resolve dampness problems, normally with the replacement of the render with a waterproof based render.

Re-rendering at
lower ground floor level

ACTION REQUIRED: You need to make enquires with the existing owners to check and confirm what information they have in relation to the re-rendering work.

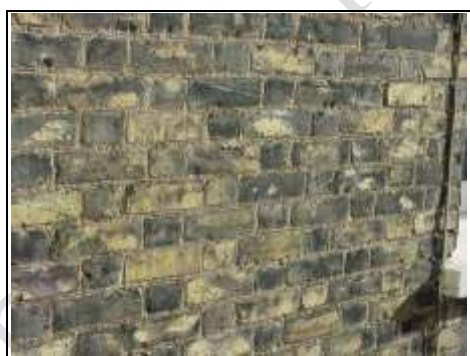
Rear brickwork where ad hoc repointing is needed

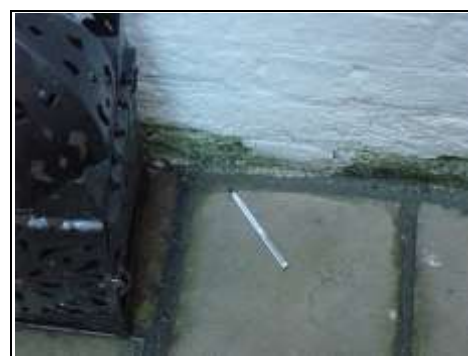
Painted brickwork to rear with areas of mould to the base

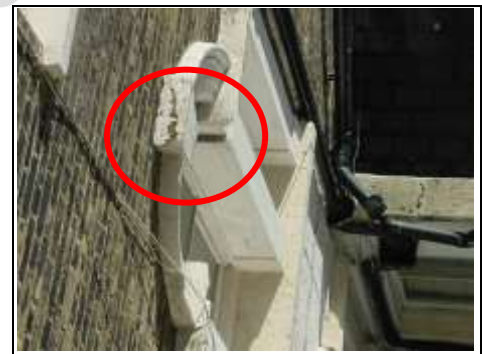
A feature of this era of property is the mouldings around the windows and doors. Equally they can give ledges that water can sit on, for example the keystone to the top of the arch over the window in the adjacent photo.

Keystone on arch of window

ACTION REQUIRED: You do need to ensure that when the repointing has been completed that you also redecorate all the mouldings. Please see our comments in the Executive Summary.

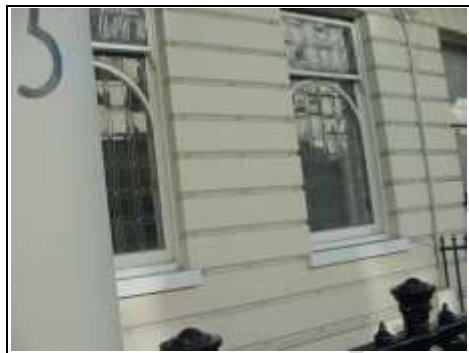
The property has single glazed timber sliding sash windows. We would specifically comment the timber is in below average condition and will need repair. We would expect new timbers to be spliced in.

Single glazed windows

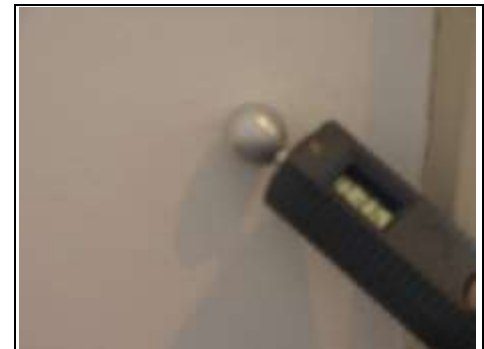
A random visual inspection and tests with a moisture meter have been taken to the perimeter walls. In this particular case we have found dampness.

Testing for rising damp

ACTION REQUIRED: Please see the Executive Summary

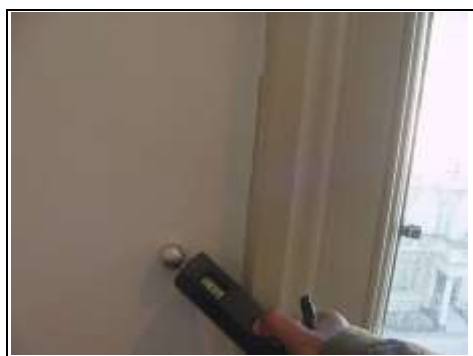
We used a damp meter on the external walls. We have found lateral dampness.

Testing for lateral dampness

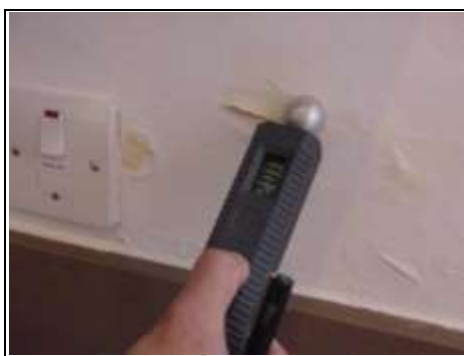
Dampness on fourth floor from box gutters above

ACTION REQUIRED: Please see our comments in the Executive Summary.

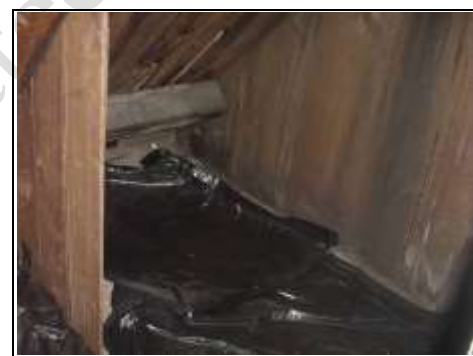
Dampness getting into roof on fifth floor

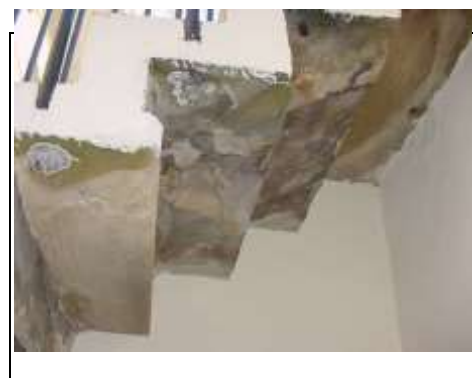
Underside of steps showing water getting through

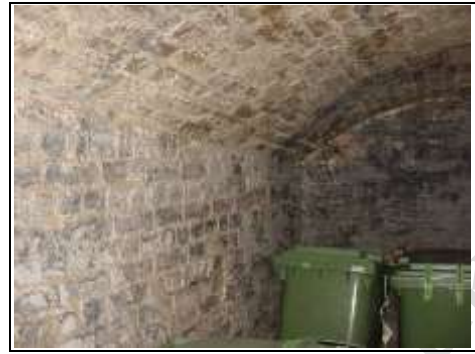
Vault under road currently being used as a bin store

ACTION REQUIRED: Please see our comments in the Design Section of the Executive Summary.

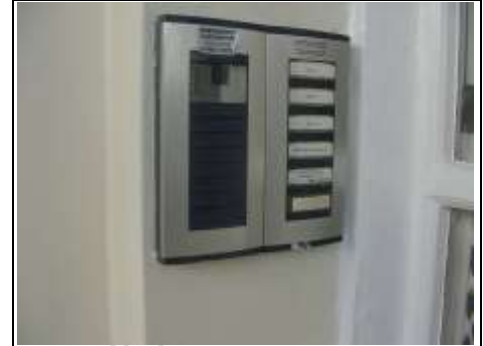
Door entry system

ACTION REQUIRED: Further information should be obtained from the vendor and the installer.

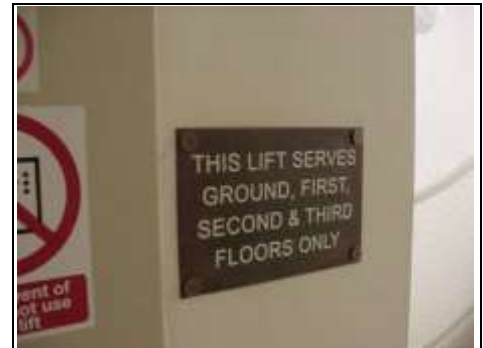
Lift sign

ACTION REQUIRED: Your solicitor should ensure that your lift is on a regular maintenance contract and that there are no anticipated future replacement costs.

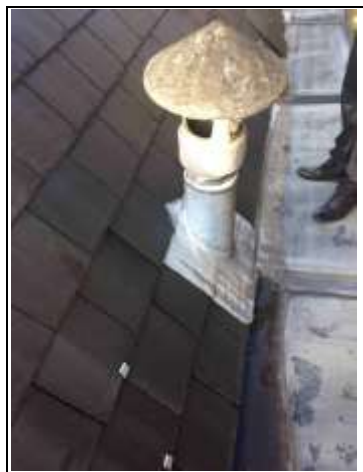
In a property of this age there may well be some asbestos. In this case we have noticed there is an old asbestos flue to the side of the building and also at roof level to the rear.

Asbestos flue to main/loft conversion roof on left hand side

We are Building Surveyors and not Asbestos Surveyors and as such the only way to be a hundred per cent certain with regards to Asbestos in a property is to have an Asbestos report carried out.

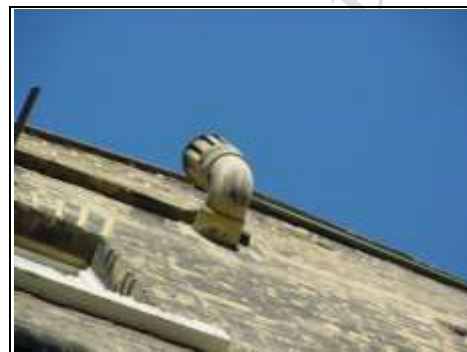
Asbestos flue to rear

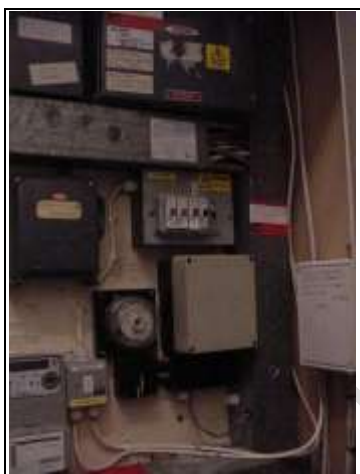
Electrics in cupboard
on ground floor

ACTION REQUIRED: Your legal adviser to obtain any records and ensure that the electric system is up to standard.

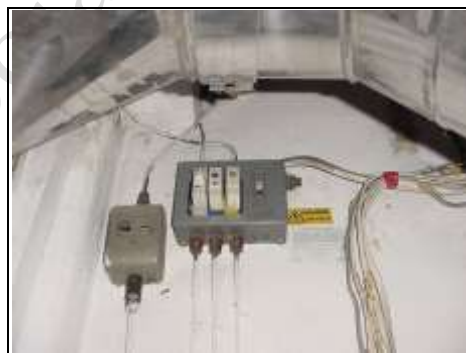
Electrics in boiler room

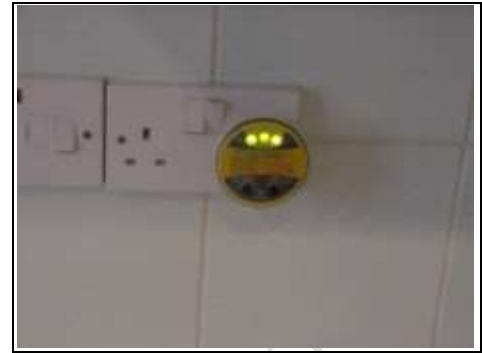
We carried out an earth test in a few of the kitchens and these have been satisfactory.

Earth test taken in
ground floor kitchen

ACTION REQUIRED: As the property is changing occupancy an Institute of Electrical Engineers (IEE) test and report should be carried out by a NICEIC registered and approved electrical contractor or equivalent.

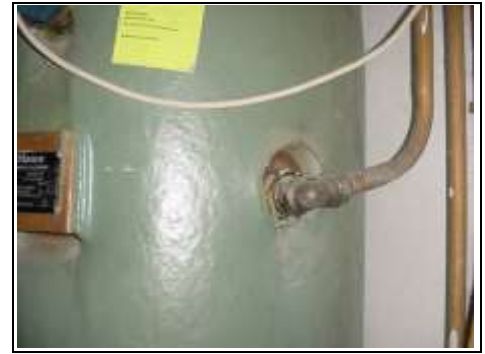
We believe you need to look at the provision of hot water throughout the property again. We cannot believe this one hot water cylinder provides water for the various apartments (excluding the top floor which has a separate system).

Factory lagged hot water cylinder in middle void

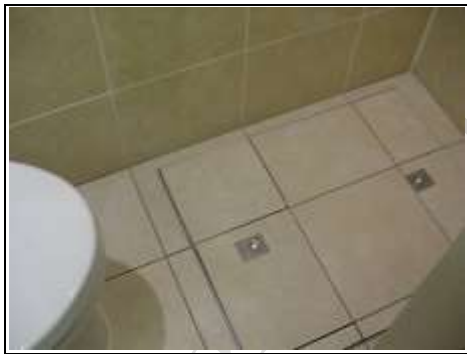
Manhole in lower ground
floor apartment

ACTION REQUIRED: A closed circuit TV camera must be put down the drains to establish their condition, particularly as they are about to have an increased loading if you are going to split the property into several/many units. This can often be a weakness in refurbishment projects where the drains are not brought up to the standard required.

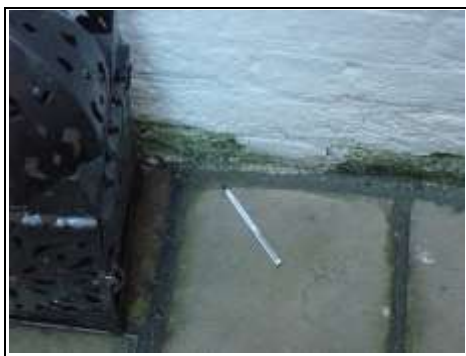
Tiled floor with areas of mould

ACTION REQUIRED: Please see our comments with regard to dampness in the property in the Executive Summary and the Walls Section.

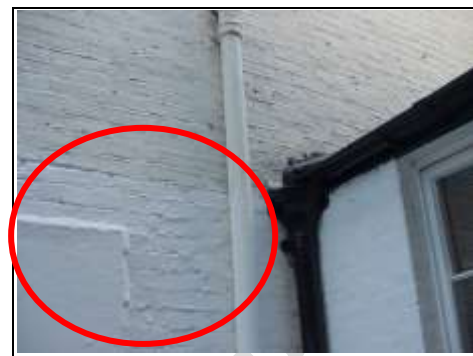
Wall only painted to bottom half
